PRODUCT CAMPAIGN BULLETIN

APPLICABILITY: SUBJECT: 2005~06MY Subaru Baja Fuel Pump Outlet Pipe
 NUMBER:
 WVJ-20R

DATE:
 October 2009

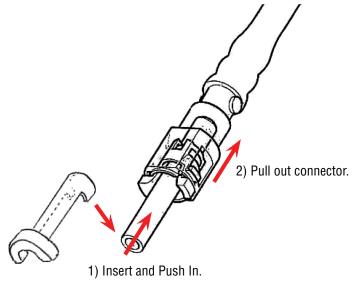
The special tool: 42099AE000, which is set up to separate fuel hoses with quick connectors in the engine compartment, can also be used for return and delivery sub hoses. The quick connector can be unlocked by inserting the special tool around the pipe and pushing it forward as shown. Pull out and separate the connector.

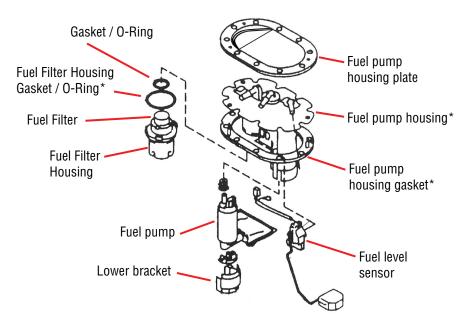
(*) Indicates replacement part contained in Fuel Pump Housing Kit P/N 42029AE02A

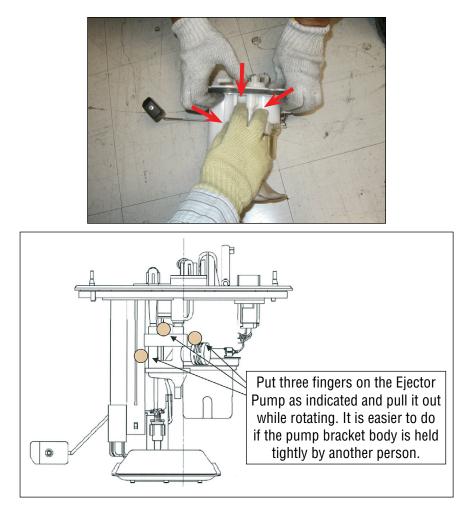
2) Put three fingers on the Ejector Pump, as indicated in the photo and illustration (this should be done with the assistance of another person.)

3) Pull the Ejector Pump away from the Pump Bracket Flange pipes, while another person holds the Pump Bracket Flange.
