## FIELD SERVICE CAMPAIGN – 18114

06 December 2018

Radiator Stay Rod

WorkStar®

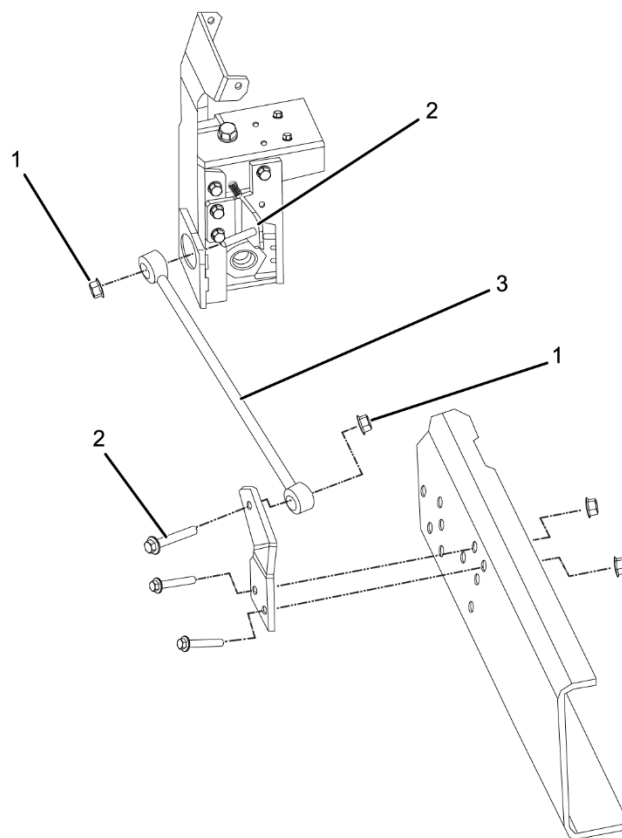
**Figure 1. Stay Rod**

Certain WorkStar® models may have been built with a left-side radiator stay rod of insufficient length, resulting in reduced radiator to fan clearance.

1. Nut (2)
  2. Bolt (2)
  3. Left-side stay rod
- 
7. Remove bolts (Figure 1, Item 2) and nuts (Figure 1, Item 1) from left-side stay rod (Figure 1, Item 3), refer to appropriate service manual for detailed instructions. Save bolts and nuts for reuse.
  8. Remove stay rod.
  9. Install new radiator stay rod using existing bolts and nuts.
  10. Using a torque wrench, tighten bolts and nuts to 90 - 100 lb-ft (122 - 135 N•m).
