FIELD SERVICE CAMPAIGN – 18121

18 December 2018

Front Axle Left-Side Spring Spacer

International® MV™ Series and DuraStar®

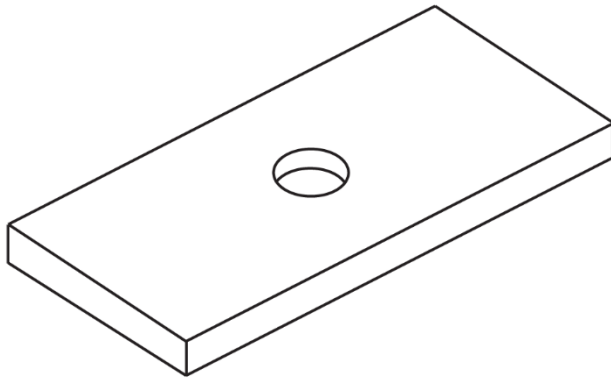
Figure 1. Spacer

Certain MV™ Series and DuraStar® models may have been built with an incorrect spacer for the left-side front axle spring resulting in a lean condition.

NOTE: Ensure the lower tabs fit into the hole in the axle and the center pin tab of the spring fits into the spacer.

9. Insert spacer (Figure 1) on left-side with tab pointing down.
10. Raise floor jack to remove any space between spacer, axle and spring.
11. Install new U-bolts.
12. Using a torque wrench, in a diagonal pattern, tighten U-bolts in 50 lb-ft (68 N•m) increments to a final value of 260 – 300 lb-ft (192 – 222 N•m).
13. Lift vehicle and remove jack stands.
14. Lower floor jack and remove from under vehicle.
15. Remove wheel chocks.
