**Document ID:** IK1200163

**Title:** Updated I6 EVRT/VGT Diagnostics Check Sheet and Turbocharger Repair Procedures for engines that exhibit DTC 353 / 354

**Applies To:** 2004- 2006 MY EGR DT 466 and 570 with EVRT/VGT Turbos with ESN 2,000,001 - ESN 3,000,000

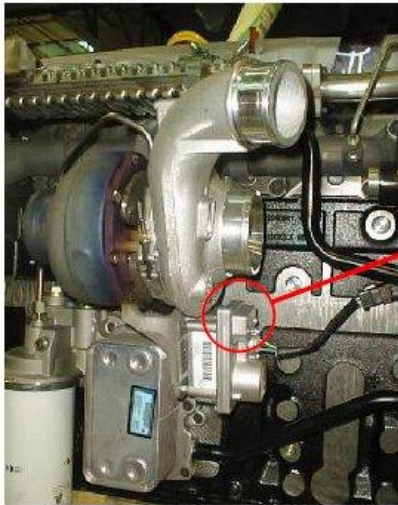
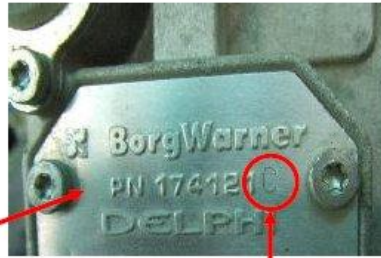
Suffix Stamp Location

2. Locate and identify the Suffix Stamp next to the Borg Warner Actuator Part Number embossed on the name plate. The Suffix Stamp will be a letter designation, but also maybe blank and not have a Suffix stamp letter.

**Decision Step 4A:** If it does not have Suffix stamp next to the part number, replace the actuator with Actuator Service Kit P/N 1847620C91.

**Decision Step 4B:** If the Suffix stamp next to the part number is A, B, C or D, replace the actuator with Actuator Service Kit P/N 1847620C91.

**Decision Step 4C:** If the Suffix stamp next to the part number is E, go to Step 5 Check the EBP Sensor Part Number.

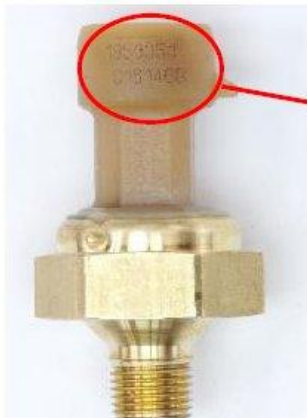
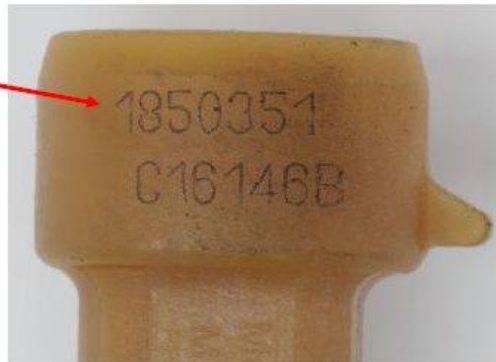
The printed part number will appear on 2 lines of the sensor body. The seven digit part number will be on the first line, and the second line will start with the part number suffix (ex. C1).

**Decision Step 5A:** If the EBP Sensor is not part number 1850351C1, replace the sensor.

**Decision Step 5B:** If the EBP Sensor is part number 1850351C1, The sensor does not need replaced unless you suspect EBP sensor is out of range. perform the EBP diagnostics steps in the Engine Diagnostic Manual [EGES 270-1 EBP Sensor](#) to validate the EBP sensor.

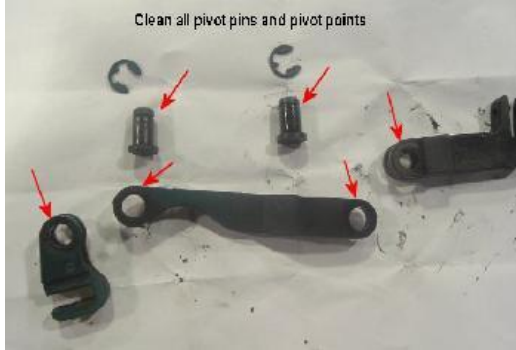
**Decision Step A:** If the linkages and pins are excessively worn (steps or elongated holes), replace the linkage.

**Decision Step B:** If the linkages and pins are not excessively worn, continue repair the linkage.

3. Apply anti-seize compound to all points of contact on the fork levers, pins, and the linkage using 1870706C1 Lubricant or commercially available equivalent.
