**Title:** IC Bus with ISB Frequent Regeneration**Applies To:** IC Bus ISB

This document will guide the user through resolving Frequent Regen issues on IC Bus with ISB 6.7.

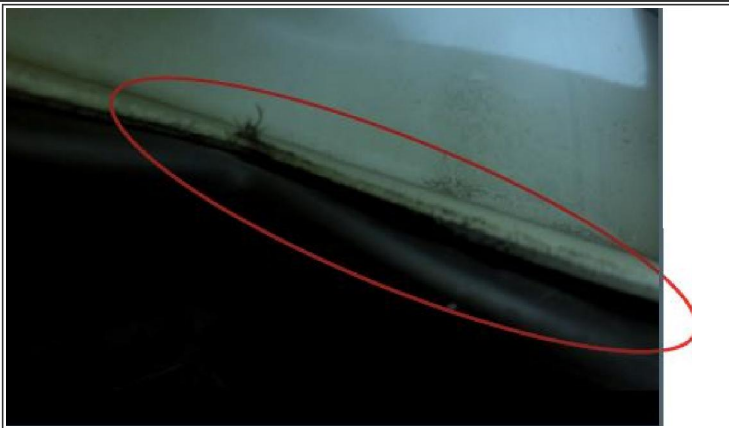
1. Airbox boot seal to the hood compromised. Middle section may appear bent or folded in. The seal position looks off-centered from the hood.

| Step | Action | Decision |
|---|---|---|
| | <b>DIAGNOSTIC:</b><br><br>With the hood in the fully latched position, inspect the accordion boot seal to hood.<br><b>See Figure 1 and 2</b><br><br>Is a gap present between the seal and hood? | <b>Yes.</b><br>Replace the cover assembly. |

**Figure 1: Gap between Boot seal and Hood**

| Step | Action | Decision |
|---|---|---|
| | <b>DIAGNOSTIC:</b><br><br>Use INSITE™ electronic service tool to monitor the compressor intake air temperature and ambient air temperature sensor values.<br>Perform a road test with the engine at peak power and a vehicle speed of 48 km/h [30 mph] or greater.<br>Record the compressor inlet temperature and the ambient air temperature.<br>Calculate the differential temperature:<br>Compressor inlet temp - ambient air temperature = differential temperature.<br>Maximum Differential Temperature = 20°F | <b>Yes.</b><br>Replace the cover assembly and retest.<br><b>See Figure 1 and 2 below</b> |

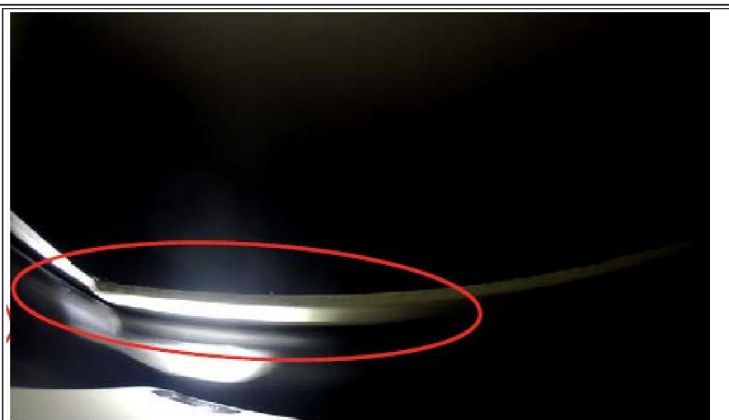
**Figure 2: Hood misaligned with respect to Boot seal**
