**Countries:** CANADA, UNITED STATES **Document ID:** IK2600236  
**Availability:** ISIS, FleetSIS, IsSIR **Revision:** 5  
**Major System:** PROGRAMMING SUPPORT **Created:** 5/9/2018  
**Current Language:** English **Last Modified:** 12/6/2018  
**Other Languages:** NONE **Author:** Charles Schroeder  
**Viewed:** 1039

**Title:** Cummins ECM Programming Procedure for LT, HV, MV, LoneStar

**Applies To:** EPA 2017 Cummins equipped LT, HV, MV, LoneStar built prior to June 4, 2018

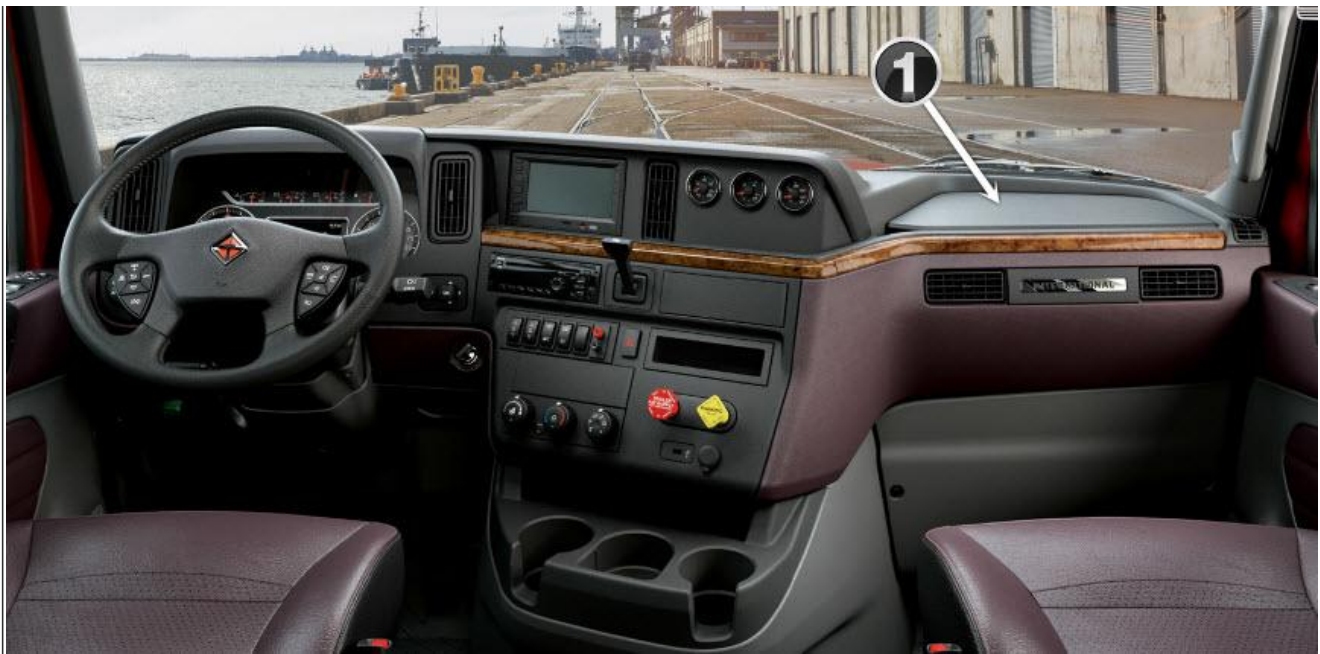
**Figure 1 - Fuse Panel Location**

1. Fuse Panel Cover

- A. Use the 3 pin connector in the engine compartment
- B. Remove the fuses for the door pods (no longer recommended):
  1. Remove the fuse panel cover located at the top of the dash on the passenger side of the vehicle.
  2. Reference the fuse panel graphic and locate the fuse locations for **Driver Side Window/Door/Mirror** and **Passenger Side Window/Door**
  3. Remove both fuses
  4. Connect to the ECM using the vehicle 9-pin diagnostic connector
  5. Update the ECM calibration with INSITE
  6. Once all programming is complete disconnect the service tool from the vehicle 9-pin diagnostic connector
  7. Re-install fuses for Driver Side Window/Door/Mirror and Passenger Side Window/Door
