SI B01 21 18  
Warranties

## **UPDATE !** N63 ENGINE: OIL CONSUMPTION CLASS ACTION SETTLEMENT DIAGNOSIS AND REPAIR PROCEDURES (VERSION 7.0)

This Service Information bulletin supersedes SI B01 21 18 **dated December 2018**

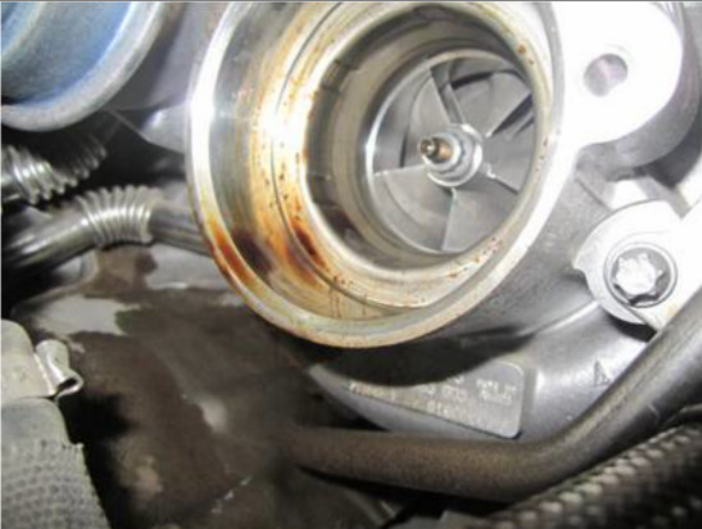
| 9. Inspect the turbochargers for engine oil leakage. | |
|---|---|
| | <p>The turbocharger is OK.</p> <p>No engine oil can be seen around the turbocharger impeller.</p> |

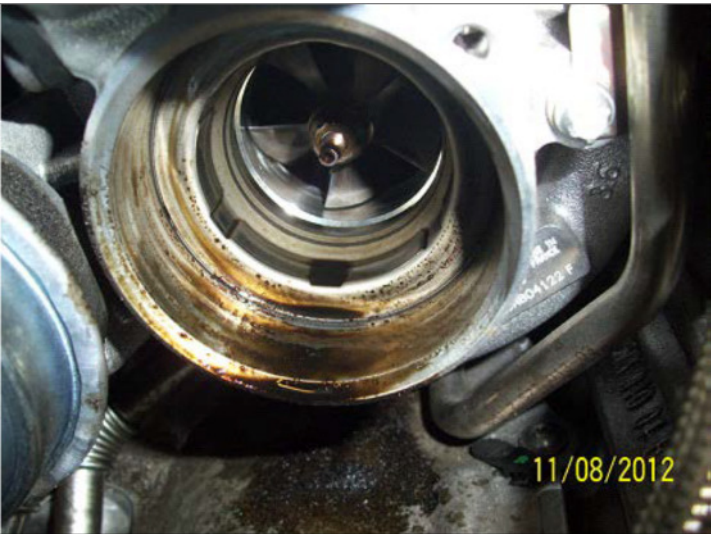
| 9. Inspect the turbochargers for engine oil leakage. | |
|---|---|
| | <p>The turbocharger is OK.</p> <p>No engine oil can be seen around the turbocharger impeller.</p> |

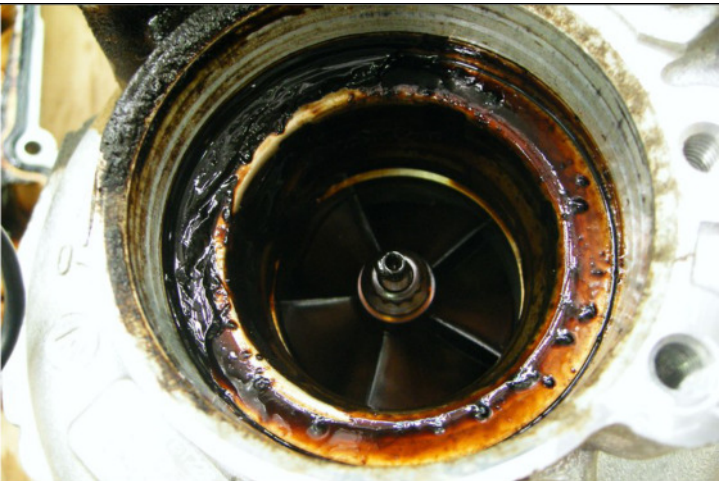
| 9. Inspect the turbochargers for engine oil leakage. | |
|---|---|
| | <p>The turbocharger is not OK.</p> <p>The turbocharger impeller seals are leaking engine oil.</p> |

If the turbocharger inspection is "NOT OK", then replace the turbochargers in conjunction with the recommendations in step 10. Go to step 10.

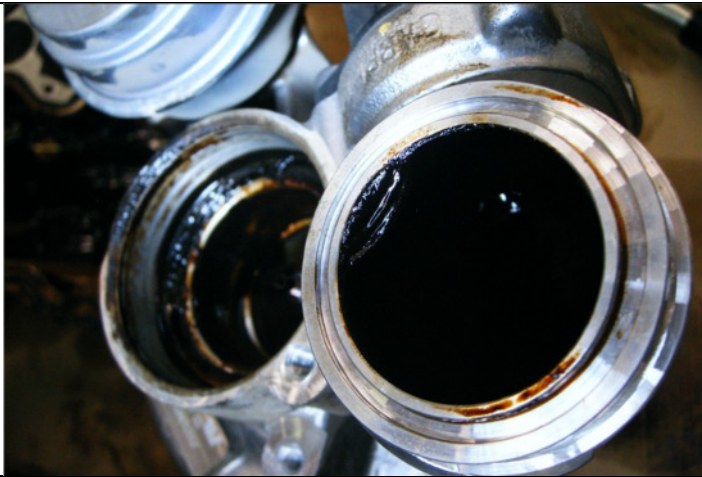
The turbocharger is not OK.

The turbocharger impeller seals are leaking engine oil.

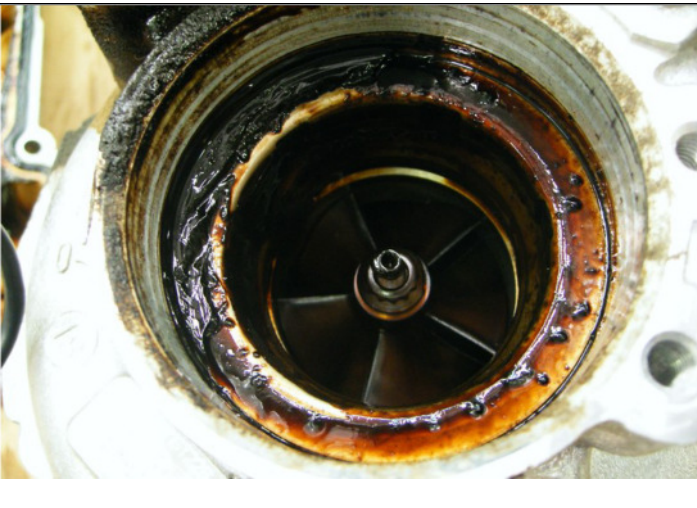
| | <p>The turbocharger is not OK.</p> <p>The turbocharger impeller seals are leaking engine oil.</p> |

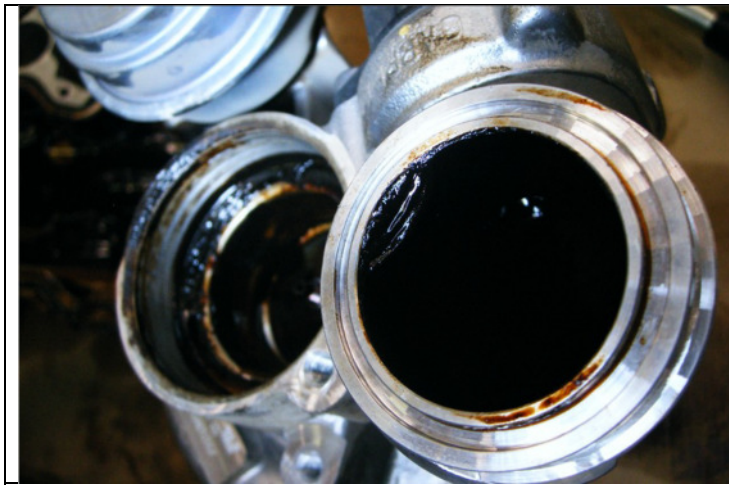
The turbocharger is not OK.

The turbocharger impeller seals are leaking engine oil.

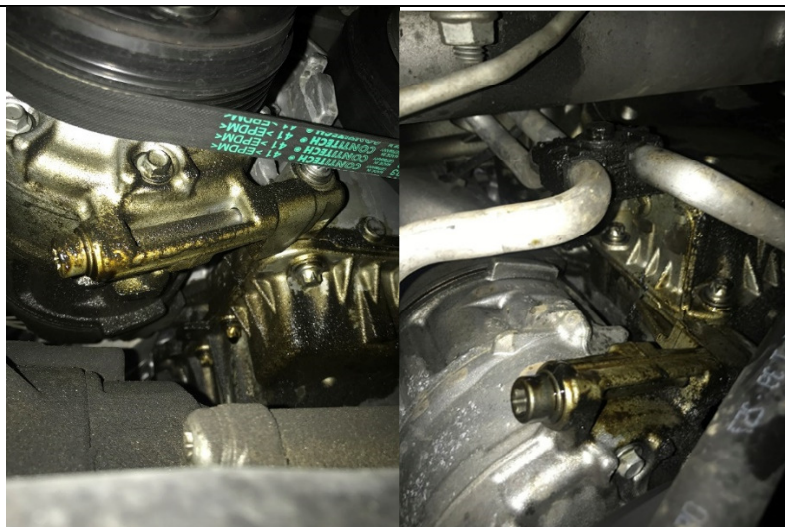
Front cover is leaking. Go to step 7.

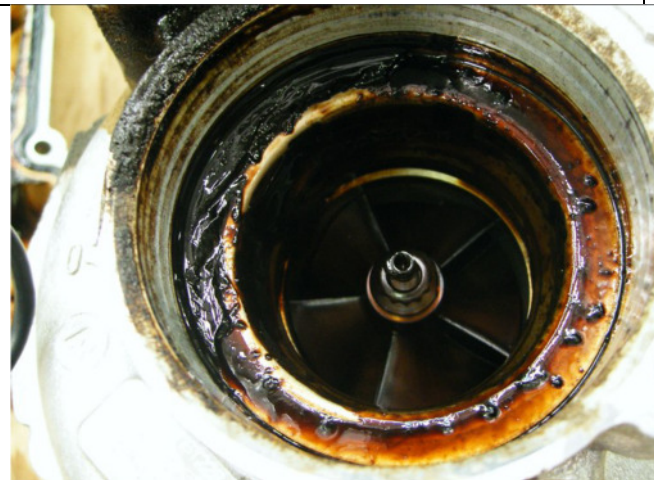
The turbocharger is not OK.

The turbocharger impeller seals are leaking engine oil.

If the turbocharger inspection is "NOT OK", then replace the turbochargers in conjunction with the recommendations in step 11. Go to step 11.

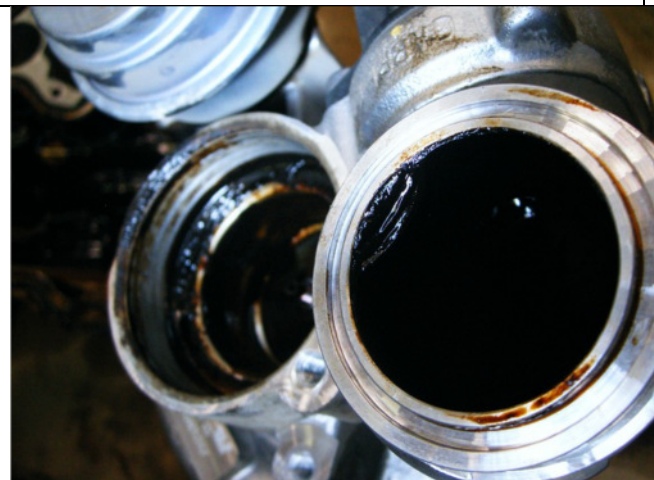
The turbocharger is not OK.

The turbocharger impeller seals are leaking engine oil.

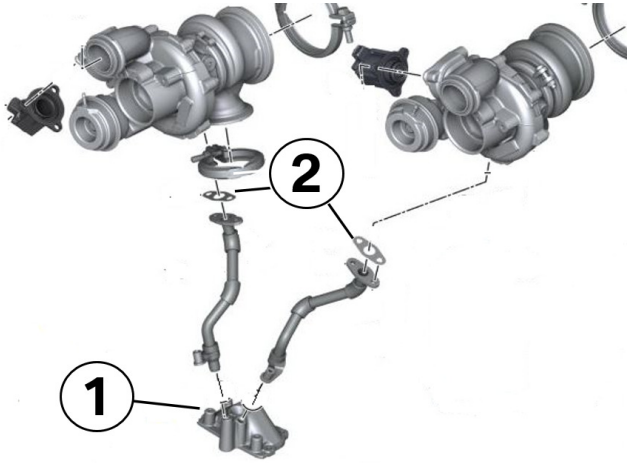
If engine oil is found under the turbos using a borescope then the oil return line cover (1) or the oil return line gaskets (2) are leaking engine oil.

(1) The oil return cover comes with all 3 O-rings. Use P/N 11 42 7 935 572.

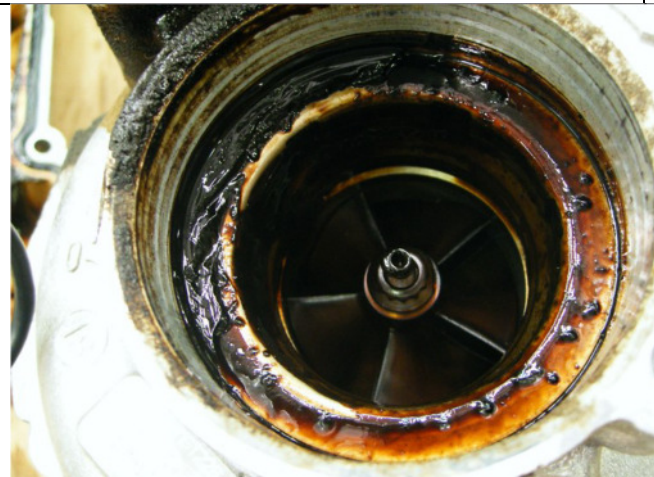
The turbocharger is not OK.

The turbocharger impeller seals are leaking engine oil.

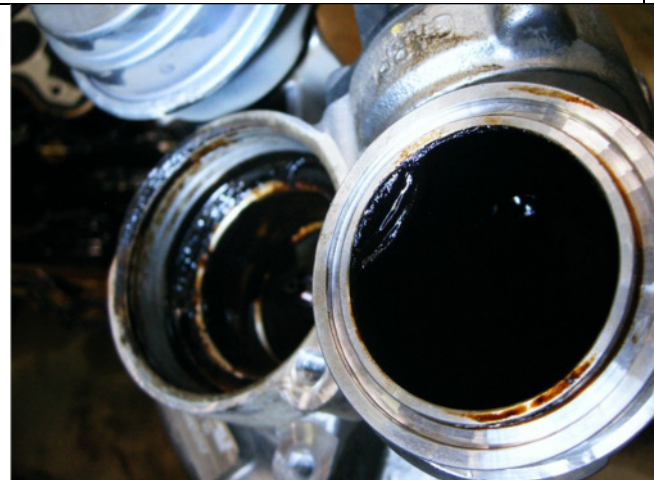
The turbocharger is not OK.

The turbocharger impeller seals are leaking engine oil.
