SI B11 16 18  
Engine

## DELIVERY STOP: N63R AND N63M ENGINE - CHECK ENGINE OIL SUPPLY CIRCUIT FOR CONTAMINATION

This Service Information bulletin replaces SI B11 16 18 **dated October 2018**

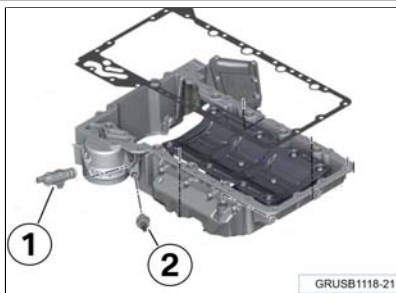
The components are installed on the right side of the upper oil sump (oil pan)

- (1) Solenoid valve for oil pressure control
- (2) Oil pressure sensor

1. Remove the engine oil pressure sensor and the solenoid valve for oil pressure control as per the following repair instructions.

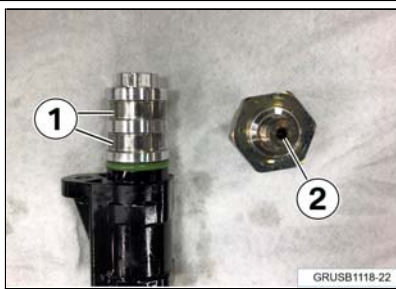
- 2. With the components removed inspect the surfaces for metallic debris.

Inspect the solenoid valve screens (1).

Inspect the hole in the pressure sensor (2).

The screen on the solenoid valve and the pressure sensor bore should be clean, no debris is allowed to be present.

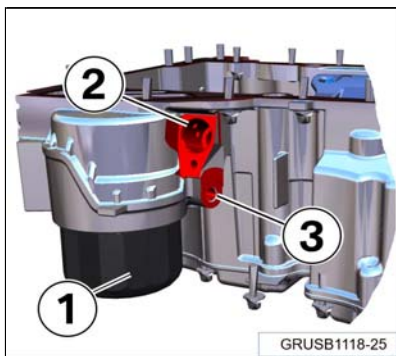
Inspection (location) overview:

- 1. Oil filter plastic cap
- 2. Solenoid valve for oil pressure control
- 3. Oil pressure sensor

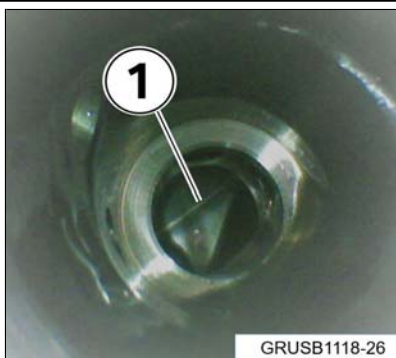
- 3. Using a borescope inspect the solenoid valve machined bore in the upper oil pan.

This bore should be clean without any debris present.

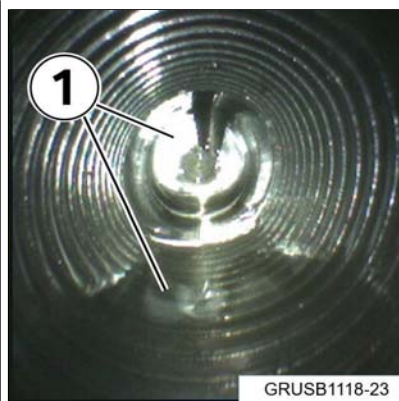
4. Using a borescope inspect the oil pressure bore in the upper oil pan.

This threaded bore should be clean without any debris present.

If metallic debris is not found during the inspections (pass) then inspect the removed solenoid valve O-ring, if not damaged reinstall the solenoid valve as per the repair instructions. If the O-ring is damaged then the entire solenoid will need to be replaced using the part number found in the parts table.

**If metallic debris is found during the inspections (fail) then the engine must be replaced.**
