SI B51 25 16  
Body Equipment

December 2018  
Technical Service

## RATTLE FROM DOOR LOCK STRIKER

This Service Information bulletin replaces SI B51 25 16 **dated August 2016**

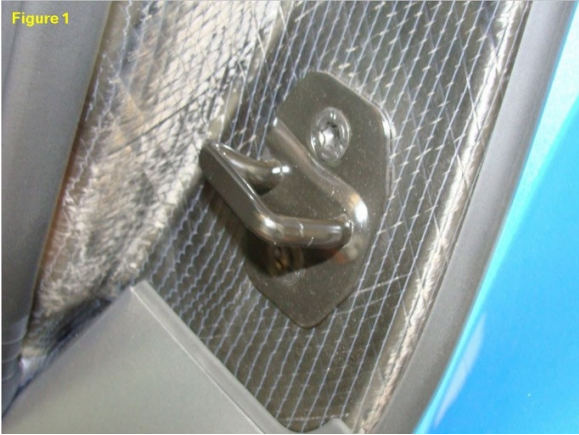
A rattle may be heard from the driver's side or passenger's side door lock striker, or the door lock striker may show evidence of improper contact. The paint on the striker may be worn off.

Improper adjustment of the door lock striker.

| <p>Figure 1</p> | <ol style="list-style-type: none"><li>1. Open and close door while noting the contact between the door striker and door lock mechanism. Look for a worn area on door lock striker. If paint surface damage to striker is observed, replace striker before proceeding. Refer to ISTA Repair instructions "51 21 003 Replacing door detent (lock striker), front left or right".</li></ol> <p><b>Note: If the striker has to be replaced, make sure to mark the current position of the striker (with tape) to avoid having to adjust striker excessively.</b></p> |

Adjust the door lock striker, replace the door lock striker if damaged (paint removed from striker surface).

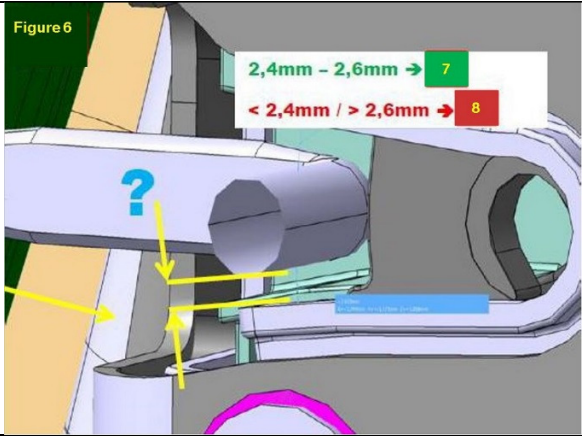
| <p>Figure 6</p> <p>2,4mm - 2,6mm → 7<br/>&lt; 2,4mm / &gt; 2,6mm → 8</p> | <p>6. Determine the distance between the lower edge of the door lock aperture and striker with a feeler gauge. (Nominal value = 2.4 mm to 2.6 mm).<br/>If the observed value is between 2.4 mm and 2.6 mm, proceed to Step 7.<br/>If the observed value is less than 2.4mm or greater than 2.6 mm, proceed to Step 8.</p> <p><b>Note: Graphic shown is the right side door.</b></p> |

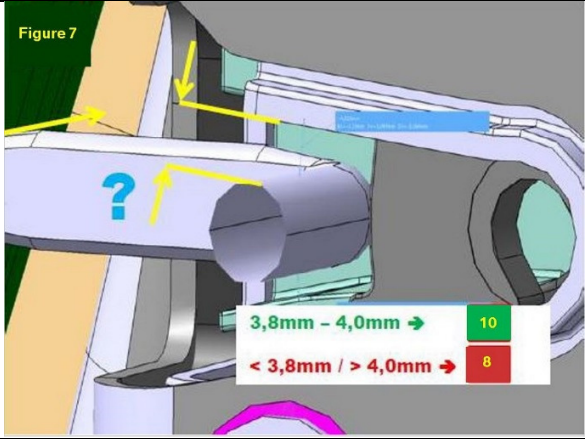
| <p>Figure 7</p> | <p>7. Determine the distance between the upper edge of the door lock aperture and striker with a feeler gauge. (Nominal value = 3.8 mm to 4.0 mm).</p> <p>If the observed value is between 3.8 mm and 4.0 mm, proceed to Step 10.</p> <p>If the observed value is less than 3.8mm or greater than 4.0 mm, proceed to Step 8.</p> |
