SI B51 28 18
Body Equipment

GROANING NOISE AT DOOR SILL DURING ENTRY OR EXIT

I12 (i8 Coupe)	I15 (i8 Roadster)
----------------	-------------------

Procedure to repair i8 groaning noise at door sill while entering and exiting

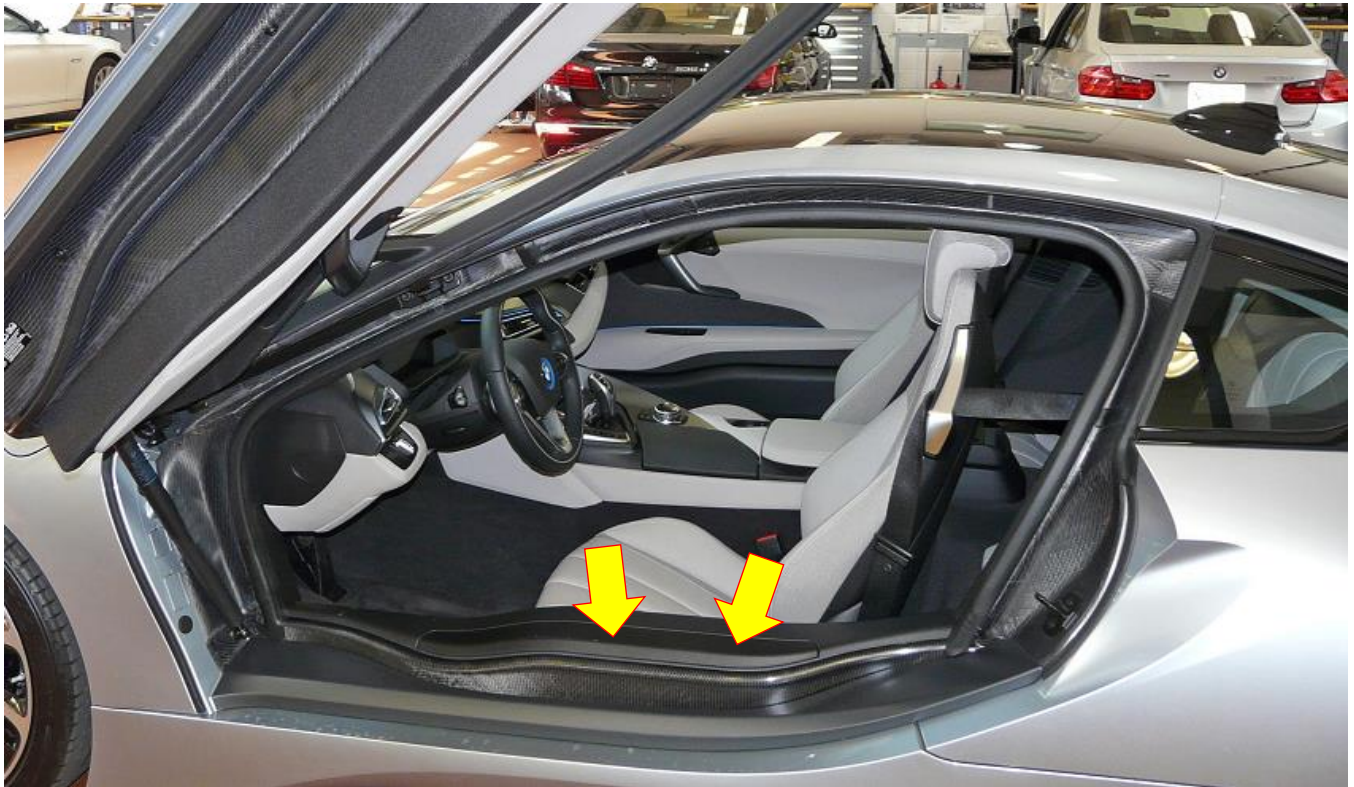
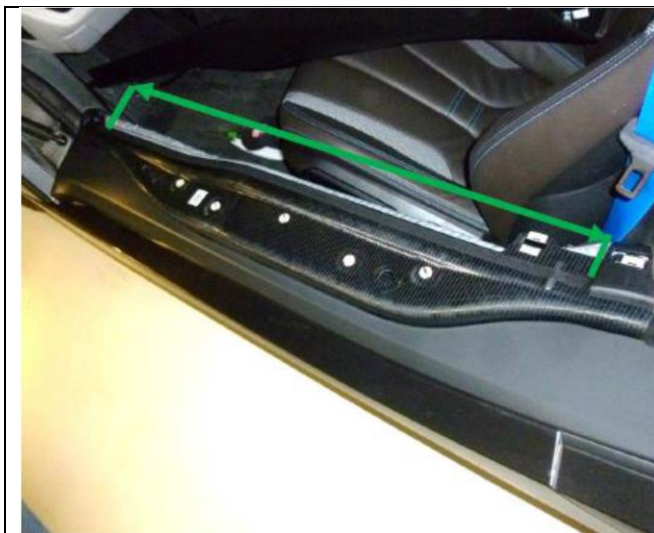
A groaning or creaking noise may be heard when the driver presses against the sill trim (arrows) while supporting themselves as they enter or exit the vehicle. Inspect both sides of the vehicle for noise, and perform this procedure for one or both sides as needed.

1. Carefully remove the sill trim.

- Refer to Repair Instructions 51 47 ...
“Removing and installing/replacing front left or right cover on door sill cover strip”
- Use special tool 00 9 325
