SI B52 07 18
Seats

SEAT THIGH SUPPORT UPHOLSTERY IS PROTRUDING

F22 (2 Series Coupe)	F23 (2 Series Convertible)	F30 (3 Series Sedan)	F31 (3 Series Sports Wagon)
F32 (4 Series Coupe)	F87 (M2)

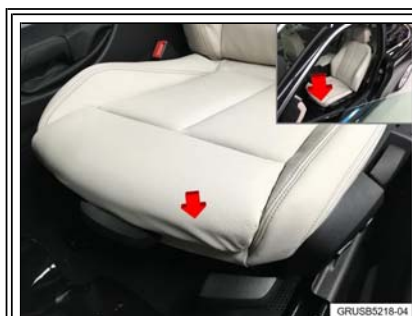
The upholstery of the sport seat adjustable thigh support may become exposed. The protrusions (general location indicated by arrow) can occur on either front corner of the seat thigh support.

The upholstery may dislodge slightly from the thigh support base over time from repeated compression due to normal use.

Reattach the seat upholstery to the thigh support base.
