## CHECK CONTROL MESSAGE LANE CHANGE WARNING FAILED

G02 (X4)
----------

Produced from April 2018 (Start of Production) thru December 1, 2018

**Determining the correct G02 rear radar sensor mounts and harness routing**

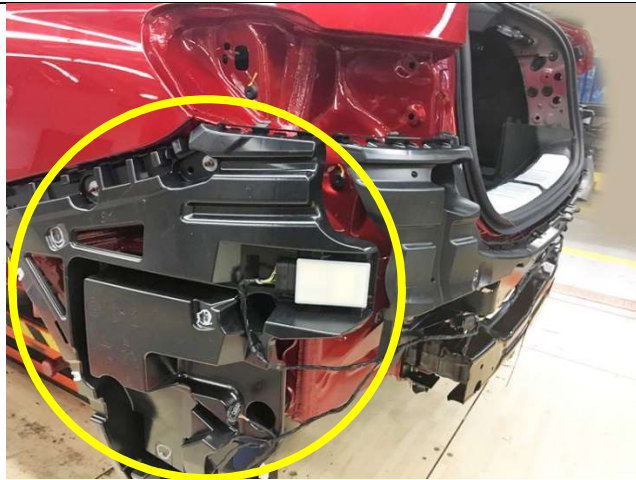
**X4 xDrive30i with no Aerodynamic kit:**

- Correct: **Black**-colored sensor/bumper mount (circled)

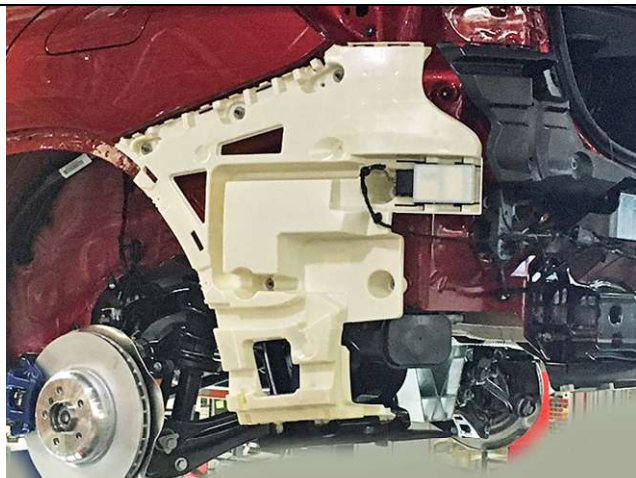
- Incorrect: **White**-colored sensor/bumper mount.

4. All models: If the incorrect sensor mount is observed on either the left or right side, replace it. Refer to Repair Instructions 51 12 828 "Removing and installing/replacing the bumper guide, rear left or right (bumper cover removed)".

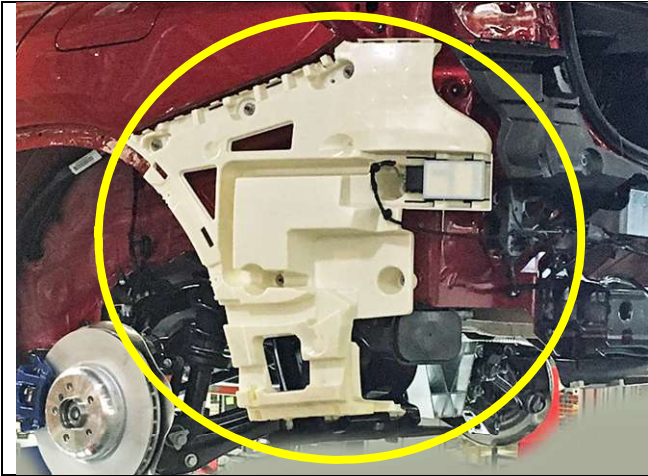
**X4 xDrive30i with optional Aerodynamic kit (code 715)/M Sport bumpers;  
X4 M40i all**

- Correct: **White-colored** sensor mount (circled).
- Incorrect: Black-colored sensor mount

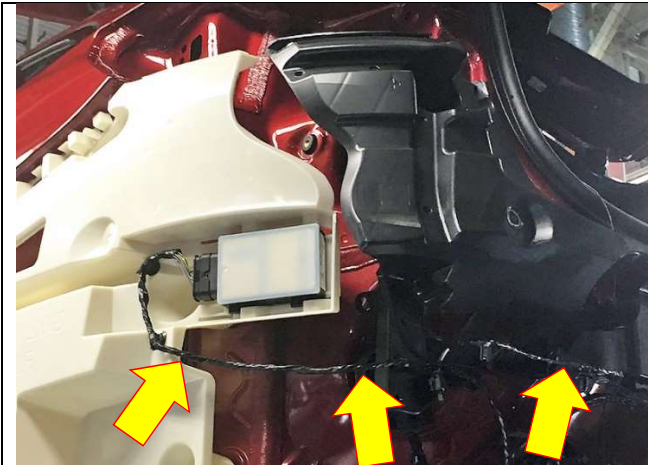
5. Check the routing of the harness for the rear side radar sensors.

**Correct:** Harness runs downward from the sensor mount ledge, then horizontally along the lower portion of the bumper mount (arrows).

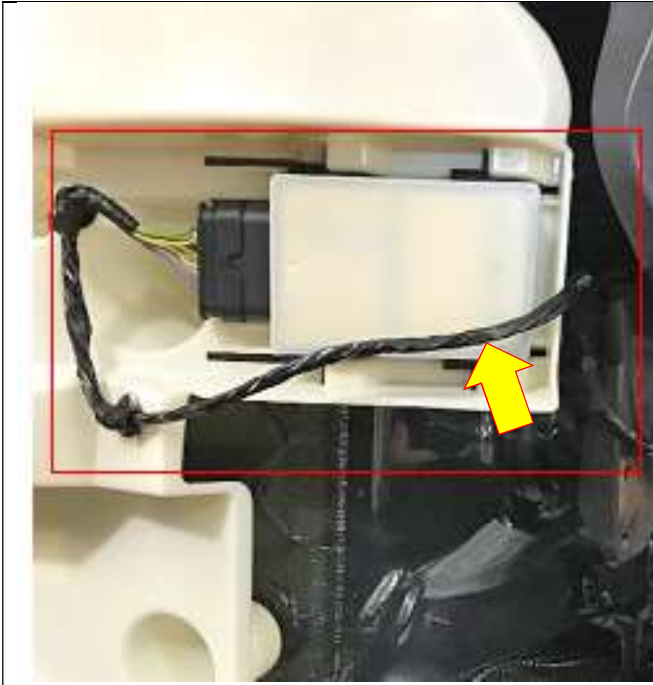
**Incorrect:** Harness runs upward from the sensor, partially blocking the signal area of the sensor.

Reposition the harness.

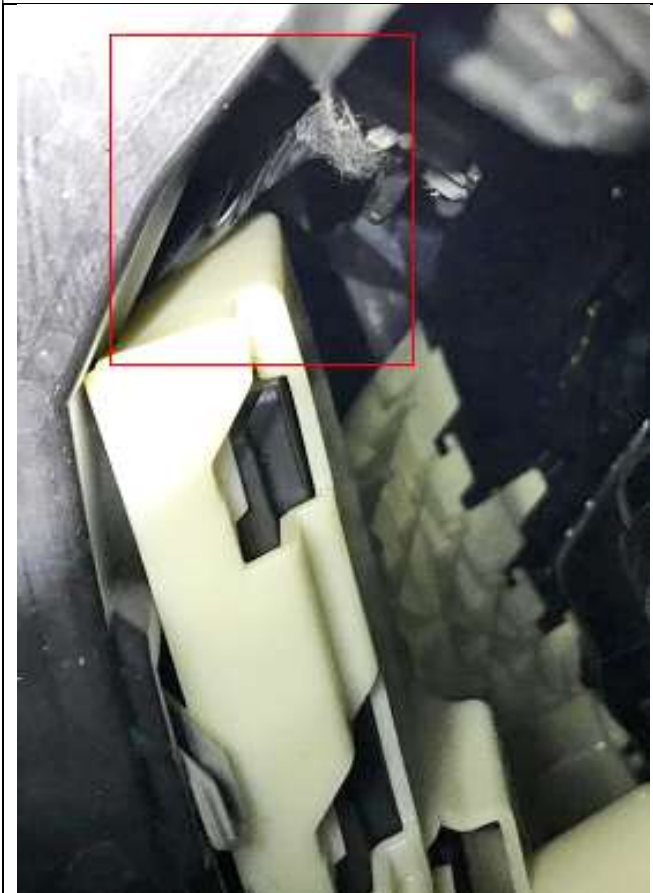
Harness can also run upwards and be pinched at the edge of the sensor mount (circled).

Reposition the harness and check for damage to the harness sheathing and to any wires inside.
