## GROANING NOISE FROM DRIVER'S BACKREST

I12 (i8 Coupe)

View PDF attachment [B72 01 18 attachment](#).

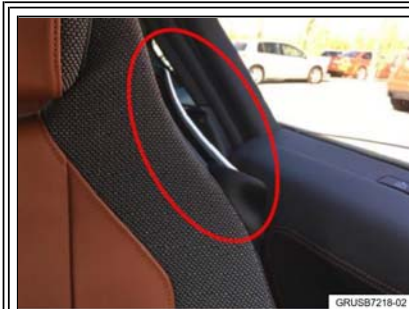
Friction between the contact points of the safety belt guide cover and the safety belt guide carrier plate which is attached to the backrest (general location is circled).

Install friction tape between the contact points of the safety belt guide cover and the safety belt guide carrier plate.

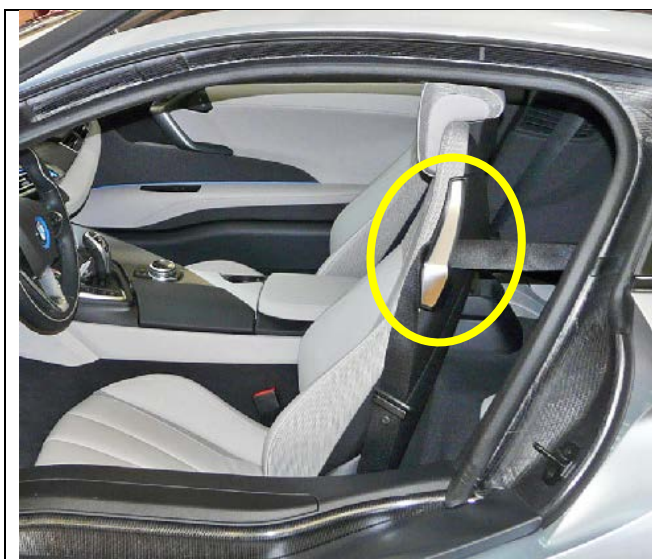
General area to be repaired.

The passenger backrest is not affected.

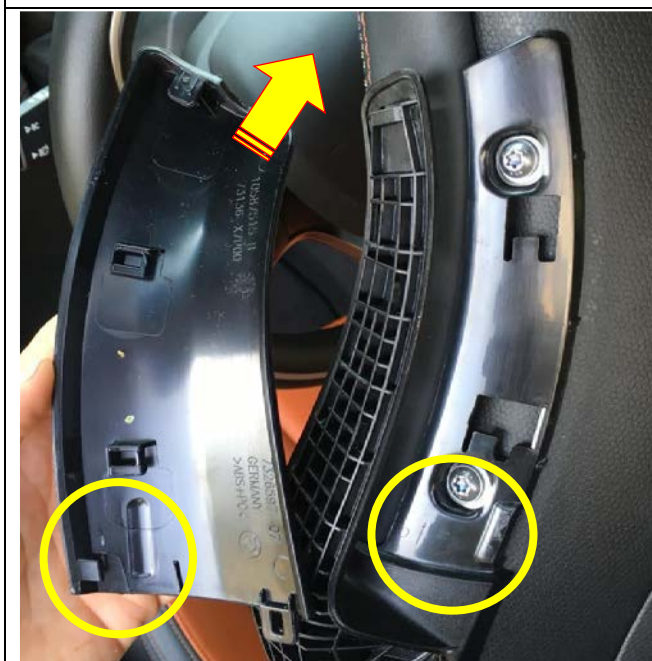
The contact and corresponding abrasion points are circled, and shown in detail in Step 2.

1. Remove the safety belt guide trim by carefully prying upward and outwards from the outer edge with a suitable trim removal tool.

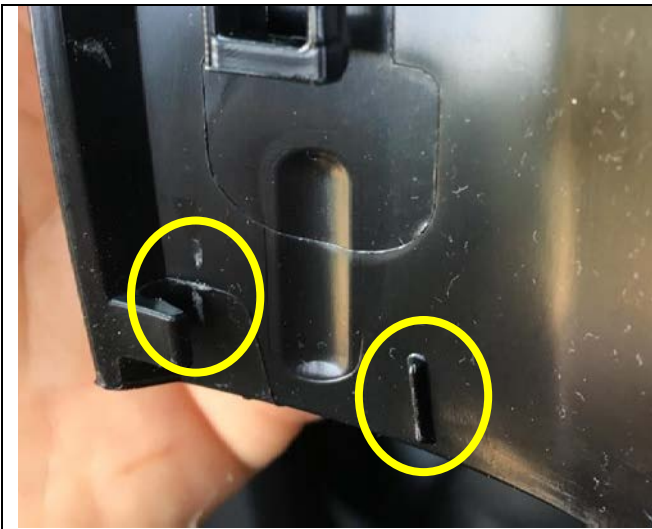
2. Look closely for material abrasion (circled) on the belt guide trim and on the carrier plate.

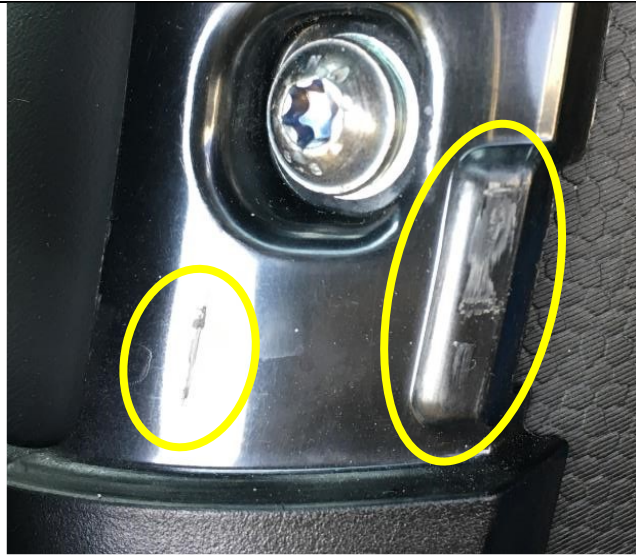
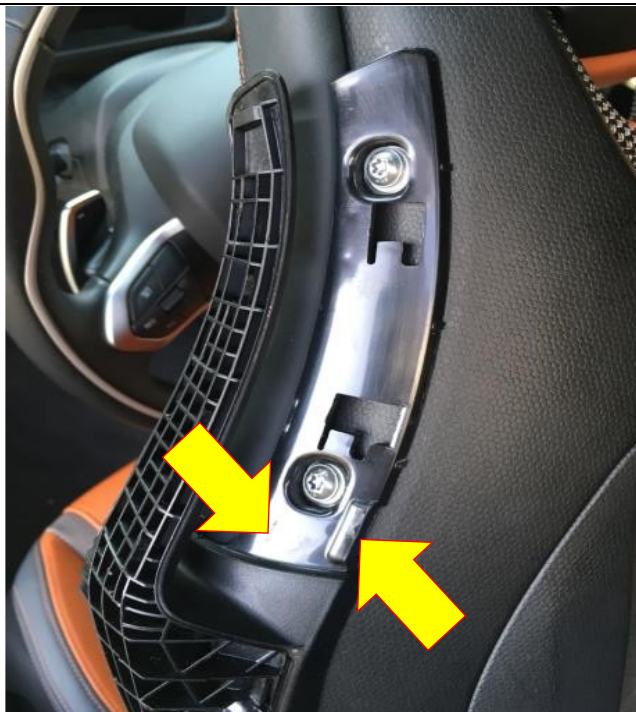
General location shown at left; close-up below.

3. Apply film tape 83 19 9 407 798 to the carrier plate at the contact points (arrows/circled).
