SI M11 01 17  
Engine

## FAULT 118002 - MIXTURE TOO RICH SETS DURING WINTER WITH COLD AMBIENT TEMPERATURES

This Service Information bulletin supersedes SI M11 01 17 **dated January 2018**.

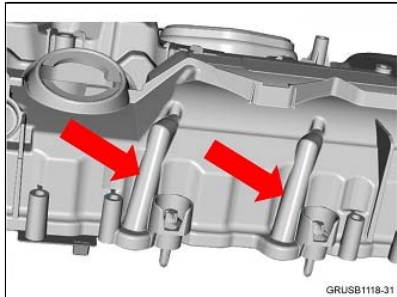
| <p style="text-align: right; font-size: small;">GRUSB1119-31</p> | <p>The older version is shown to the left.</p> |

Replace the cylinder head cover and profile gasket if the older version is equipped.

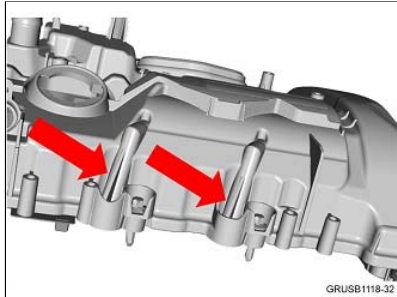
| <p style="text-align: right; font-size: small;">GRUSB1119-32</p> | <p>The newer version is shown to the left<br/>Note: This updated version can be identified by the additional supports on crankcase ventilation ports</p> |
