# Inspect HV Battery Positive Contactor Fasteners

| <b>Classification</b> | Campaign Bulletin | <b>Section/Group</b> | 16 - HV Battery System | <b>Country/Region</b> | United States, Canada |
| <b>Year</b> | 2018 | <b>Model</b> | Model 3 | <b>Version</b> | All |

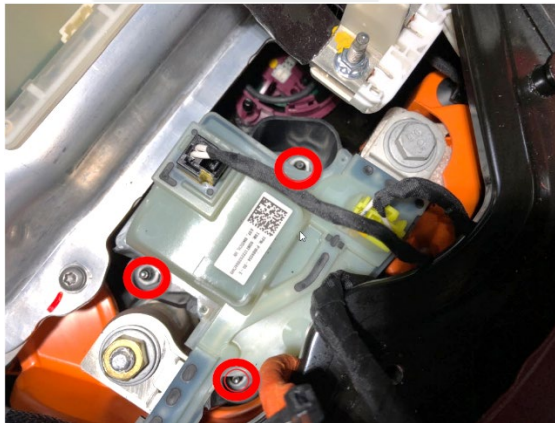
**Figure 3**

4. Visually inspect the nuts that attach the HV battery positive contactor to the penthouse floor (Figure 3).
  - If there are 3 nuts installed, skip to step 18.
  - If there are less than 3 nuts installed, describe which nuts are missing in the Cause Narrative field of the Repair Order, and then continue to the next step.

5. Remove and discard the nuts that attach the HV battery positive contactor to the penthouse floor (Figure 3).
6. Install 3 new nuts to attach the HV battery positive contactor to the penthouse floor (torque 8 Nm) (Figure 3), and then mark the nuts with a paint pen after they are torqued.

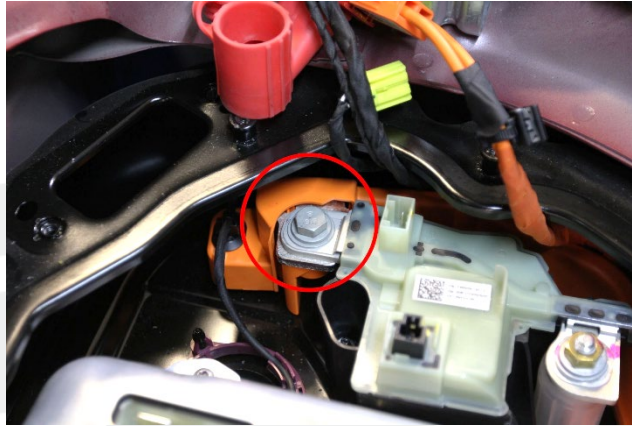
**Figure 4**

7. Visually inspect the positive DC busbar and insulator near the HV battery positive contactor, and where the busbar attaches to the contactor, for any signs of damage (Figure 4).
  - If damage is seen, take photographs of the damage, create a Toolbox session, attach the photos to the session, indicate Toolbox Article #44198 as the problem, escalate the session, and then wait for further instruction.
  - If damage is not seen, continue to the next step.

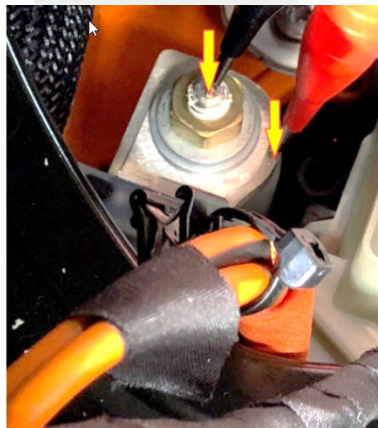
**Figure 5**

8. Use the Hioki resistance meter to measure the resistance at the HV joint between the HV battery positive contactor and the center of the HV battery positive terminal (Figure 5).

9. If the resistance:
  - Is 0.11 mOhms (110  $\mu$ Ohms) or less, skip to step 13.
  - Is greater than 0.11 mOhms (110  $\mu$ Ohms), continue to the next step.
10. Remove and discard the nut, install a new nut (torque 9 Nm), and then mark the nut with a paint pen after it is torqued.
11. Use the Hioki resistance meter to measure the resistance again at the HV joint between the HV battery positive contactor and the center of the HV battery positive terminal (Figure 5).
12. If the resistance:
  - Is 0.11 mOhms (110  $\mu$ Ohms) or less, skip to step 13.
  - Is still greater than 0.11 mOhms (110  $\mu$ Ohms), record the resistance in the Cause Narrative field of the Repair Order, and then skip to step 20.

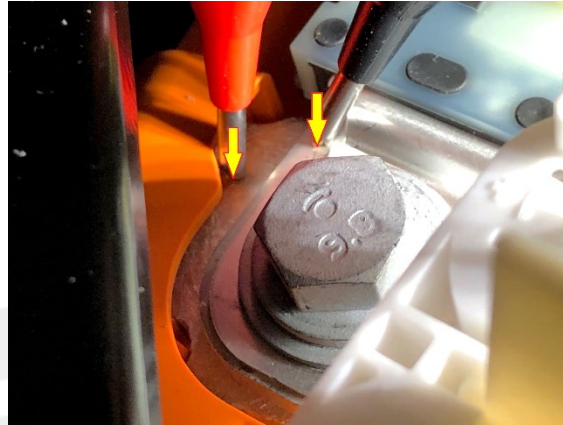
**Figure 6**

13. Use the Hioki resistance meter to measure the resistance at the HV joint between the HV battery positive contactor and the positive DC busbar (Figure 6).

14. If the resistance:
- Is 0.06 mOhms (60  $\mu$ Ohms) or less, skip to step 18.
  - Is greater than 0.06 mOhms (60  $\mu$ Ohms), continue to the next step.

15. Remove and discard the bolt, install a new bolt (torque 9 Nm), and then mark the bolt with a paint pen after it is torqued.
16. Use the Hioki resistance meter to measure the resistance again at the HV joint between the HV battery positive contactor and the positive DC busbar (Figure 6).

17. If the resistance:
- Is 0.06 mOhms (60  $\mu$ Ohms) or less, skip to step 18.
  - Is still greater than 0.06 mOhms (60  $\mu$ Ohms), record the resistance in the Cause Narrative field of the Repair Order, and then skip to step 20.
