# Replace Charge Port Insulator Pins

| <b>Classification</b> | Campaign Bulletin | <b>Section/Group</b> | 44 - High Voltage System | <b>Country/Region</b> | United States, Canada |
| <b>Year</b> | 2017-2019 | <b>Model</b> | Model 3 | <b>Version</b> | All |

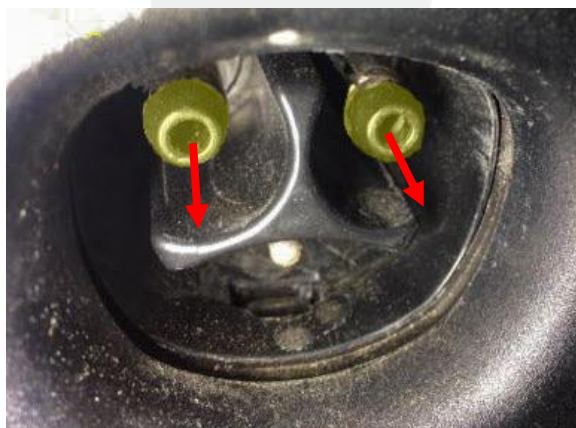
**Figure 6**

On certain Model 3 vehicles, the charge port power terminals have insulator pins that might become dislodged from the terminals, causing the charge handle not to fully connect to the vehicle and preventing the High Voltage (HV) battery to charge.

12. Remove the front and rear charge port insulator pins from the charge port assembly by carefully grabbing each insulator pin with needle nose pliers, and then pull each insulator pin to remove it from the charge port assembly (Figure 6).

13. Clean any leftover insulator pin debris from the charge port assembly with an ESD-safe vacuum.
