# Resecure Triple Camera Windshield Bracket

**Classification** Campaign Bulletin **Section/Group** 15 - Interior Trim **Country/Region** All

**Year** 2018 **Model** Model X **Version** All

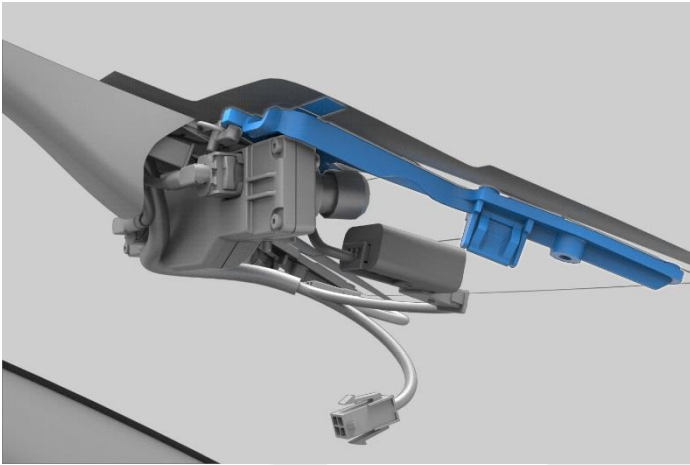
- If both sides of the bracket are flush with the windshield (Figure 3), discontinue this procedure and install all parts that were removed.
- If either side of the bracket is not flush with the windshield (Figure 4), continue to the next step.

✓ Figure 3 (RH shown, check LH also)

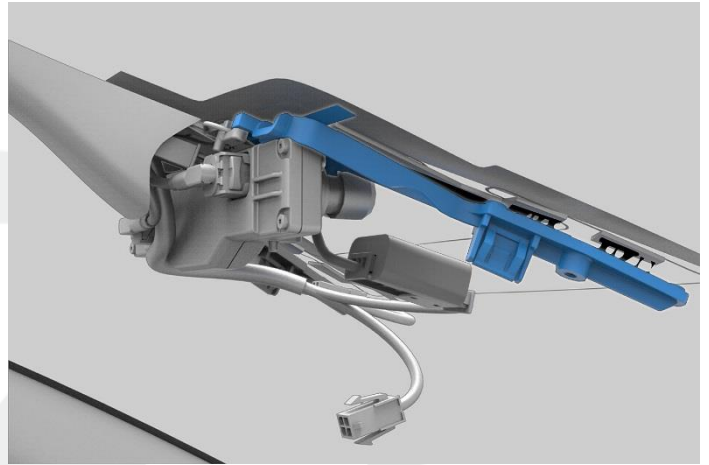
Certain Model X vehicles were manufactured with triple camera windshield brackets that were not properly secured to the windshield. The bracket may look uneven and/or move when manipulated. However, there is no effect on Autopilot functionality or rear view mirror stability. Perform the following procedure to resecure the triple camera windshield bracket to the windshield.

✗ Figure 4 (RH shown, check LH also)

6. Use IPA wipes and a trim tool/pick to remove as much old adhesive as possible from under the affected side of the triple camera windshield bracket.
