Inspect Underbody Panels and Fasteners

Classification	Campaign Bulletin	Section/Group	12 - Exterior Fittings	Country/Region	United States, Canada
Year	2018	Model	Model 3	Version	All

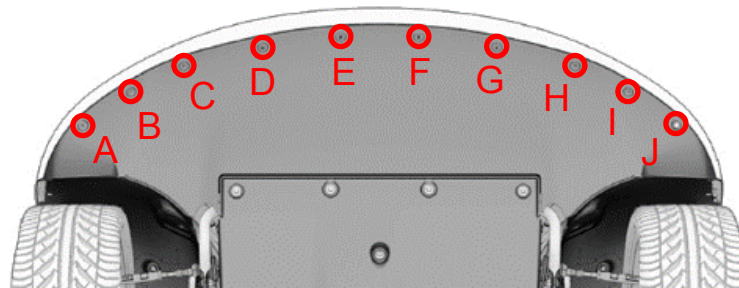
Figure 1 (○ 1128034-00-B)

1. Raise the vehicle (refer to Service Manual procedure 10000205).
2. At the front of the vehicle, inspect the valence, and comment in the Cause Narrative field of the Repair Order if the valence is missing, the damage to the valence (if any), and which push rivets (if any) are missing (Figure 1).

3. If the valence is present and undamaged, install any missing push rivets. (Figure 1).
4. Inspect the front aero shield panel, and comment in the Cause Narrative field of the Repair Order if the panel is missing, the damage to the panel (if any), and which bolts and nuts (if any) are missing (Figure 2).

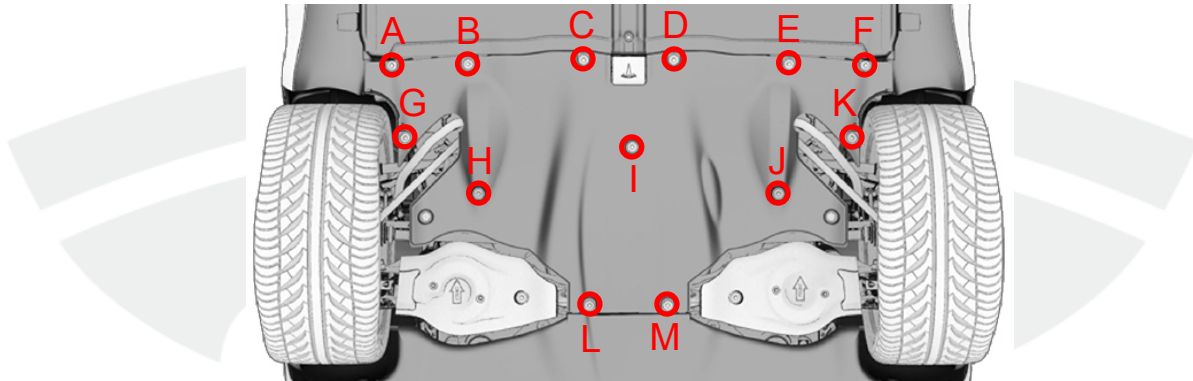
Figure 3 (○ 1083017-00-A (torque 5 Nm))

5. If the front aero shield panel is present, torque all present bolts and nuts to the correct specification (Figure 2), and then comment in the Cause Narrative field of the Repair Order which bolts and nuts were under torqued.
6. If the front aero shield panel is undamaged, hand install all missing bolts and nuts, and then torque those bolts and nuts to the correct specification (Figure 2).
7. Inspect the mid aero shield panel, and comment in the Cause Narrative field of the Repair Order if the mid aero shield panel is missing, the damage to the panel (if any), and which bolts (if any) are missing (Figure 3).

8. If the mid aero shield panel is present, torque all present bolts to the correct specification (Figure 3), and then comment in the Cause Narrative field of the Repair Order which bolts were under torqued.
9. If the mid aero shield panel is undamaged, hand install all missing bolts, and then torque those bolts to the correct specification (Figure 3).
10. At the rear of the vehicle, inspect the diffuser, and comment in the Cause Narrative field of the Repair Order if the diffuser is missing, the damage to the diffuser (if any), and which bolts (if any) are missing (Figure 4).
