# TECHNICAL SERVICE BULLETIN

## 3.5L EcoBoost - Illuminated MIL - DTCs P0325, P0327, P0330 And/Or P0332 - Built On Or Before 30-Sep-2016

18-2367

Ford
2016-2017 Police Interceptor Utility
2016-2017 Explorer

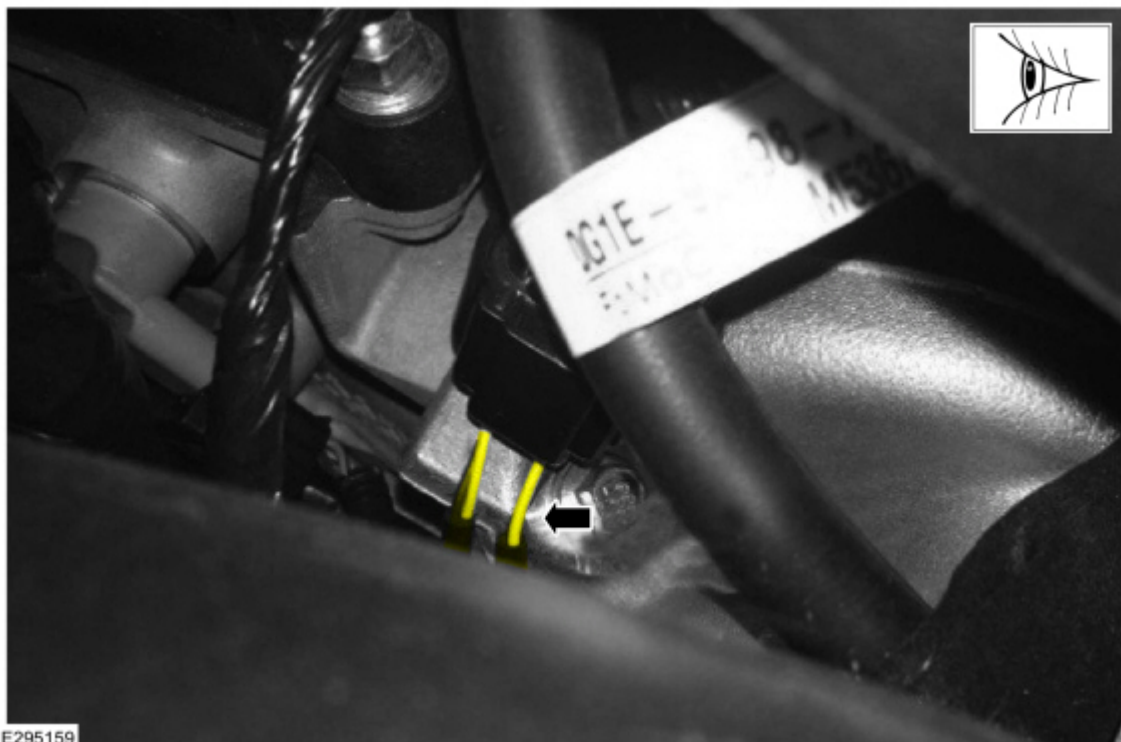
Figure 1

**Issue:** Some 2016-2017 Explorer/Police Interceptor Utility vehicles equipped with a 3.5L EcoBoost engine built on or before 30-Sep-2016 may exhibit an illuminated malfunction indicator lamp (MIL) with diagnostic trouble codes (DTCs) P0325, P0327, P0330 and/or P0332. This may be caused by a wire chafe condition near the knock sensor connector C109.
