TECHNICAL SERVICE BULLETIN

Vista Roof - Glass Binding/Sticking, Glass Stuck Open Or Closed, Noisy Operation Including Chatter, Rattling, And/Or Grinding

18-2374

11 December
2018

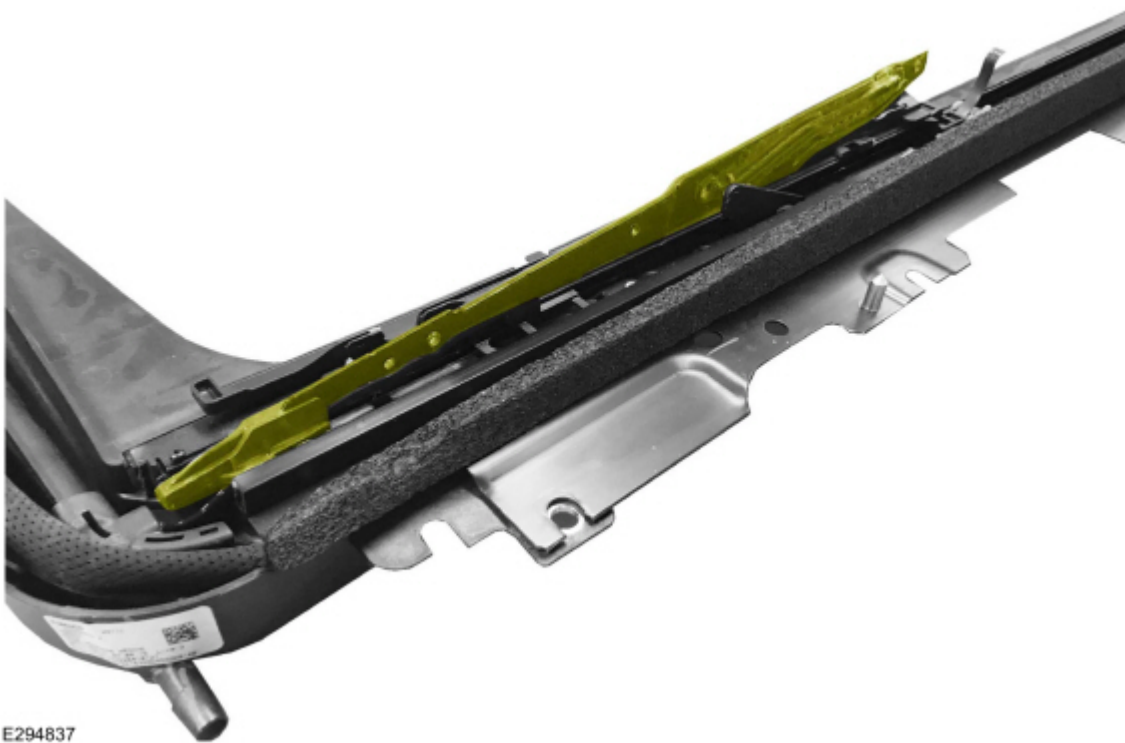
Figure 1

Issue: Some 2015-2019 F-150, 2017-2019 F-Super Duty, 2018-2019 Expedition/Navigator vehicles equipped with a vista roof opening panel may exhibit a binding/sticking, glass stuck open or closed, noisy operation including chatter, rattling, or grinding. This may be due to the glass brackets cracking and/or breaking apart. The glass panel brackets are serviceable separately from the frame assembly and require the roof opening panel glass to be moved to the vent position.

(1). Yes - replace the roof opening panel glass brackets. Make sure any and all debris is removed from the frame track during repairs. Refer to Workshop Manual (WSM), Section 501-17B. (Figure 1)
