## Reversing camera closes

| Topic number | LI54.65-P-063067 |
| Function group | 54.65 Parking assist |
| Validity | Model 253 with SA code 218 (Reversing camera) |

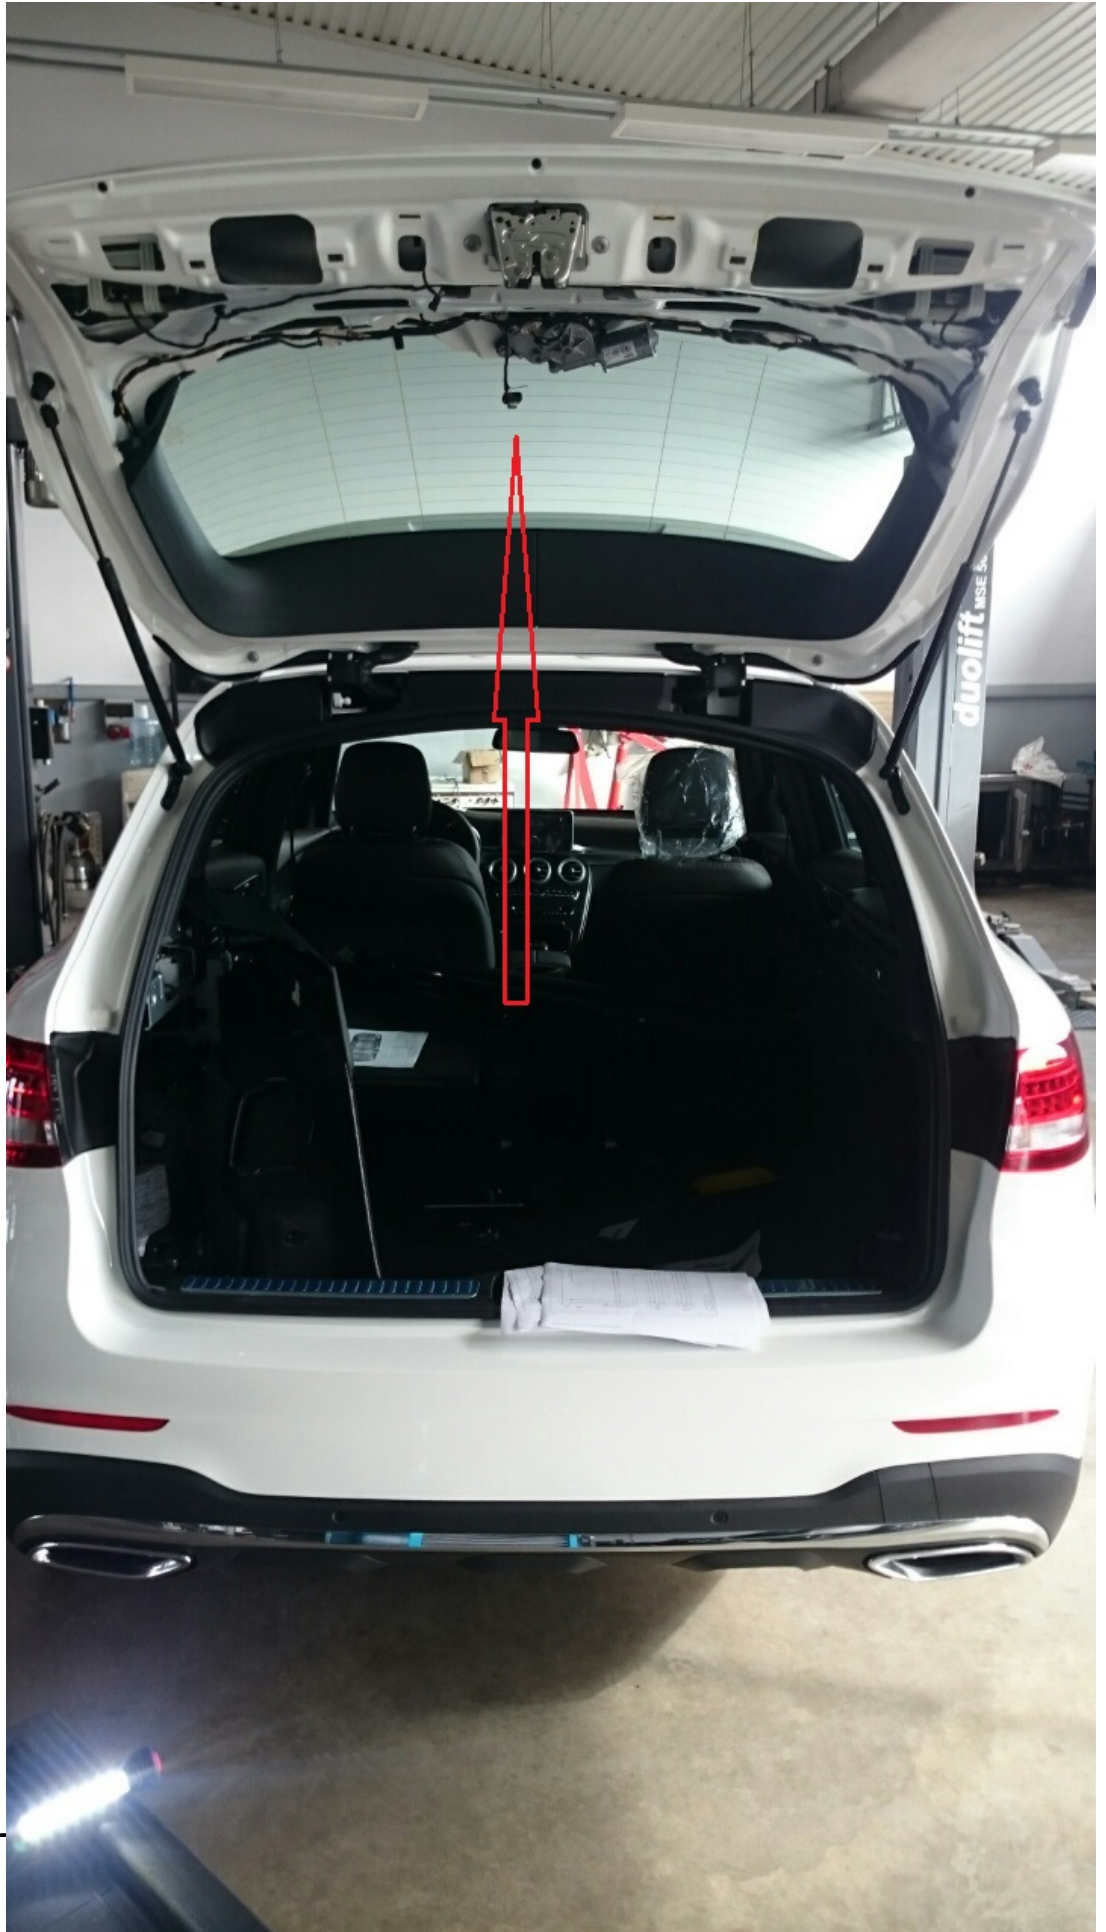
image of connector.jpg:

Pins 1 and 2 on the rear camera cover motor (M35/2) might be loose (the line has detached from the female contact). This is due to a crimping fault; the lines are 0.13mm<sup>2</sup> (small cross section).

| image of connector.jpg | Picture of connector |

Repair using pigtail (contact socket with loose cable ends).
