<b>Subject:</b> <b>MAZDA CONNECT AUDIO SOURCE AHA / PANDORA / STITCHER / BLUETOOTH® IMPROPER OPERATION WHEN CONNECTED TO USB PORT</b>	<b>M-Tips No.:</b> MT-002/18
	<b>Last Issued:</b> 12/05/2018

## APPLICABLE MODEL(S)/VINS

2014-2018 Mazda3	2016-2019 CX-3	2016-2019 CX-9
2016-2018 Mazda6	2016-2019 CX-5	2016-2019 MX-5

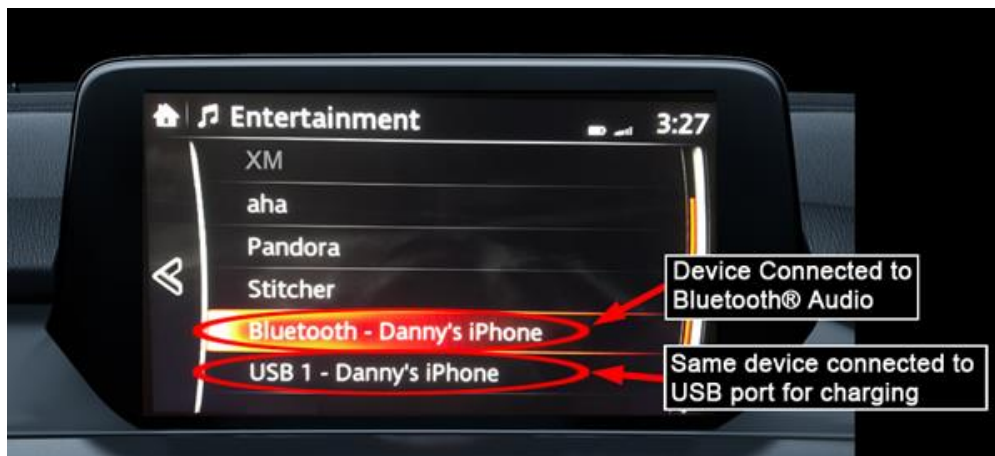
- Blank Screen and/or No Audio Sound
- Phone will not charge

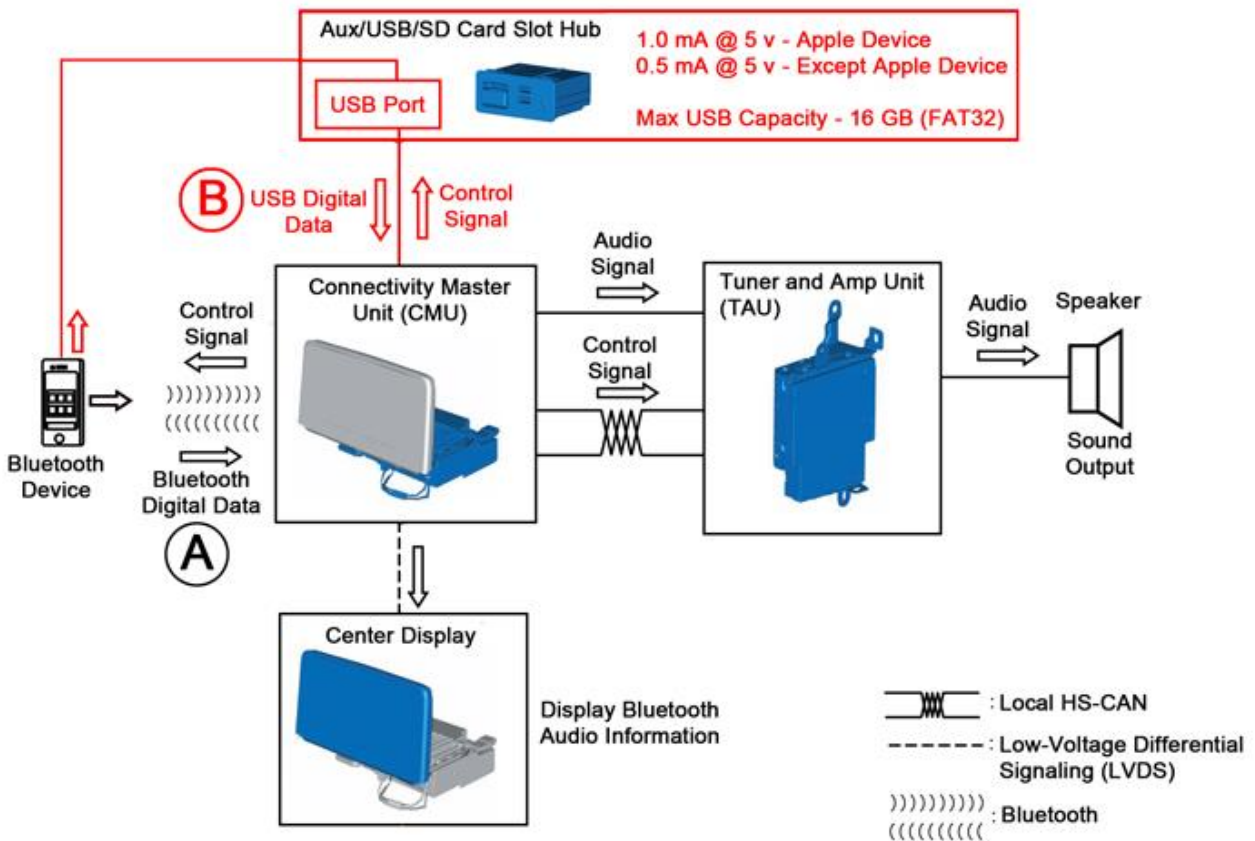
- The MAZDA CONNECT system has reached its capacity limits when streaming music with audio source aha/Pandora/Stitcher/Bluetooth® and also connected to the USB port.
- The MAZDA CONNECT system has reached its capacity limits when the customer's USB device capacity exceeds 16 GB (e.g. 64 GB iPhone X). The MAZDA CONNECT system USB port capacity is 16 GB (FAT32).

When streaming music with audio source aha/Pandora/Stitcher/Bluetooth® (without USB connection), the Connectivity Master Unit (CMU) is able to process Bluetooth® digital data (A) and output audio sound and display Bluetooth® audio information. If the same device is connected to the USB port for charging, the CMU processes both Bluetooth® digital data (A) and USB digital data (B) from the same device at the same time. In this case, CMU resources may be exceeded, causing a Blank Screen and/or No Audio Sound.

Mazda recommends not to connect any devices to the USB port when streaming music with audio source aha/Pandora/Stitcher/Bluetooth®.
