## QUARANTINE NOTICE

<b>Reference number:</b>	<b>QN-01-1144</b>	<b>Issued: 23 November, 2018</b>
<b>Subject:</b>	<b>Incorrect Alignment of Door Latch Striker</b>	
<b>Model(s):</b>	<b>Vantage 19MY</b>	
<b>VIN range:</b>	<b>Refer to the separately published list of affected Vehicle Identification Numbers (VINs)</b>	
<b>Applicable to:</b>	<b>All Dealers</b>	
<b>Distribute to:</b>	<b>After Sales Manager</b> <b>Executive Manager</b> <b>Service Manager</b> <b>Sales Manager</b>	<b>Warranty Staff</b> <b>Technician(s)</b> <b>Parts Staff</b>

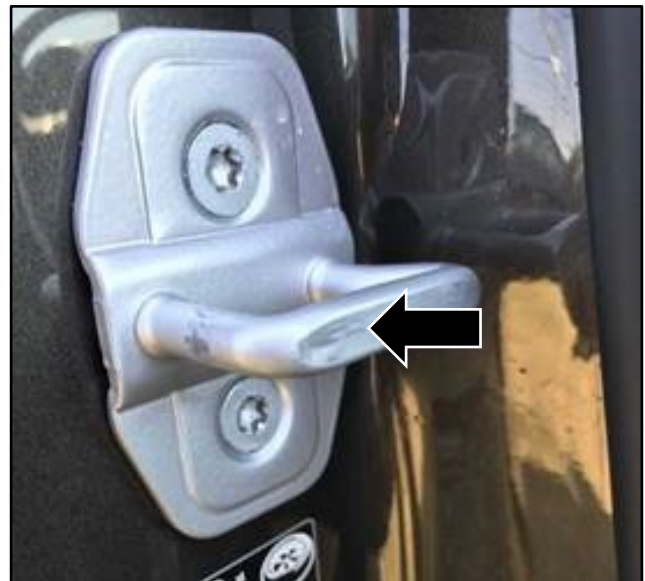
**Figure 1**

**Note: If contact marks are visible on the door striker (refer to Figure 1), the door striker is not correctly aligned.**

1. Visually inspect the door striker on both sides of the vehicle to make sure that it is aligned correctly.
2. If the door striker is aligned correctly and damage is not visible on the flat edge of the door striker, the check is complete.
3. If the door striker is not correctly aligned, the door striker must be removed (refer to Workshop Manual Procedure 01.14.CA for the right side door striker or 01.14.CB for the left side door striker).

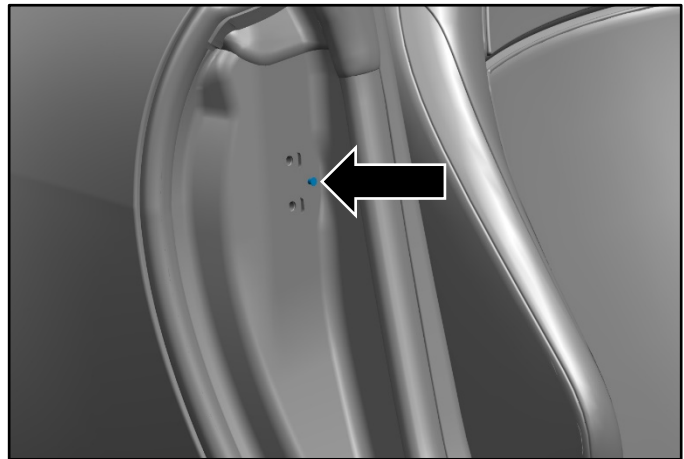
Figure 2

4. Visually inspect the rivet head to make sure that it is flush on the door opening panel (refer to Figure 2).

5. If the rivet head is not aligned correctly, use a punch (6mm diameter flat nose) with a mallet to align the rivet head correctly.
6. Install the door striker (refer to Workshop Manual Procedure 01.14.CA for the right side door striker or 01.14.CB for the left side door striker).
7. Do a check to make sure that the door closes correctly. Adjust the door if necessary.
