QUARANTINE NOTICE

Reference number:	QN-01-1145	Issued: 23 November, 2018
Subject:	Door Clash to Bonnet	
Model(s):	Vantage 19MY	
VIN range:	Refer to the separately published list of Vehicle Identification Numbers (VINs)	
Applicable to:	All Dealers	
Distribute to:	After Sales Manager Executive Manager Service Manager Sales Manager	Warranty Staff Technician(s) Parts Staff

Reason for this Quarantine Notice

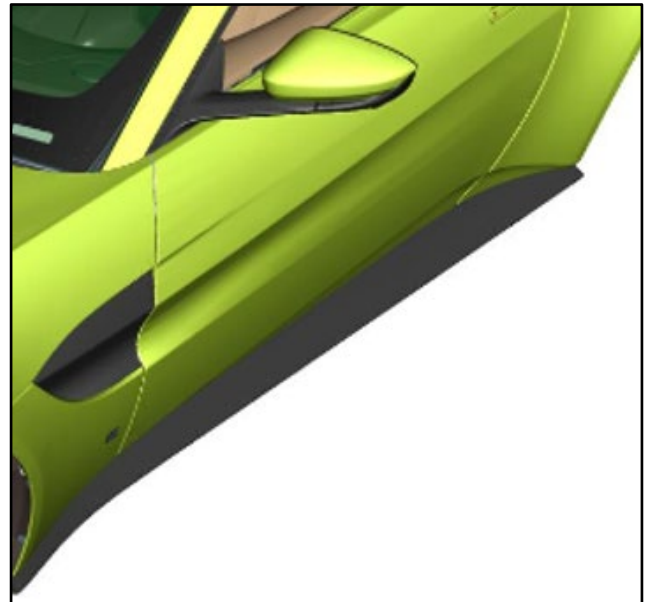
Figure 1

1. Open the side doors and check that they do not touch the parts in front of them.
 - If a door touches the bonnet, do steps 2 thru 3.
 - If a door touches the front wing panel, do steps 4 thru 5.
 - If both doors open without problem the procedure is completed.
