## QUARANTINE NOTICE

Reference number:	QN-10-1127V3	Issued: 23 November, 2018
Subject:	Fuel Filler Latch	
Model(s):	Vantage 19MY	
VIN Range:	Refer to the separately published list of Vehicle Identification Numbers (VINs)	
Applicable to:	All Dealers	
Distribute to:	After Sales Manager Executive Manager Service Manager Sales Manager	Warranty Staff Technician(s) Parts Staff

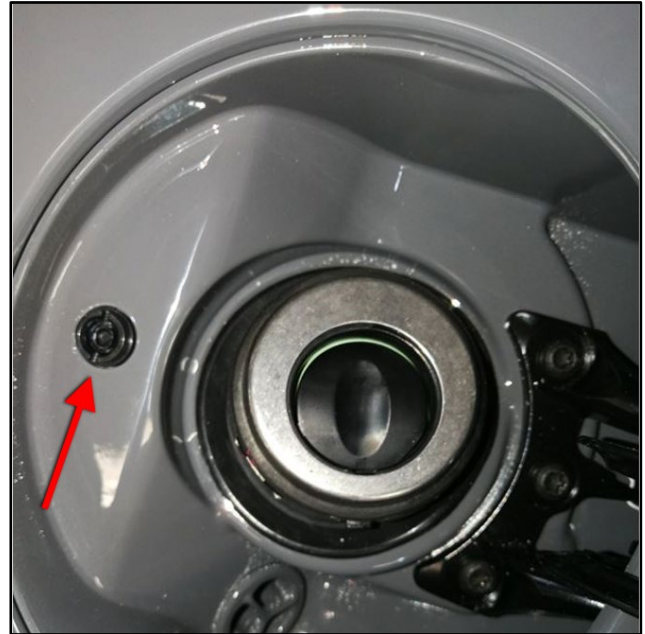
**Figure 1**

Aston Martin has found that the fuel filler latch mechanism can move out of position. If the fuel filler latch is not in the correct position the fuel filler door will not open or close correctly.

1. **Note:** *The fuel filler latch is shown by the arrow in Figure 1.*

Open and close the fuel filler door five times to check the operation of the fuel filler latch.

If the fuel filler door does not open or close correctly, do Part B of this Quarantine Notice.
