SERVICE ACTION

Reference number:	SA-01-1144	Issued: 23 November, 2018
Subject:	Incorrect Alignment of Door Latch Striker	
Model(s):	Vantage 19MY	
VIN range:	Refer to the separately published list of affected Vehicle Identification Numbers (VINs)	
Applicable to:	All Dealers	
Distribute to:	After Sales Manager Executive Manager Service Manager Sales Manager	Warranty Staff Technician(s) Parts Staff

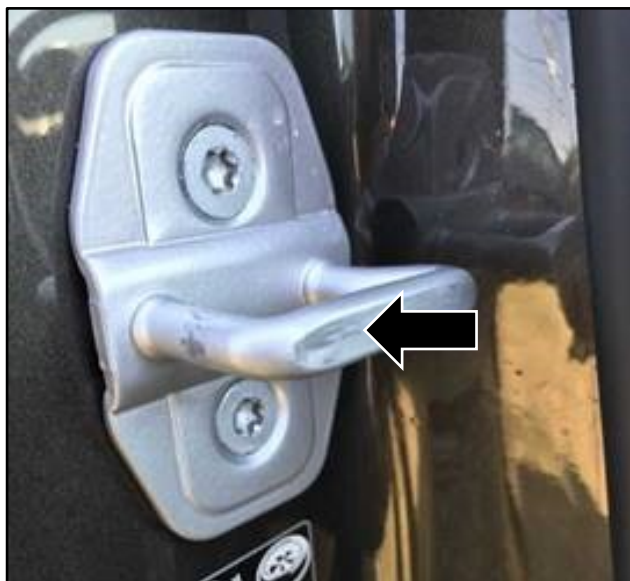
Figure 1

Note: If contact marks are visible on the door striker (refer to Figure 1), the door striker is not correctly aligned.

1. Visually inspect the door striker on both sides of the vehicle to make sure that it is aligned correctly.
2. If the door striker is aligned correctly and damage is not visible on the flat edge of the door striker, the check is complete.
3. If the door striker is not correctly aligned, the door striker must be removed (refer to Workshop Manual Procedure 01.14.CA for the right side door striker or 01.14.CB for the left side door striker).

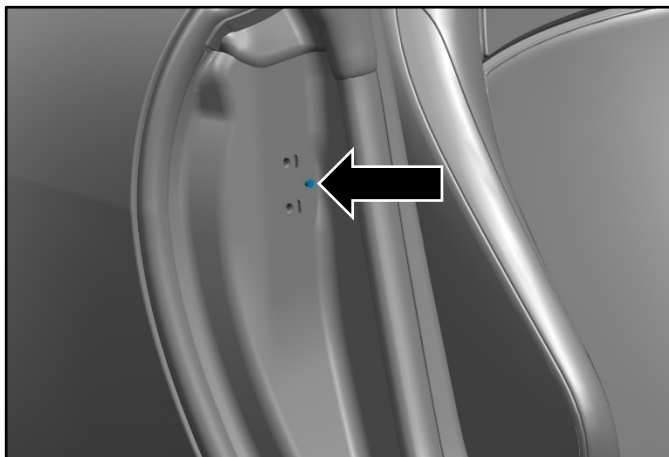
Figure 2

4. Visually inspect the rivet head to make sure that it is flush on the door opening panel (refer to Figure 2).

5. If the rivet head is not aligned correctly, use a punch (6mm diameter flat nose) with a mallet to align the rivet head correctly.
6. Install the door striker (refer to Workshop Manual Procedure 01.14.CA for the right side door striker or 01.14.CB for the left side door striker).
7. Do a check to make sure that the door closes correctly. Adjust the door if necessary.
