SERVICE ACTION

Reference number:	SA-01-1145	Issued: 23 November, 2018
Subject:	Door Clash to Bonnet	
Model(s):	Vantage 19MY	
VIN range:	Refer to the separately published list of Vehicle Identification Numbers (VINs)	
Applicable to:	All Dealers	
Distribute to:	After Sales Manager Executive Manager Service Manager Sales Manager	Warranty Staff Technician(s) Parts Staff

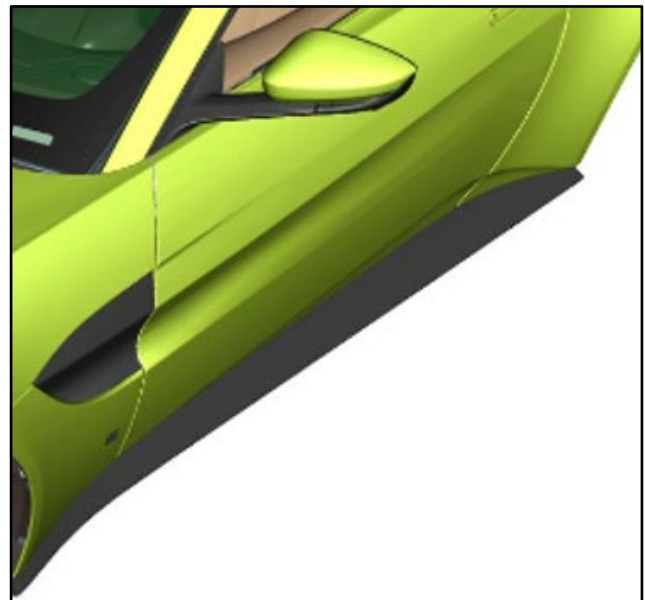
Figure 1

1. Open the side doors and check that they do not touch the parts in front of them.
 - If a door touches the bonnet, do steps 2 thru 3.
 - If a door touches the front wing panel, do steps 4 thru 5.
 - If both doors open without problem the procedure is completed.
