Subject: TIB 23-002: Eaton Endurant Transmission Clutch Bolt Torque

**23-002**

PACCAR Transmissions and Eaton Endurant Transmission Clutch Bolt Torque

12/4/2018

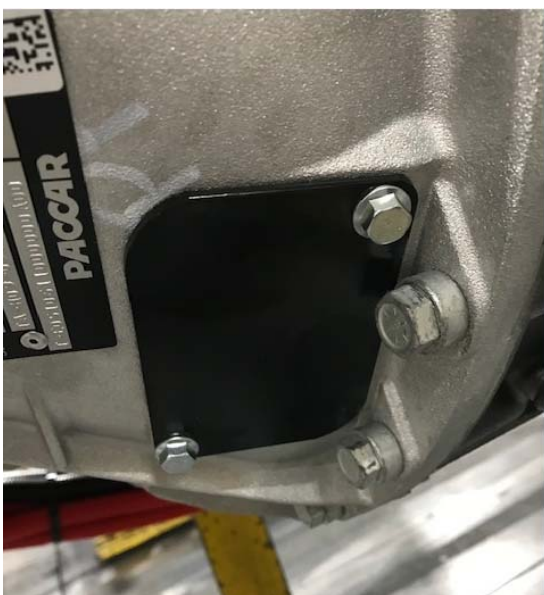
1. Remove the access plate from the transmission bell housing.

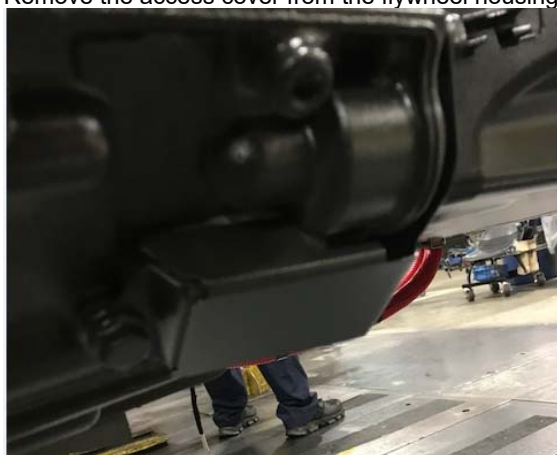
2. Remove the access cover from the flywheel housing.

3. Use the MX engine cranking tool to rotate the engine until a clutch bolt is accessible through the transmission bell housing access plate.
4. Torque the bolt to 45 lb-ft. (61 N·m).
5. Apply a witness mark to the bolt.
6. Repeat this process for the remaining 11 bolts.
7. Reinstall the transmission bell housing access plate.
8. Reinstall the flywheel housing access cover.

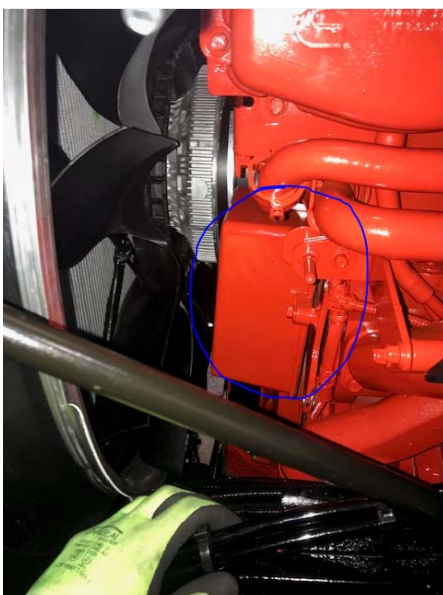
1. Remove the access plate from the transmission bell housing.
2. Remove the air compressor muffler on the left front of the engine.

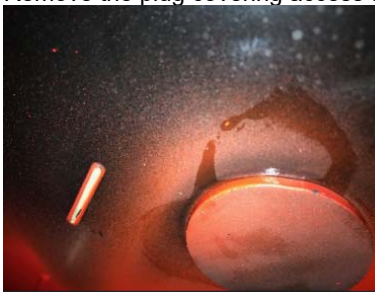
3. Remove the plug covering access to the insert on the end of the crank.

4. Technician 1 rotates the engine while Technician 2 watches for the clutch bolt to become accessible.
5. Torque the bolt to 45 lb-ft. (61 N·m).
6. Apply a witness mark to the bolt.
7. Repeat this process for the remaining 11 bolts.
8. Reinstall the transmission bell housing access plate.
9. Reinstall the plug covering access to the insert on the end of the crank.
10. Reinstall the air compressor muffler on the left front of the engine.
