Preliminary Information

PIP4751G Hybrid Drivability Concerns Jerk Bump Or Surge At Low Speeds

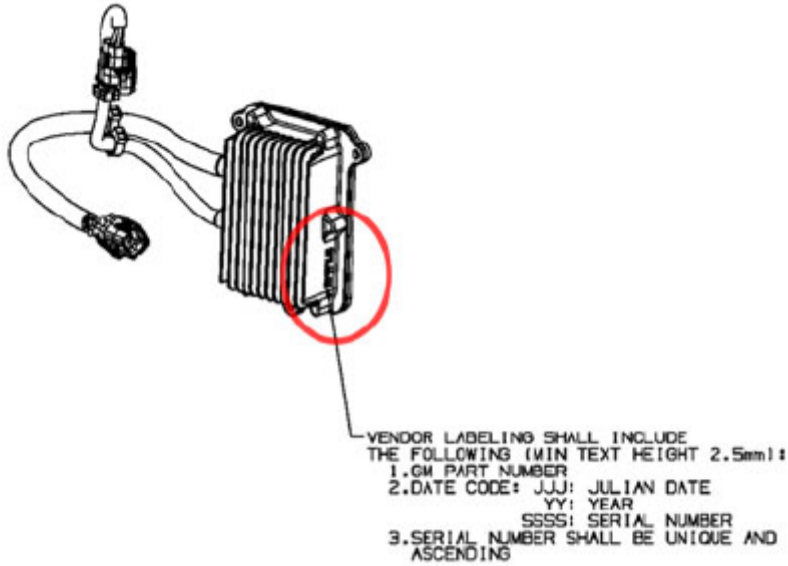
- 1) Check all vehicle modules and address any DTCs that may be present except for P2797 or P0C2B.
- 2) Once other DTCs have been addressed obtain the date code off of the auxiliary transmission fluid pump control module as indicated in the figure below.

5) If the customer concern does not re-produce, the "Hybrid Low, 1-2 clutch" assembly is operating normally and the control module has a Date Code of 089-11-XXXX or older, replace the auxiliary transmission fluid pump control module.
