Preliminary Information

PIC6344 Stall no Start

Brand:	Model:	Model Years:	VIN:		Engine:	Transmissions:
			from	to		
Buick	LaCrosse	2018 - 2019	All	All	LHN	All

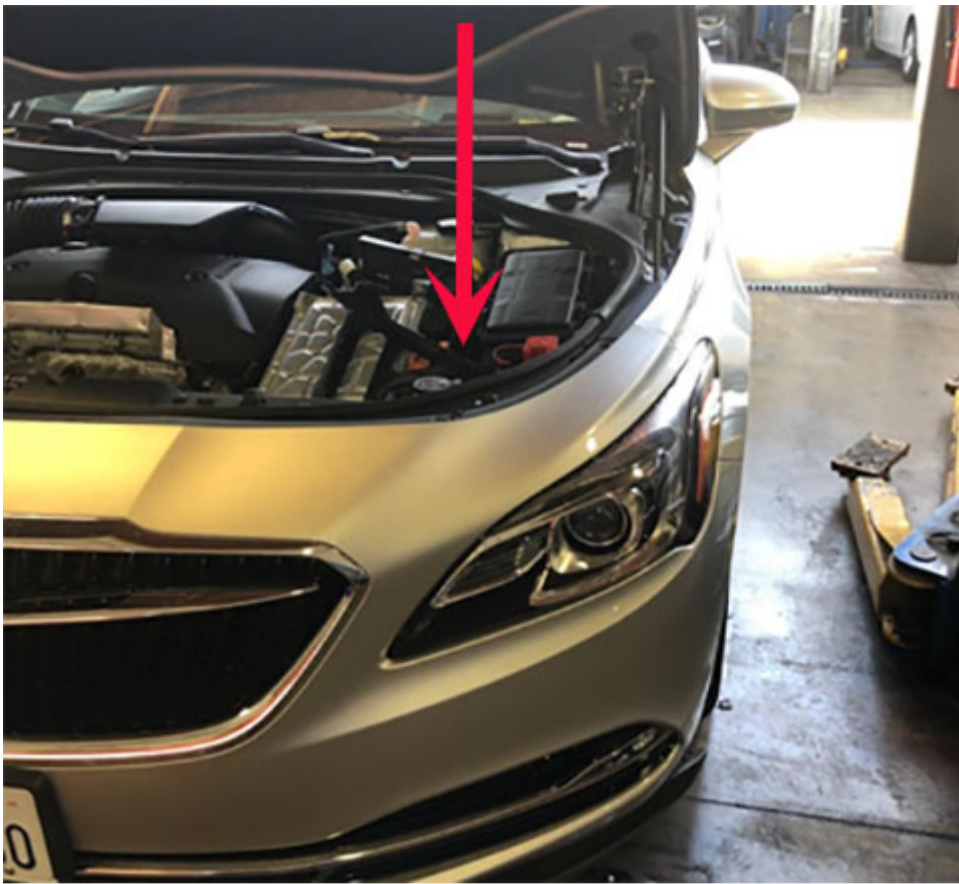
Locate G103 on the left frame rail underneath the Starter Generator Control Module (SGCM) bracket.

The general location of G103 is shown below.

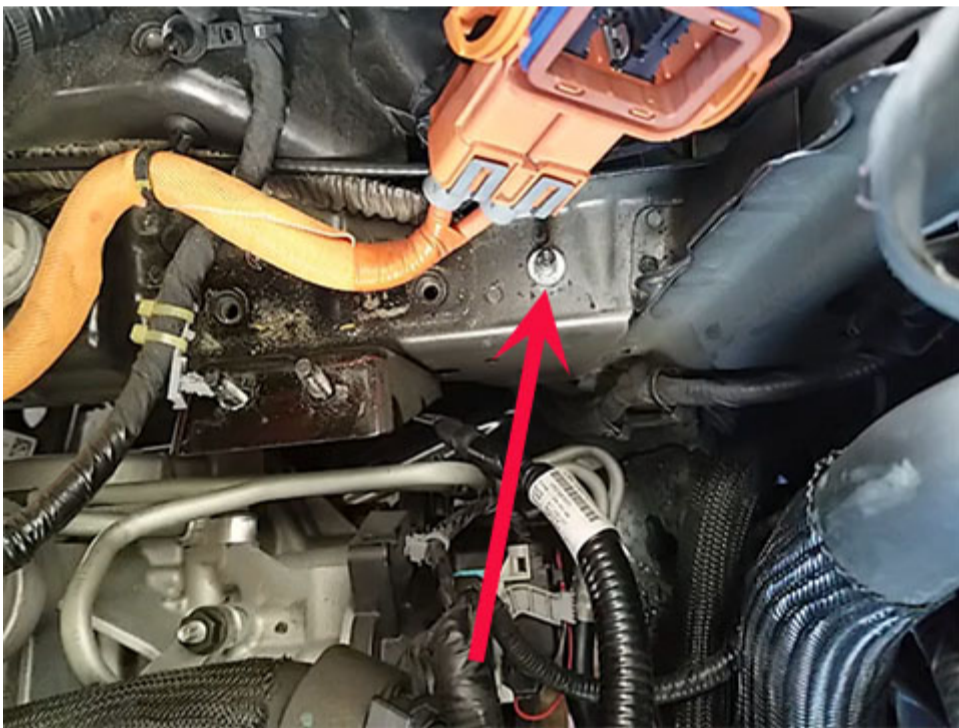
Note G103 with the cable removed below:

If the cable is not installed on the stud on the frame rail locate the cable and install it on the stud.

The cable may be hanging down or possibly tucked up behind other components and may not be readily visible.

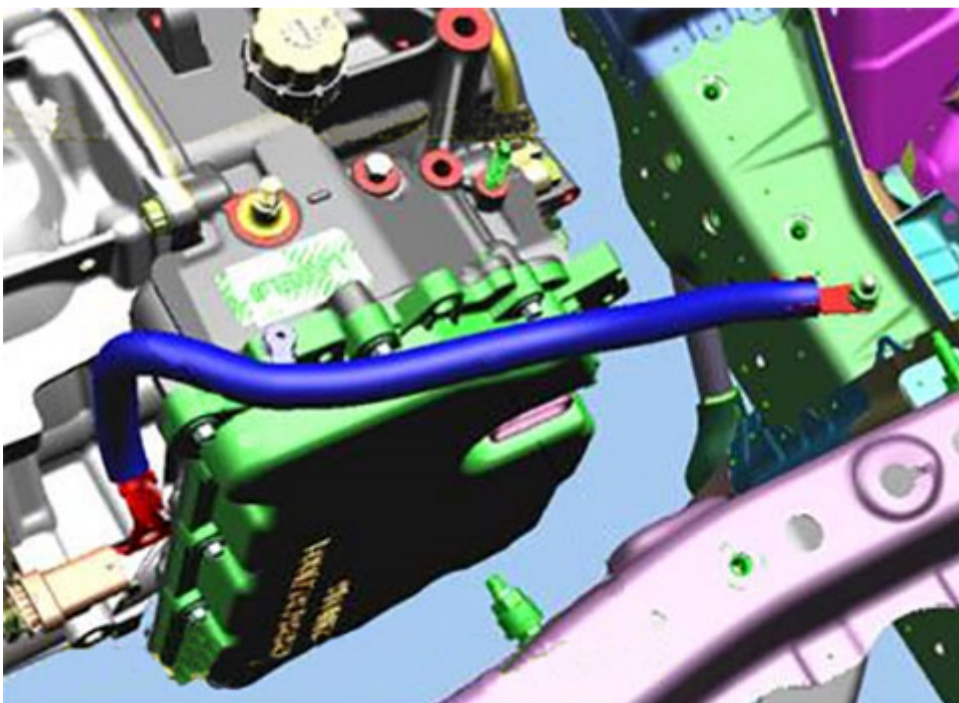
The ground cable runs from the transmission housing to G103 on the frame rail.

If the cable is installed on the stud ensure that it is secured underneath the attaching nut and then follow it back and ensure that it is attached to the transmission housing on the opposite end.

Verify that both ends of the cable are properly torqued.
