Preliminary Information

PIP5197L Possible Oil Consumption / Leaks – Blue Smoke Exhaust – Whistle Noise – DTC P0171 and/or P0300 and/or P0299

Models

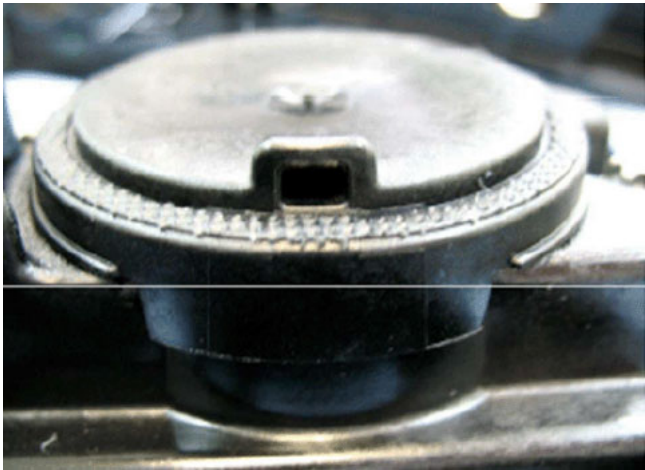
Check the PCV orifice for leaking oil or drawing vacuum at idle thru its external port. (The PCV orifice is an integral part of the camshaft cover). (See picture below).

If the PCV orifice external port is leaking oil or vacuum, replace the camshaft cover and perform the following testing.

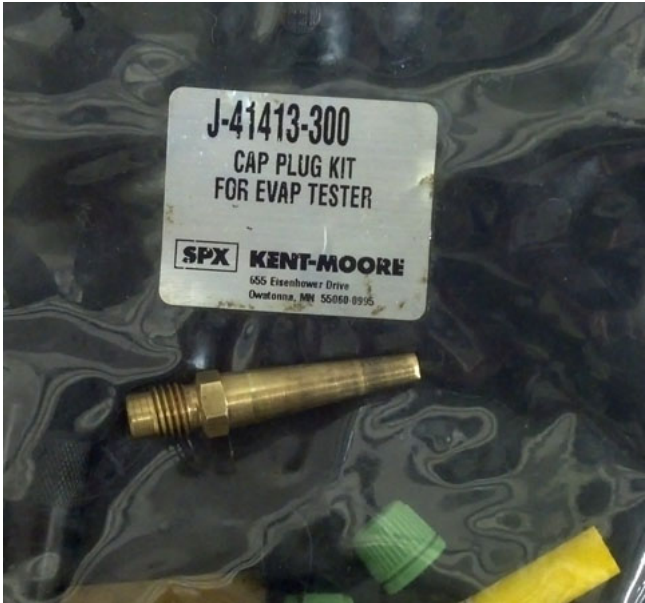
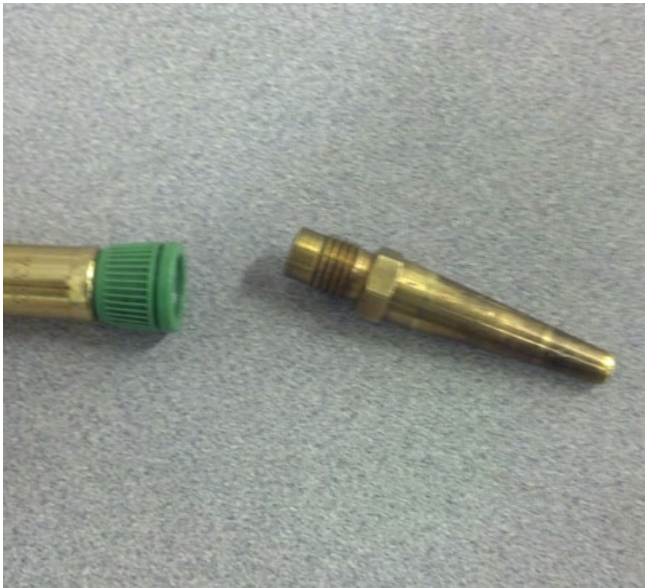
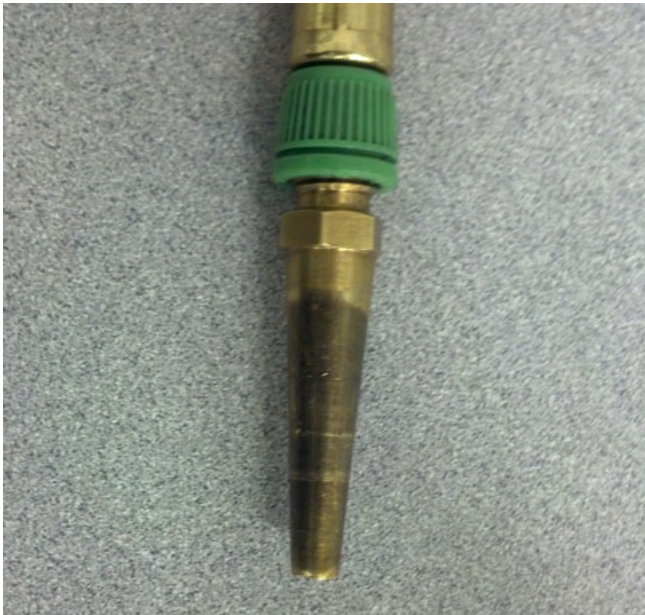
Next (refer to the pictures below) use the ESST gage and connect the ESST fitting at the engine oil dipstick hole of the camshaft cover.

Then start the engine,with the engine running at hot idle in park, snap the throttle and record the crankcase pressure.

If the crankcase pressure test reading is found to be a normal, between -11 and -18 inches of H<sub>2</sub>O (during the hot idle in park and during snap throttle testing) Then, continue by cleaning any oil residue from all induction system components.

If the crankcase pressure test reading is found to be an abnormal reading between -10 and 0 inches of H<sub>2</sub>O (during the hot idle in park and during snap throttle testing), this pressure reading is an indication of a cylinder leakage related concern, possibly caused by a weak or broken piston ring land.

Complete a cylinder leakage test to determine if the cause is a possible weak piston ring or broken piston ring land.

If a broken piston ring land is found, replace all four piston assemblies and retest for proper crankcase pressures.

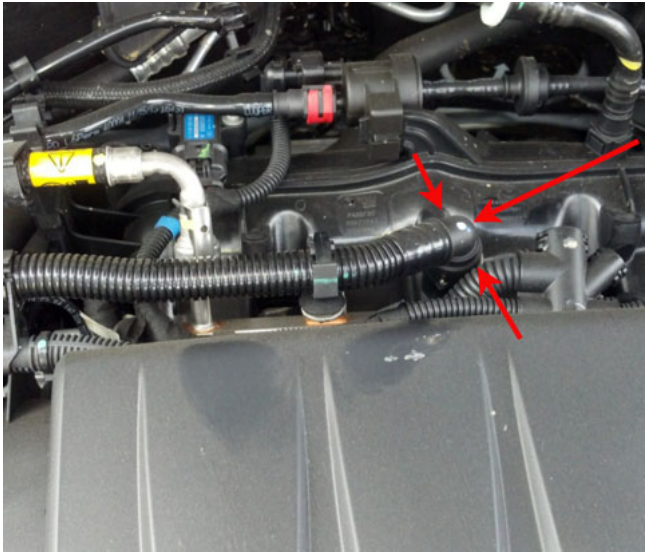
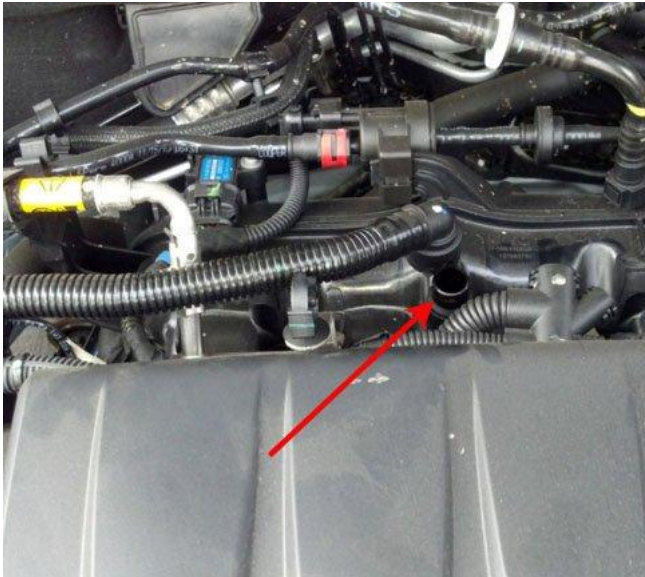
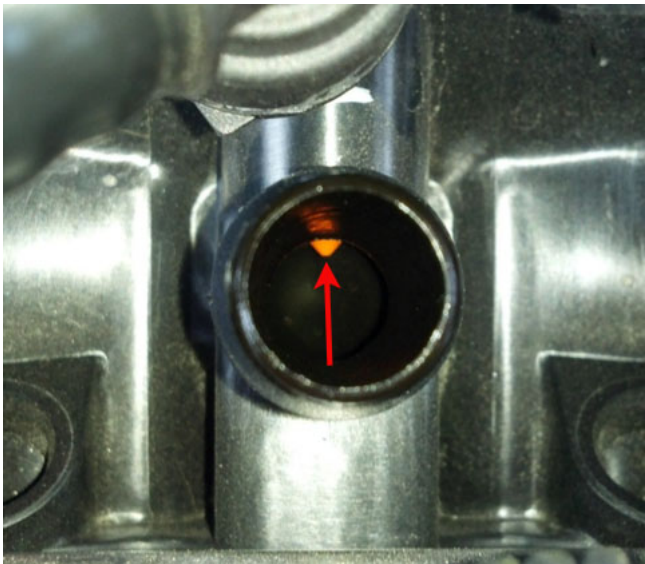
Check for a missing intake manifold Non Return Valve that may have damaged the PCV orifice diaphragm. (See pictures below for inspection procedure).

**If the non return valve is not visible as shown in picture, then use a long cotton swab to wipe any excess oil from the valve to validate.**  
**If the non return valve is still not visible, then intake manifold removal for inspection is required to validate.**  
**If the valve is present reinstall the intake manifold. Do not replace.**  
**Properly seated Non Return Valve as viewed with the intake manifold removed.**

If the intake manifold Non Return Valve is missing, then replace the intake manifold assembly,
