Bulletin No.: PIP5610A

PIP5610A Low Power Hesitation or Sluggish Feeling on Acceleration

Brand:	Model:	Model Years:	VIN:		Engine:	Transmissions:
			from	to		
Chevrolet	Malibu	2016 - 2019	All	All	1.5 LFV	All

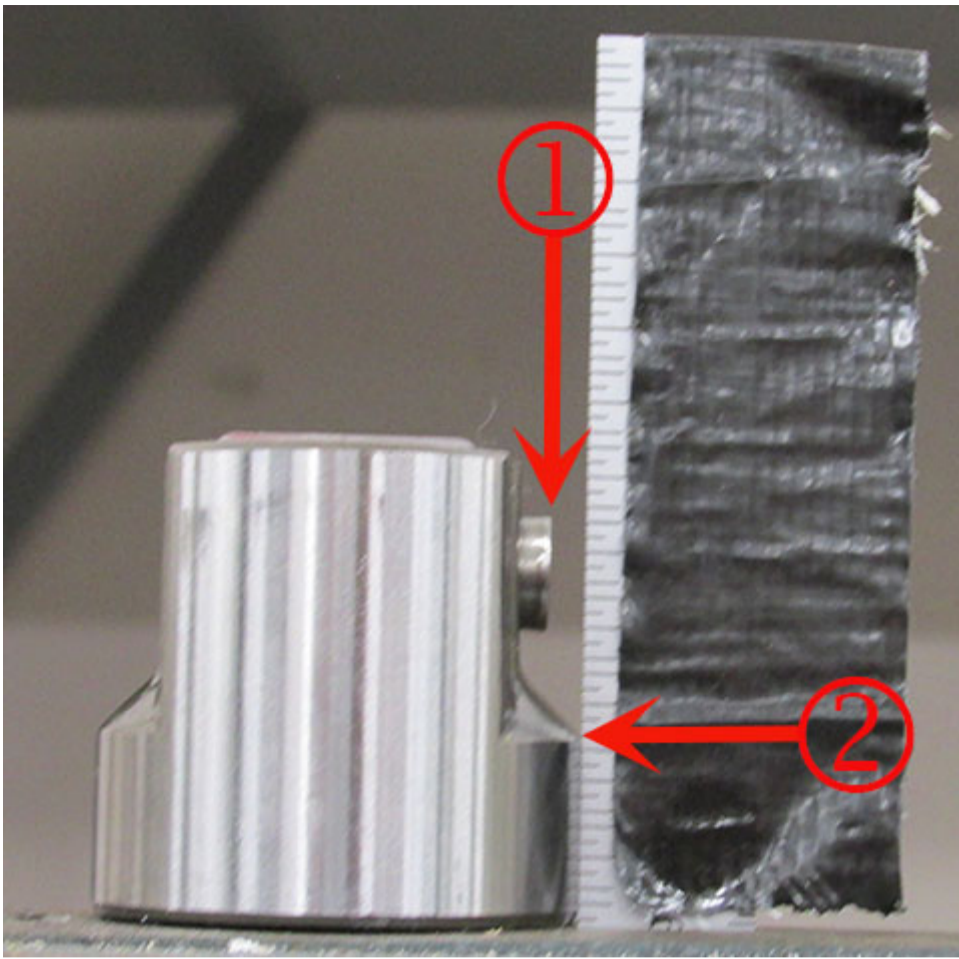
Photo below shows normal lateral movement of pin (1) when pushed all the way to one side. (Note pin does not protrude past body (2) of follower)

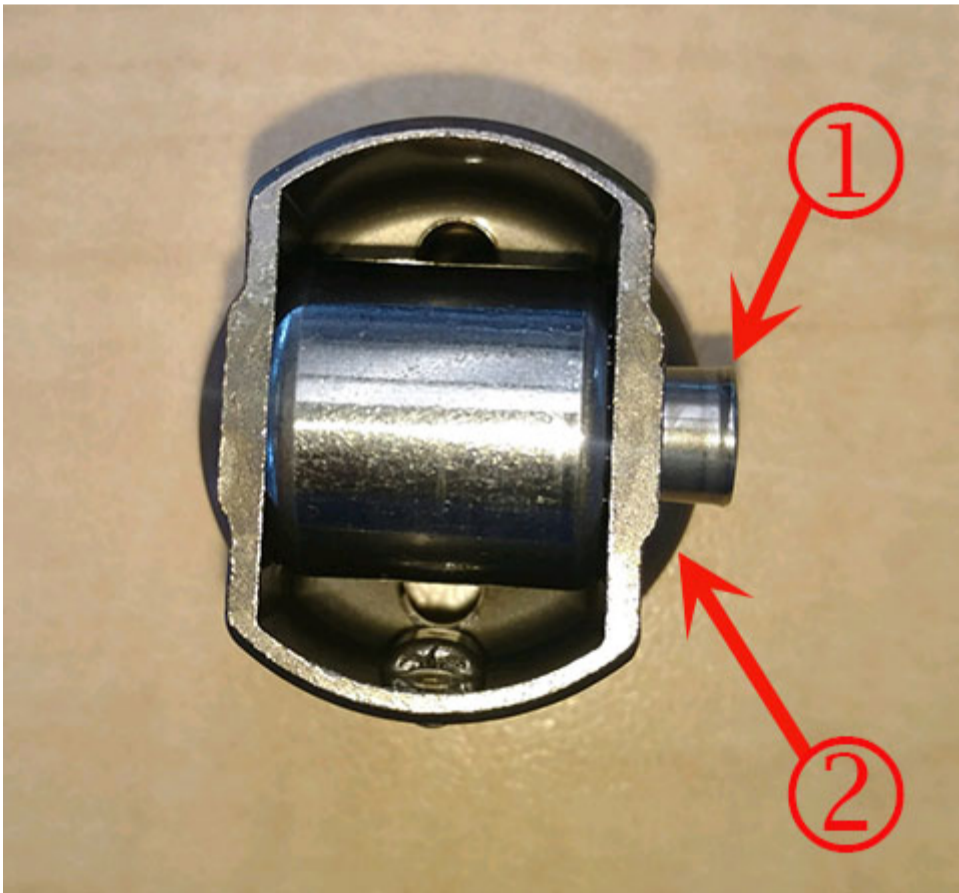
Photo below shows follower pin (1) with excessive lateral movement. Note how pin is protruding past body (2) of follower. When the "pin walk" is this excessive it will contact and damage the cylinder head follower bore.

If abnormal roller follower pin walk was found, replacement of the roller follower will be required. Note: if you have any doubt regarding excessive pin walk then replace the roller follower and evaluate.

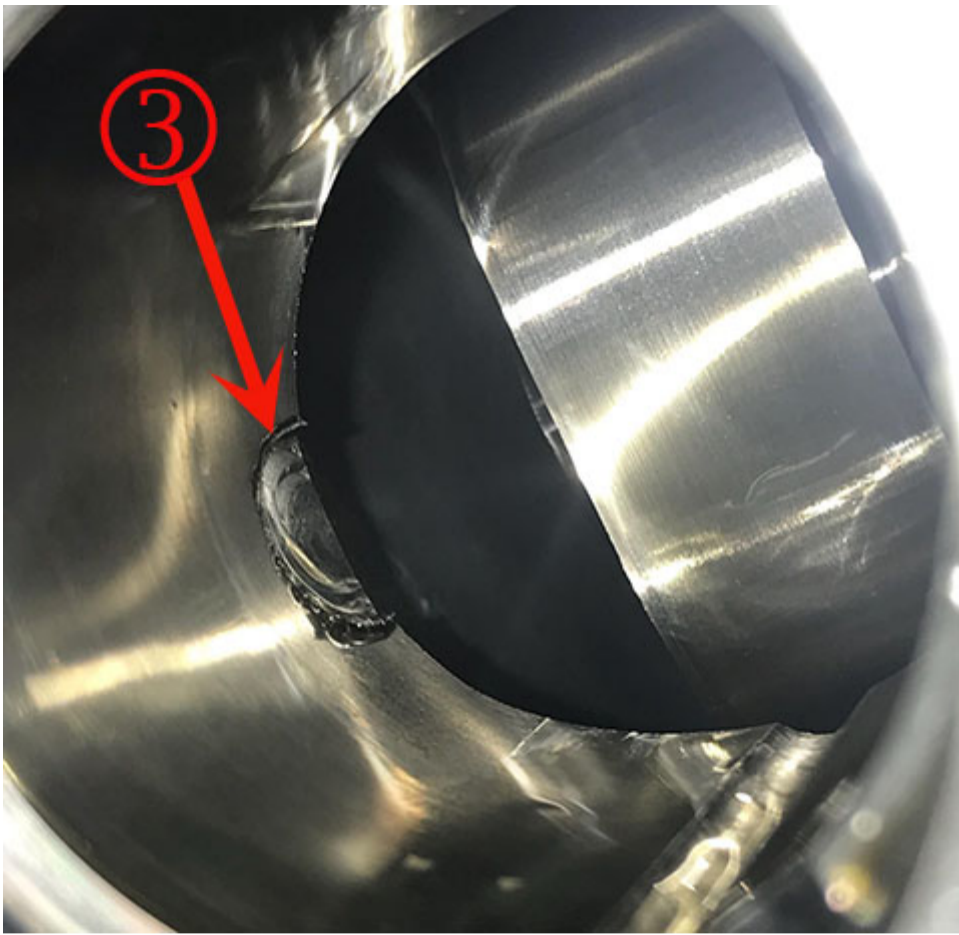
Photo below shows cylinder head bore (3) damage when pin protrudes past body of follower.

Cylinder head replacement would be required if the follower pin has already contacted and damaged the roller follower bore in the cylinder head.
