## PIP4374C Hybrid Inspect Transmission Three Phase Cables for adequate clearance to body

Brand:	Model:	Model Years:	VIN:		Engine:	Transmissions:
			from	to		
Chevrolet	Tahoe	2008	All	All	All	M99
GMC	Yukon	2008	All	All	All	M99

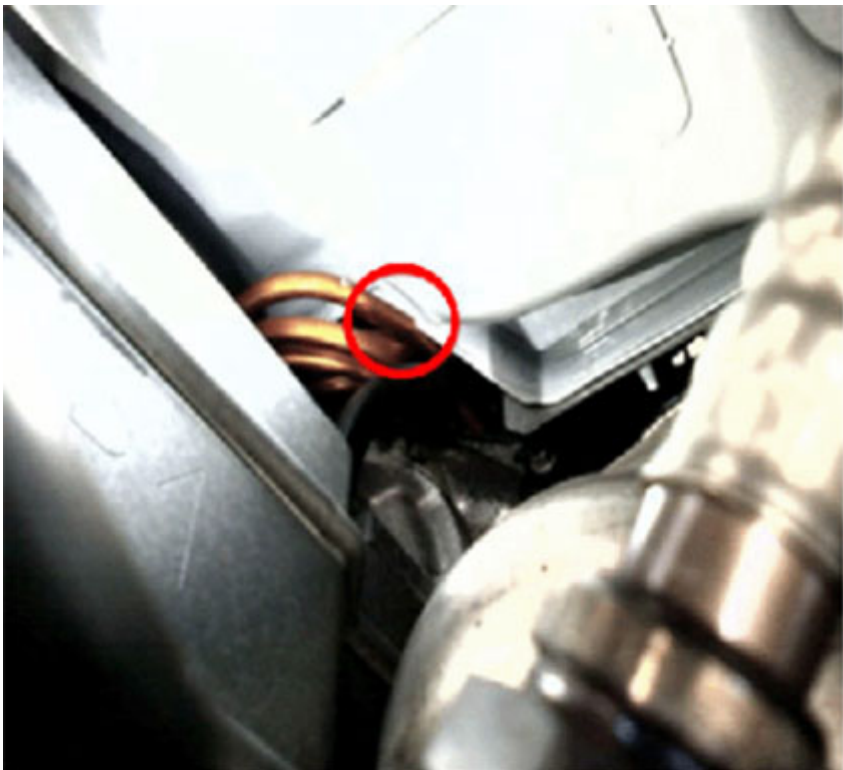
The above condition may be caused by a damaged or rubbed through 3-phase transmission electrical cable (see photo1).

If the clearance between the cables and the pinch weld is insufficient or the cables are damaged or dented the 3 phase cables will require replacement.

These cables should ONLY be replaced by a qualified Hybrid technician. Do not attempt to straighten the cables to add clearance.

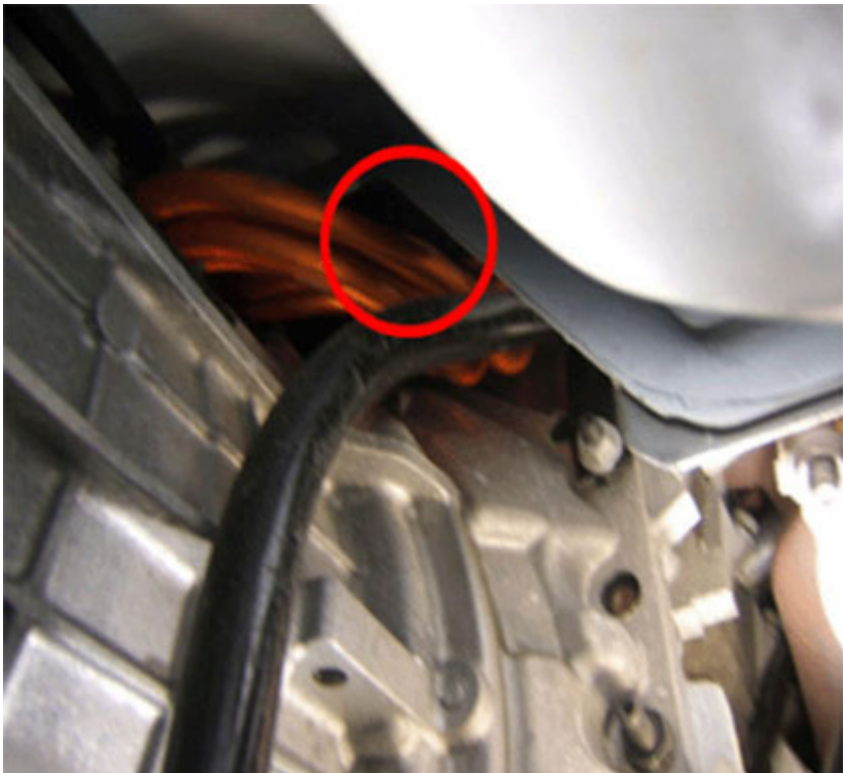
There should be a minimum of 1/4 inch (6.35mm) between the cables and the body pinch weld (see attached photo 2).
