Preliminary Information

PIP4432E HYBRID Transmission Fluid Leak at The Propshaft Slip Yoke

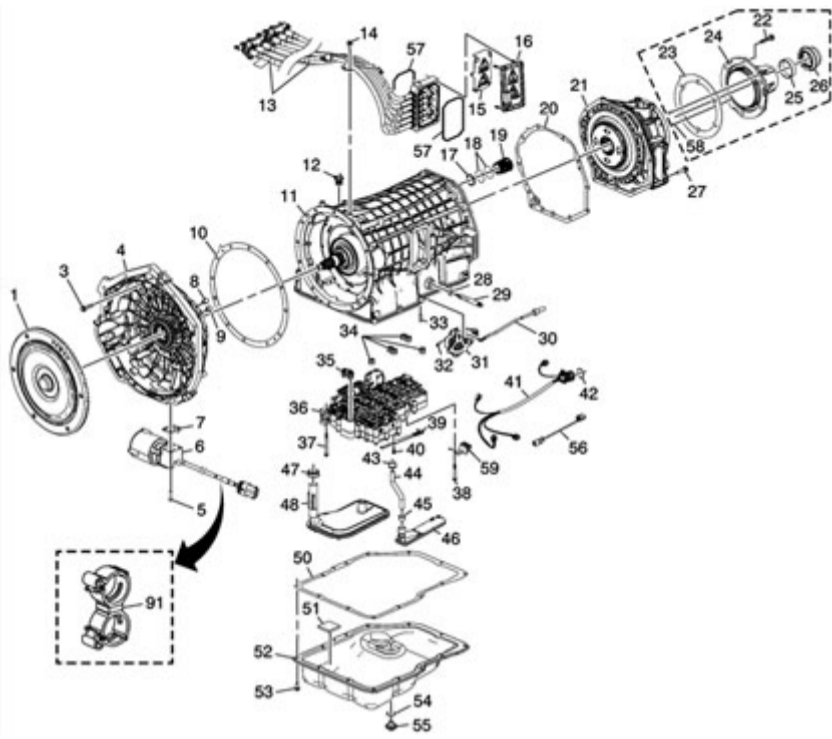
Some customers may have a concern of a transmission fluid leak. This condition may be mistaken for a leak from the transmission output shaft seal or transmission and or transfer case vent tube.

If the vehicle is a 2wd and if the leak is isolated to the output shaft seal (item 26), replace the complete output housing extension assembly (item 24) and gasket (item 23). The housing will come complete with the seal and bushing.
