## Preliminary Information

PIT4614C Hybrid No Crank With DTC B009F or Service Hybrid message with no codes.

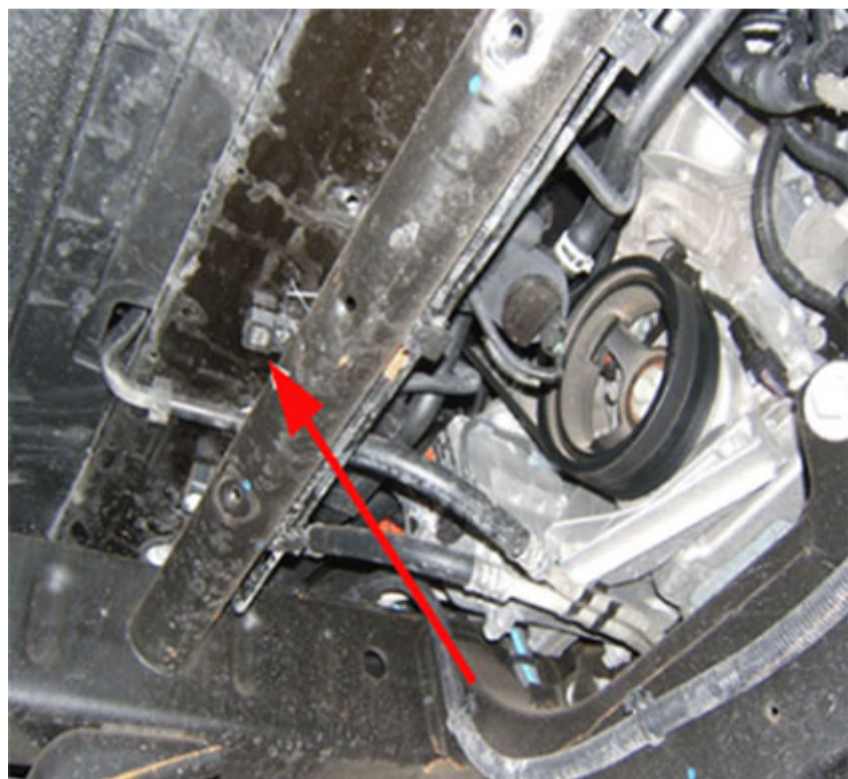
**This concern may be caused by water intrusion past the weatherpack seal on the High Voltage Circuit Impact Detection (HVCID) sensor. The sensor is located in the center of the lower radiator support. (See Photo below)**

- 1. Inspect the HVCID sensor for cracks and the terminals for corrosion. Replace sensor and/or terminals and weather-pack seals if any signs of corrosion or damage is found.**
- 2. If no damage or corrosion was found and there were no codes, Leave the connector unplugged to induce a code.**
- 3. Cycle the ignition off unplug the tech2 power down for 2 minutes**
- 4. Then clear code.**
- 5. Recheck for message and codes.**
- 6. If code resets then will need to replace the sensor and terminated leads then repeat steps 2-5**
