# Preliminary Information

## PIT5647 Click or Tick Noise from Rear of Vehicle at Low Speeds When AWD is Engaged

Brand:	Model:	Model Years:	VIN:		Engine:	Transmissions:
			from	to		
Chevrolet	Equinox	2018 - 2019	All	All	All	All
GMC	Terrain	2018 - 2019	All	All	All	All
Holden	Equinox	2018 - 2019	All	All	All	All

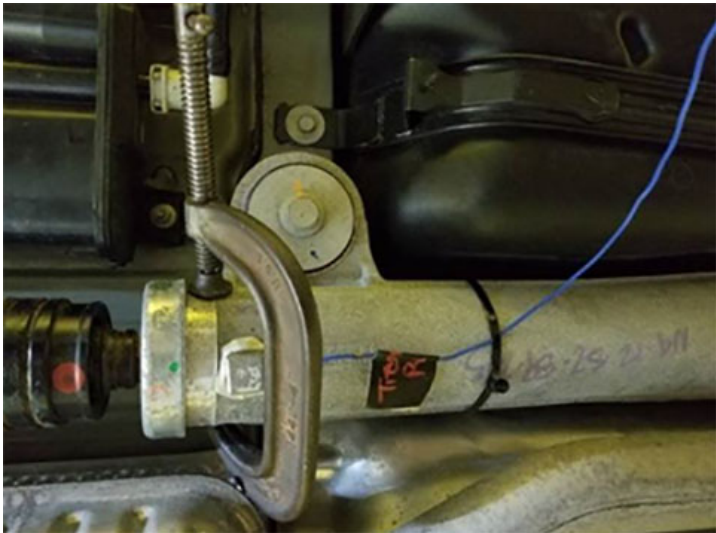
Involved Region or Country:	North America
Additional RPO/s:	F48
Condition:	Some customers may comment on a click or tick noise originating from the rear of the vehicle when traveling at slow speeds (Approximately less than 25 mph or 40 kph) while AWD is engaged.
Cause:	GM Engineering is attempting to determine the root cause of the above condition.

- 1 - With the vehicle securely lifted on a hoist, operate the vehicle to activate the All-Wheel Drive system.
- 2 - Control/confirm the noise is present by placing a C-Clamp over the torque tube in the specified location below.

3 - Remove Propshaft Assembly from vehicle per service procedure and then Re-install original Propshaft back into vehicle (make sure to align balance marks as well as replace snap rings and O-rings per service procedure).

4 - Check to see if the noise is still audible on the hoist, and perform a subjective road test.

- If the noise continues to persist, order & replace the Torque Tube per service procedures and please contact:

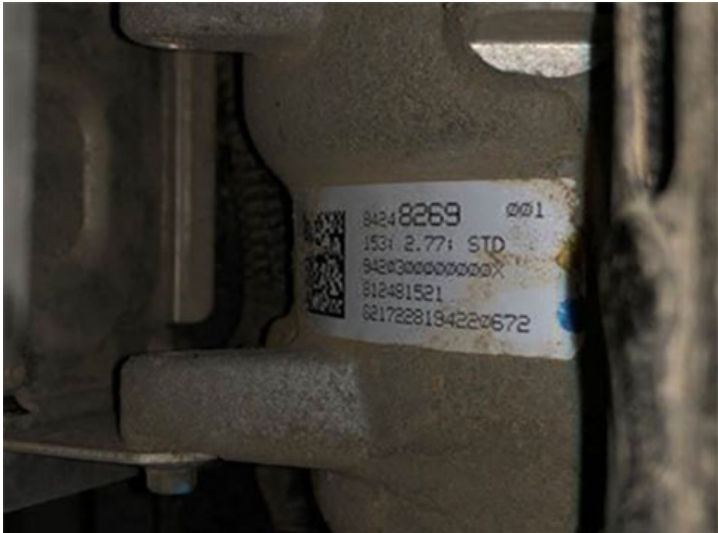
#### 2. Rear Differential Serial Number

Located on top of the differential housing beneath the control module (Example shown below)

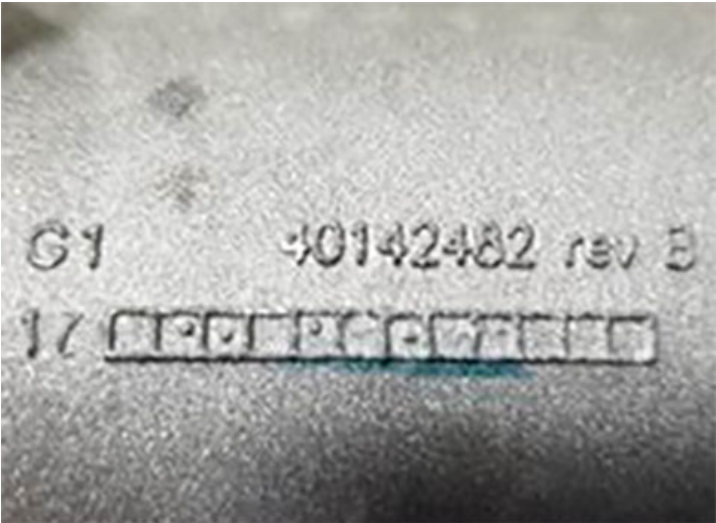
3. Torque Tube Casting Code

Located on the bottom of the torque tube, can be seen with vehicle on hoist (example shown below)
