Bulletin No.: PIC6293B **Published date:** 12/18/2018

PIC6293B Installation of the GM Accessory Interior Spectrum Lighting Kit

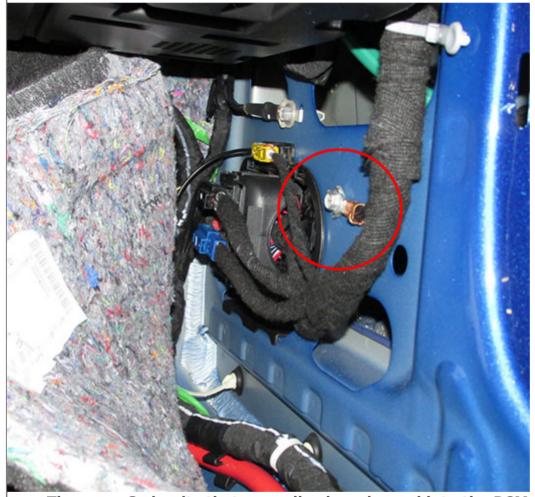
• If the entire kit has been installed and the lighting is entirely inoperative, there are a few things to go back and check. The most common area for concern is G202, which is located at the right hand kick panel. Typically, this ground has paint on it when the kit's eyelet is installed. Just tightening the fastener does not provide a good ground path if there is still paint covering the sheet metal. The fastener will have to be removed, the paint needs to be cleaned or ground off, and the ground path verified.

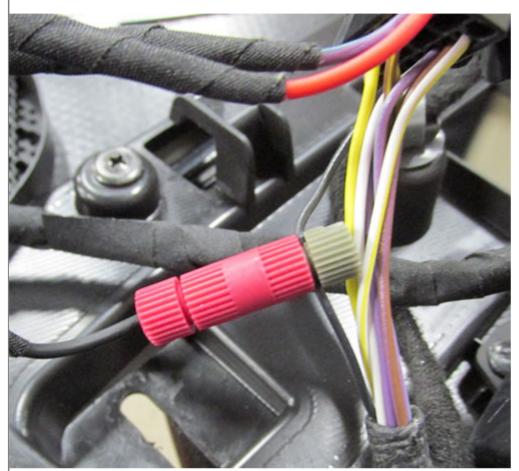
- There are 3 circuits that are spliced or plugged into the BCM related wiring. One of the circuits in the kit has a blunt cut end and must be tapped into the dash wiring going to the BCM. The two other wires have terminals crimped on the end and they are supposed to be inserted into empty BCM connector cavities. A common installation error is to install either of these circuits into the incorrect connector cavity. Either one of these terminals can easily be installed accidentally into an adjacent BCM connector cavity.
- Another common issue that is seen relates to the Posi-Tap connectors used in the kit. These connectors are used to splice the accessory harness to the vehicle's wiring harness.

Dealership technicians are to go back through the installation and verify that each connector is tight. If one or more of these connecters is/are loose, this will cause any number of performance issues with the kit. The connector shown in the photo below does not have tape or a zip tie covering it for clarity. Once the connector is properly installed, the instructions have the technician tape back the splice to the main harness using cloth tape. This will prevent the connector from loosening up over time.

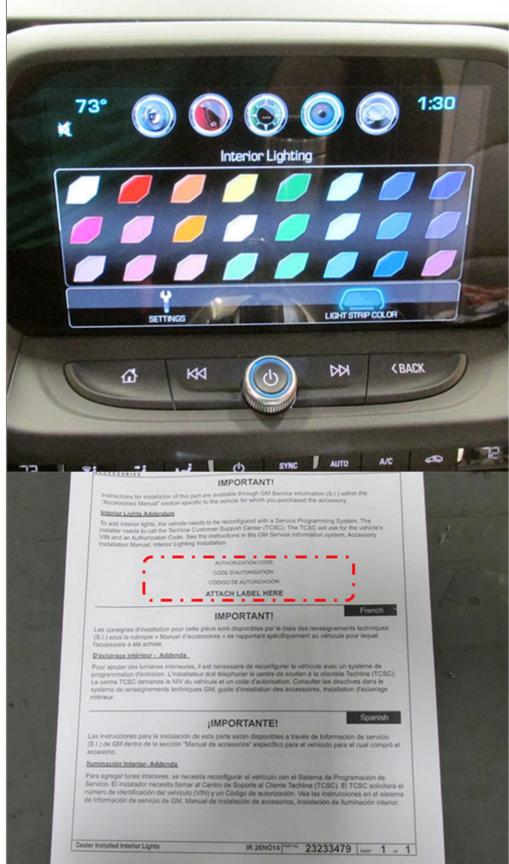
• If the vehicle is equipped with an "uplevel" radio (RPOs IO5, IO6, IOS, or IOT) various modules will require reprogramming through Techline. This programming allows the customer to select the various lighting colors on the radio's touchscreen, as seen in the color palette photo below. As seen in the second photo below, there will also be a sheet of paper included in the kit that has an authorization code printed on it. Once that code is provided to Techline, they will be able to assist in correctly programming the vehicle.

For the 2016 - 2018 models with the IO5 or IO6 radio, the HMI and the BCM will require SPS programming.

For the 2019+ models with the IOS or IOT radio, the radio and BCM will require SPS programming.

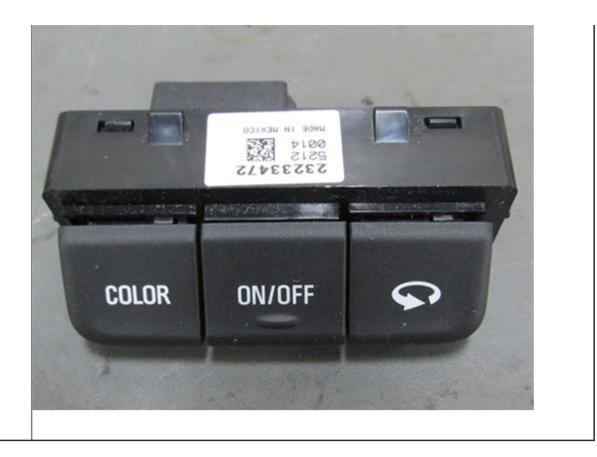
Vehicles equipped with the base radio (RPO IOB or IOR) do not require any programming. That is why the color selections are not available on the radio screen. This system uses a dashmounted switch to change the system's lighting colors. It is installed on the left hand side of the steering column. This switch can be seen in the photo below.
