SI M11 01 19
Engine

ENGINE VIBRATIONS OR NOISE

F54 (MINI Clubman)	F55 (MINI Hardtop 4 Door)	F56 (MINI Hardtop 2 Door)	F57 (MINI Convertible)
--------------------	---------------------------	---------------------------	------------------------

**Partial or full detachment damage of the crankshaft vibration damper:
B3x, B4x engines**

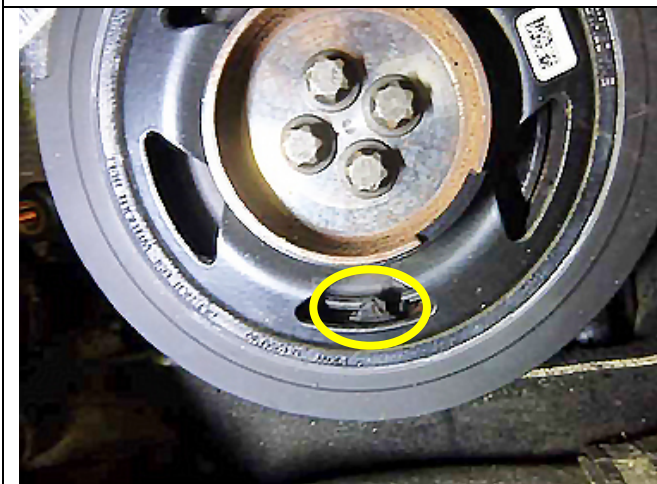
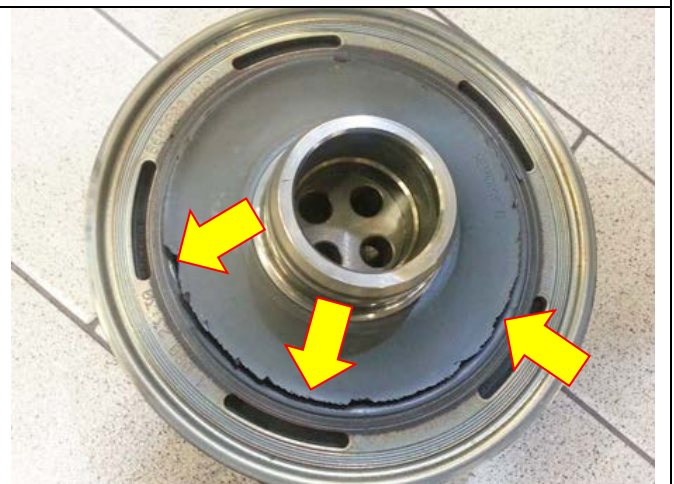
The vibration damper rubber insulator located between the drive belt pulley and its center hub has either partly or fully separated (torn). The separation will allow the two components to move independently from each other.

Partially damaged/detached bonded rubber layer between damper center hub and the outer belt pulley.

2. If cracks or damage to the vibration damper are visible or if the hub and belt pulley are no longer connected then replace the vibration damper.

Refer to Repair instruction 11 23 010 "Removing and installing/replacing vibration damper".

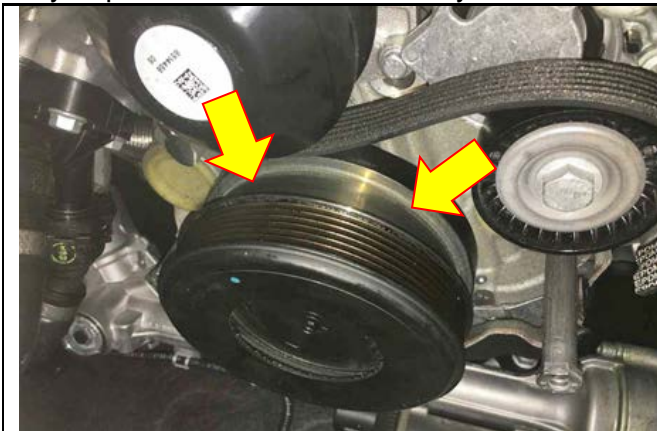
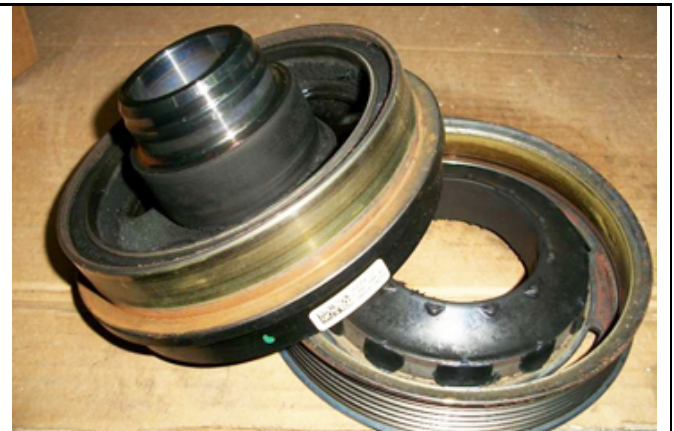
Fully separated/detached rubber layer.
