February 2019 Technical Service

SERVICE ACTION: PVC SEAM ON TAILGATE WATER CHANNEL COULD LEAK WATER, CHECK AND REWORK

F55 (MINI Cooper S 5 Door)

M41 02 18 F55 D-Pillar leak procedure

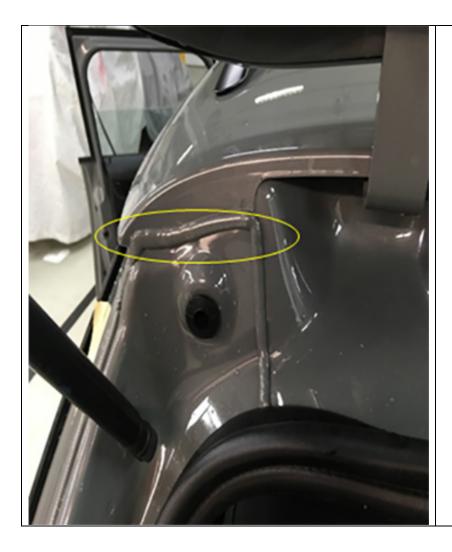
Visually inspect the body sealer at the top corners on both sides of the vehicle where the roof meets the D-Pillar in the area seen to the left.

2. Inspect the sealer for any gaps as seen to the left. Are visible gaps present in the body sealer at the D-Pillar? YES: Continue to step 8. NO: Continue to step 3.
 If no obvious gaps are present on the outside of the vehicle, the inside of the body seam will require inspection as well. Remove both luggage compartment wheel arch trim panels following repair instructions REP 51 47 151 "Removing and installing/replacing left luggage compartment wheel arch panel".

10/10/2018 4:12 AM	 Using the borescope, inspect the inside of the D-Pillar for any water intrusion while water testing.
	Is water intrusion found within the D-Pillar?
	within the D-Pillar?
	YES: Continue to step 8.
	NO: No further
	correction is required,
	the vehicle can be re- assembled.
	8. Using seam sealer PN 83
	42 2 409 985, reseal the seam shown in step 1.
	Verify the water
	intrusion is no longer
	present after sealing.
	If water intrusion is no
	longer present, because
	the seam is visible, the
	vehicle's newly sealed seam will need to be
	painted to match the
	vehicle color.
