SI M54 03 17
Special Roofs

CONVERTIBLE TOP WILL NOT COMPLETELY STOW

This Service Information bulletin replaces SI B54 03 17 dated **March 2017**.

F57 (Cooper, Cooper S, Cooper Works Convertible)

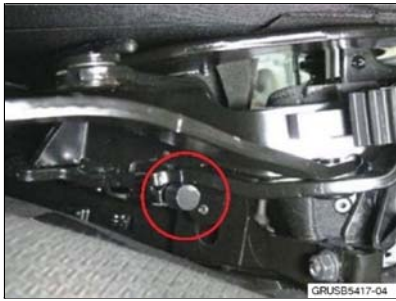
Improper adjustment of the convertible storage spacer adjustment bolt.

<ol style="list-style-type: none"> 1. Expose the left convertible top spacer adjustment bolt by opening the loading aid. 2. Loosen the lock nut. 3. Turn adjustment bolt in 1 - 2 turns.
	<ol style="list-style-type: none"> 4. Retighten lock nut. 5. Detach loading aid from left and right soft-top bow and lock. <p>Is the convertible top now compressed enough to engage lock on the left side?</p>
