SI M63 01 19
Lights

SERVICE ACTION: REWORK TAIL LIGHTS

F60 (MINI Countryman)

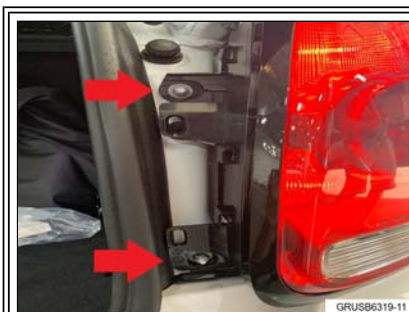
UPDATE ! 2. Visually inspect the mounting area of the tail light as shown to the left.

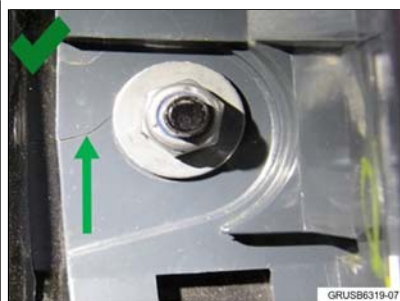
4. Reference the photos shown to the left, which demonstrate **acceptable** cracking and which require no further correction.

Single cracks are acceptable.

1 – small crack, not circulating, no net of cracks,

OK

2 – small crack, not circulating, no net of cracks,

3 – weld line, **OK Attention:** the position of the weld line can vary from model to model

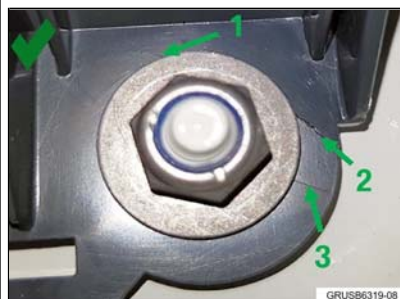
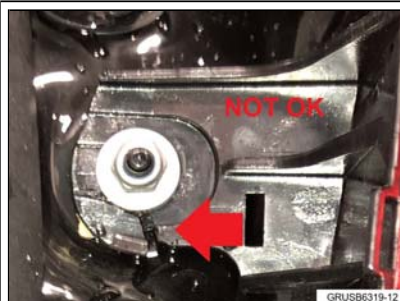
5. Reference the photos to the left showing examples of cracks that are **NOT** acceptable and which require tail light replacement.

UPDATE! Holder broken

UPDATE! Eye broken off

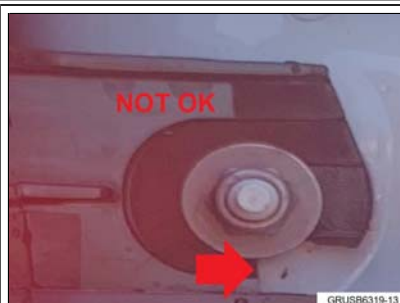
6. Does the vehicle pass the inspection, showing only acceptable cracking as shown in the step 3 examples?

YES: No further correction is required, the vehicle can be reassembled.

NO: Further repair information will be released shortly. The vehicle will require additional repairs before sale.
