ENGINE VIBRATIONS OR NOISE

**Partial or full detachment damage of the crankshaft vibration damper:
B4x, B5x engines**

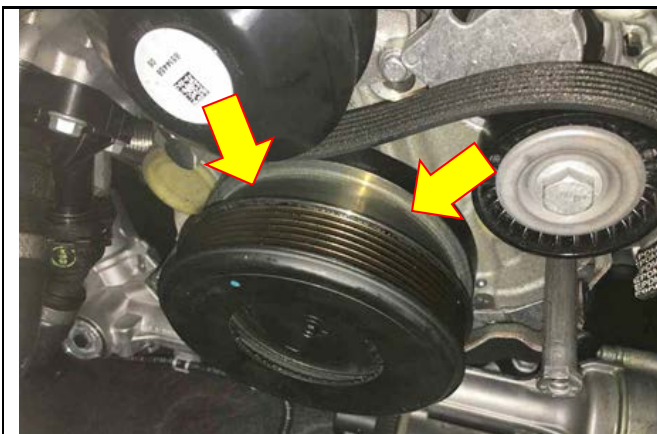
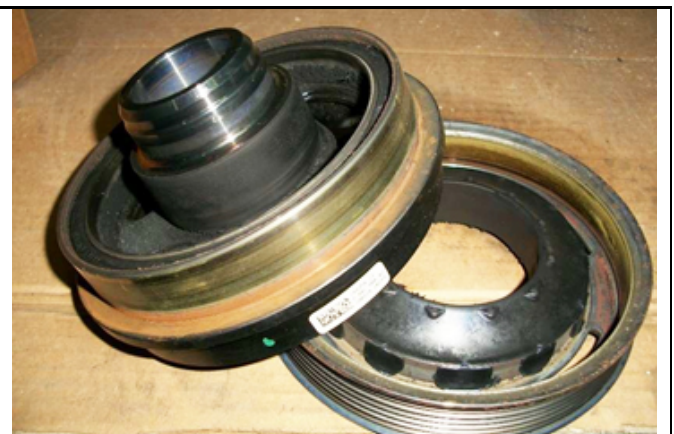
The vibration damper rubber insulator located between the drive belt pulley and its center hub has either partly or fully separated (torn). The separation will allow the two components to move independently from each other.

Fully separated/detached rubber insulator.

2. If cracks or damage to the vibration damper are visible or if the hub and belt pulley are no longer connected then replace the vibration damper.
