N63R MAP THERMOSTAT FAULTS

This Service Information bulletin replaces SI B12 13 16 **dated May 2017**

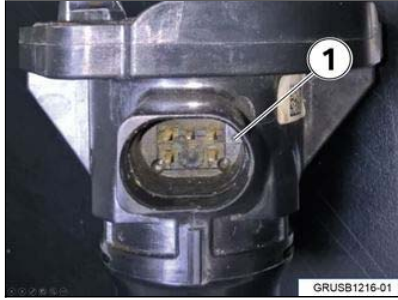
<p>1. Remove the connector for the map thermostat (1) and check for coolant.</p> <p>Is coolant present in the engine wiring sensor harness for cylinders 1-4?</p> <p>YES - replace the map sensor thermostat (PN 11 53 8 602 282) and the sensor harness (PN 12 51 8 654 414). Go to step 2.</p> <p>NO - continue diagnosis by performing the associated test plan in ISTAD.</p>

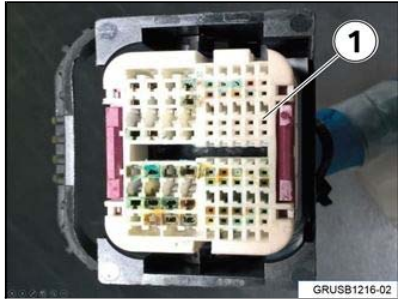
<p>2. Check the wiring harness connector at the DME for coolant (1).</p> <p>Is there any coolant at the DME harness connector?</p> <p>YES – Continue to step 3.</p> <p>NO – Repair is complete.</p>

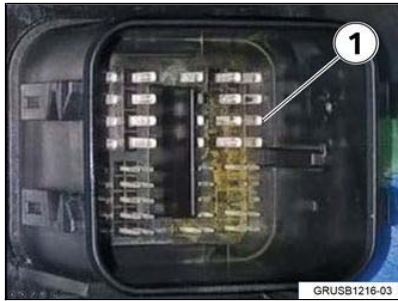
<p>3. Check the DME and PDM connector sockets for coolant contamination (1).</p> <p>Is there any contamination at the electrical connectors for the DME or PDM?</p> <p>YES- Submit a TC case to the TC DME group for DME and PDM parts replacement approval</p> <p>NO- Repair is complete.</p>
