PROLONGED ENGINE CRANK WHILE STARTING (B570)

G30 (5 Series 540d xDrive)

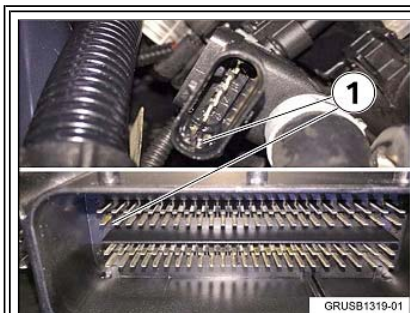
The fuel temperature/pressure sensor of the fuel supply line in the engine compartment is leaking at the connector

As a result, the fuel pre-supply pressure is often “detected” as being too low, even though it is actually within specifications.

Replace the fuel supply line in the engine compartment which contains the integrated fuel temperature/pressure sensor (PN 13 53 8 591 722).

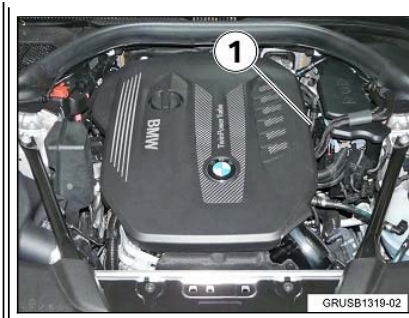
Note: The fuel supply line is located adjacent to the high-pressure fuel pump (1).

Refer to Repair Instructions 13 53 330 “Replacing all leaked oil lines”.

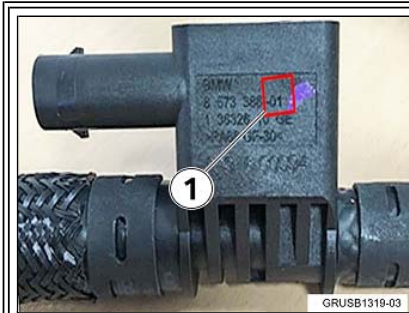
The improved fuel line can be determined by the change index (1) and part number located on the fuel temperature/pressure sensor of the fuel supply line.
