SI B17 06 17  
Cooling Systems

February 2019  
Technical Service

## COOLANT LEAK FROM LOW TEMPERATURE COOLING CIRCUIT (N63R)

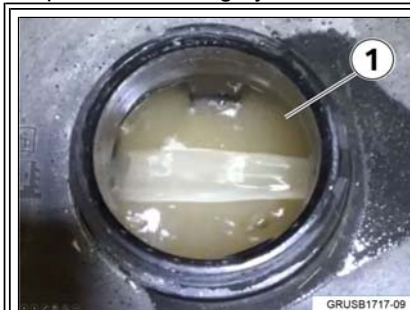
Coolant leaking from the engine compartment. Traces of coolant leaking from the expansion tank of the low temperature cooling system.

Coolant in the low temp cooling circuit may also have an acid smell and discoloration (1).

Aluminum corrosion in the charge air coolers or the radiator for the low temperature cooling is causing an unfavorable chemical reaction to the coolant.

Replace the radiator and both charge air coolers for the low temperature cooling circuit. Allow all the coolant in the system to drain during repairs (do not clamp off hoses).
