SI B34 01 14
Brakes

February 2019
Technical Service

VIBRATION WHEN BRAKING: DIAGNOSING AND REPAIRING

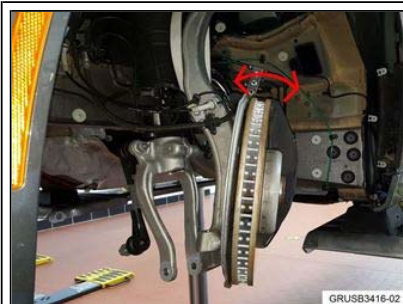
Excessive brake disc thickness variation

- Brake disc thickness variation is the result of lateral runout in the face of the brake disc.
- A brake disc with lateral runout while driving will slightly contact the brake pad once per revolution resulting in a thin spot on the brake disc.
- This consistent contact will eventually cause the brake disc to wear unevenly.

As determined by the results of following the B34 01 14 troubleshooting tree, the brakes discs (front, rear or both as applicable) are to be:

- Resurfaced using a BMW approved* "on-car" brake lathe (Non-Drilled or Non-Ceramic Brake Disc/Rotors); for additional information on brake rotor resurfacing refer to SI [B34 10 16](#) or
- Replaced.

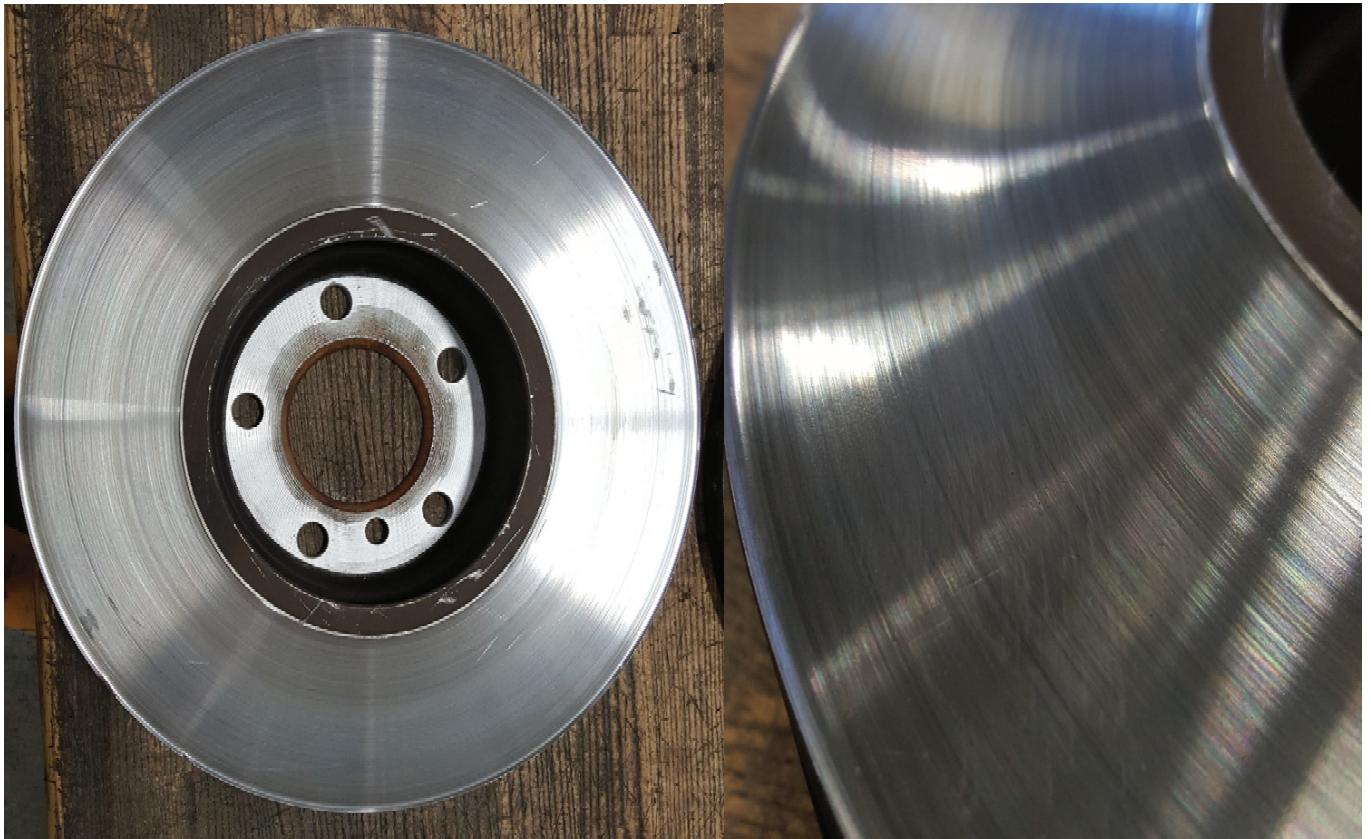
CATEGORIZATION OF BRAKE DISC-CORROSION

**CATEGORY 1 – NO CORROSION FOUND: OK TO USE NEW BRAKE PADS
(RESURFACING NOT NEEDED)**

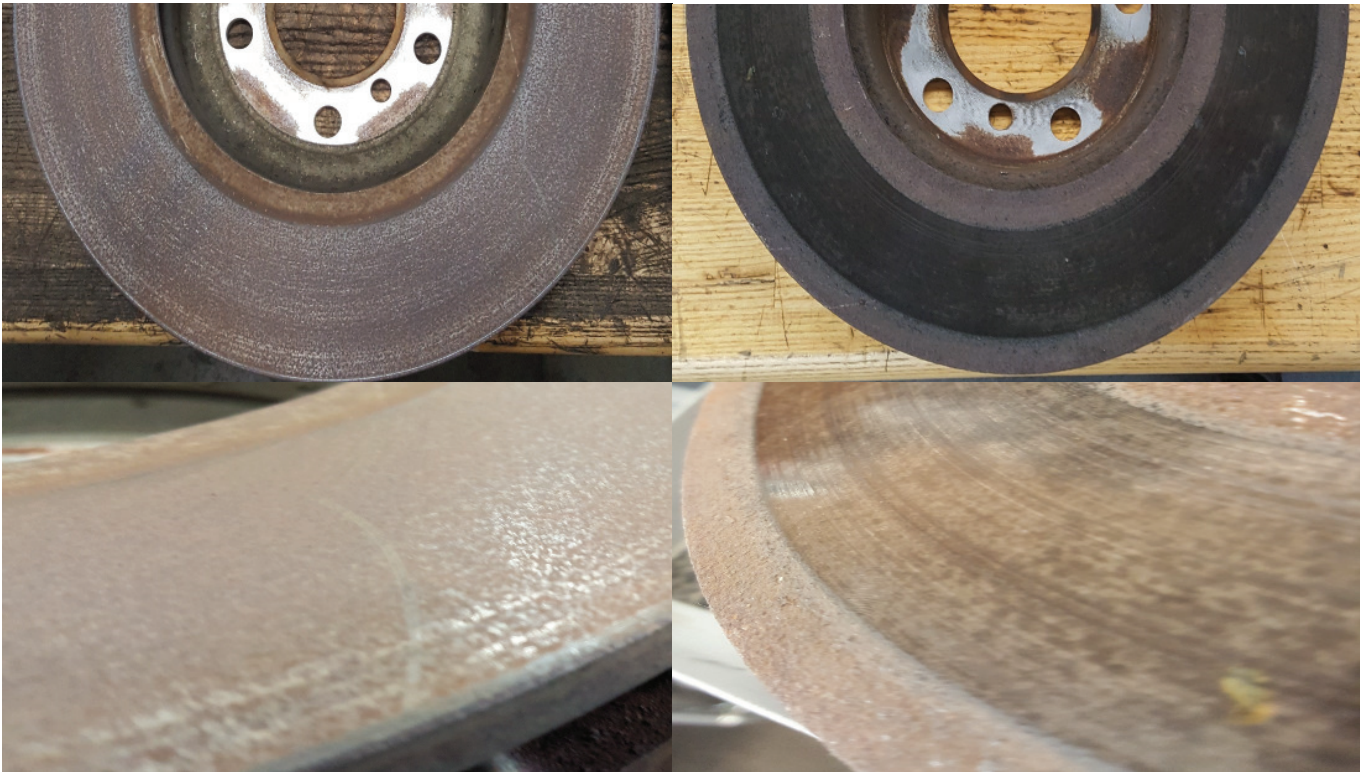
CATEGORIZATION OF BRAKE DISC-CORROSION

**CATEGORY 2 –CORROSION: CANNOT BE USED WITH NEW PADS.
OK TO RESURFACE*. AFTER CUTTING, USE NEW BRAKE PADS**

*** - IF MEASURED ROTOR THICKNESS IS ABOVE MINIMUM THICKNESS PLUS 0.5 MM**

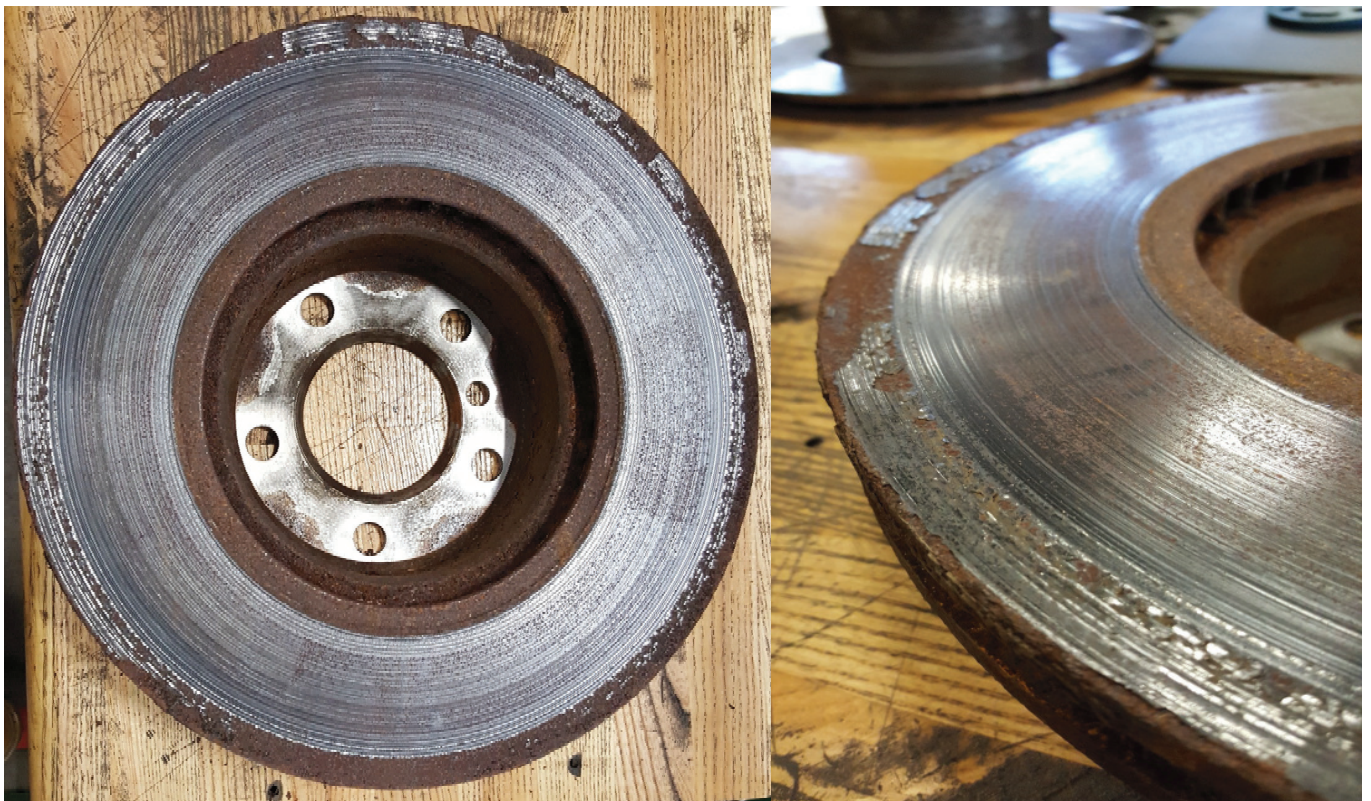
CATEGORIZATION OF BRAKE DISC-CORROSION

**CATEGORY 3 – SEVERE CORROSION: RESURFACING NOT POSSIBLE.
ROTORS MUST BE REPLACED**

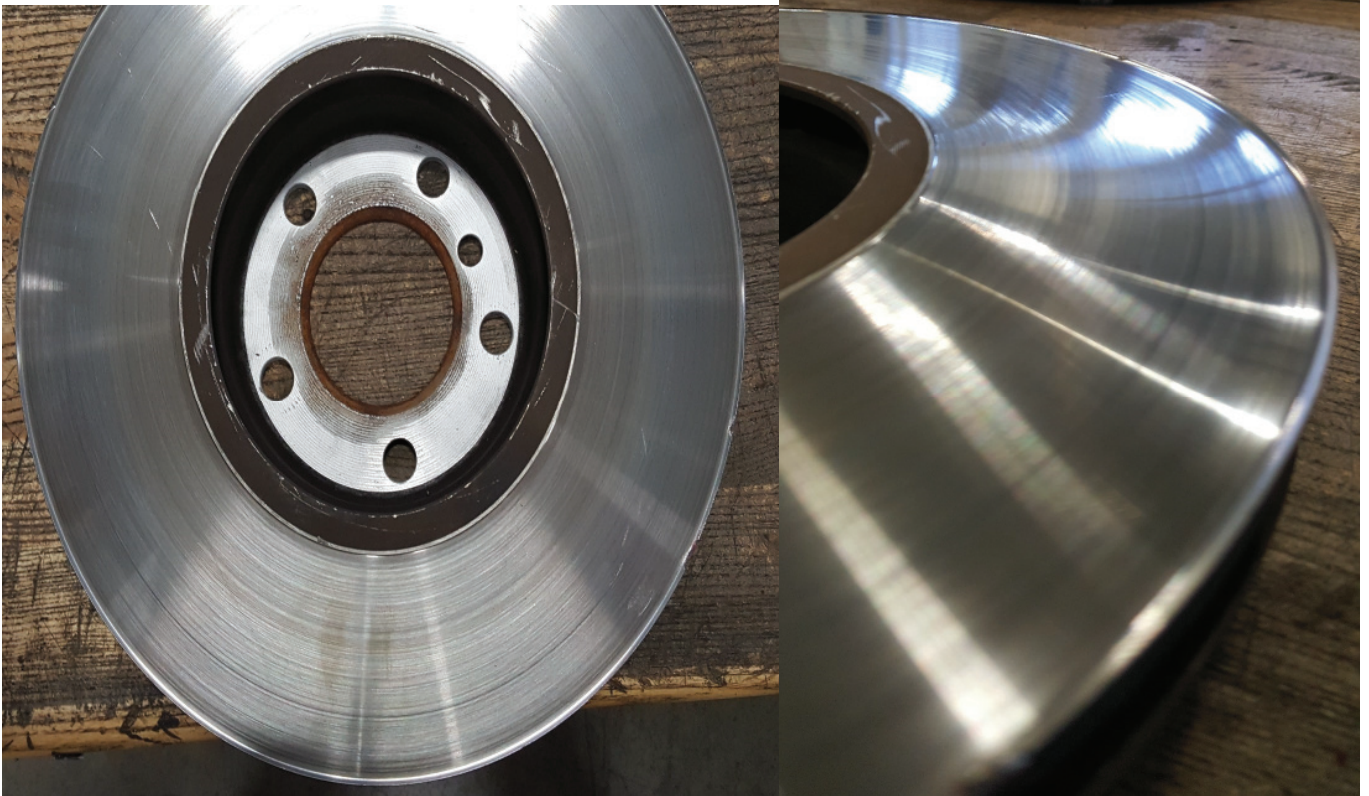
CATEGORIZATION OF BRAKE DISC-GROOVES

**CATEGORY 1 – NO GROOVES: OK TO USE NEW BRAKE PADS.
(RESURFACING NOT NEEDED)**

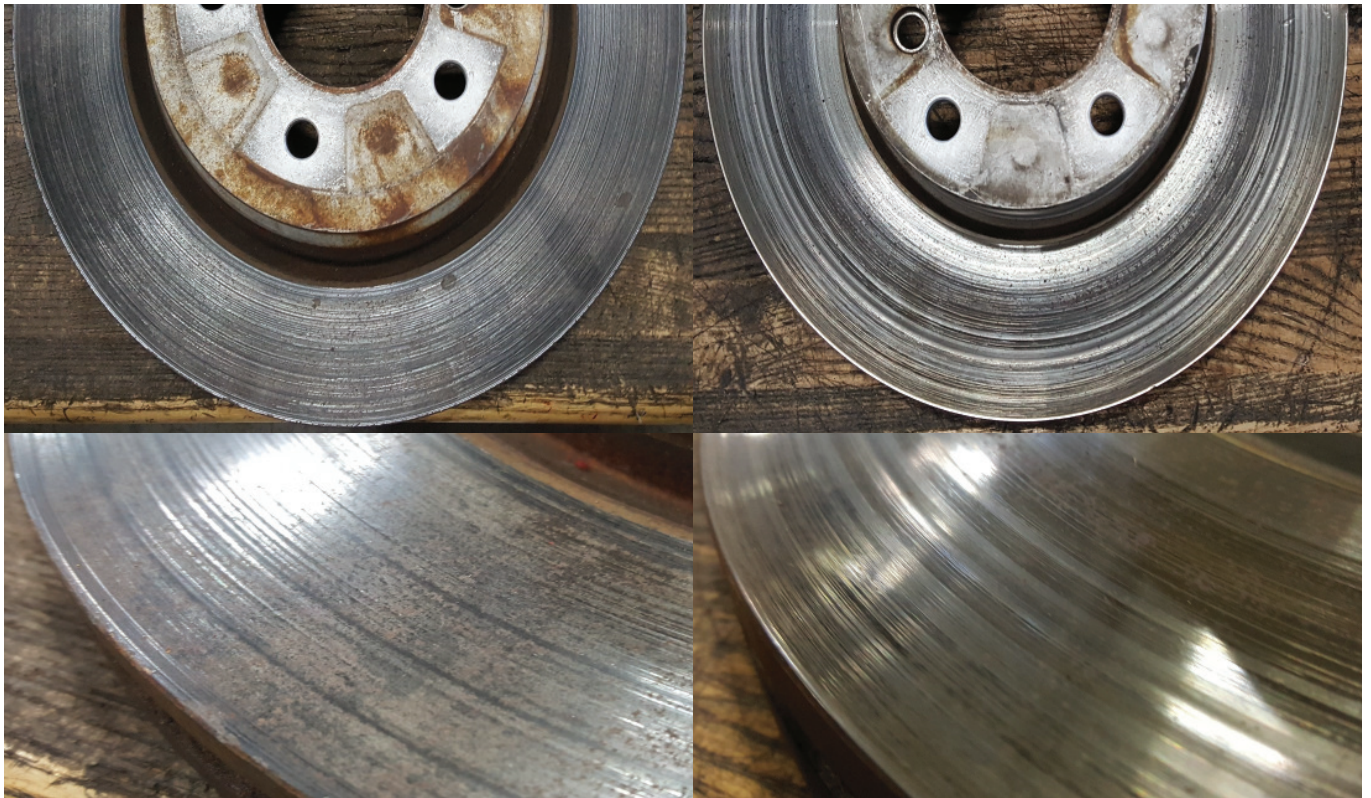
CATEGORIZATION OF BRAKE DISC-GROOVES

**CATEGORY 2 – GROOVES: CANNOT BE USED WITH NEW PADS.
OK TO RESURFACE*. AFTER CUTTING, USE NEW BRAKE PADS**

*** - IF MEASURED ROTOR THICKNESS IS ABOVE MINIMUM THICKNESS PLUS 0.5 MM**

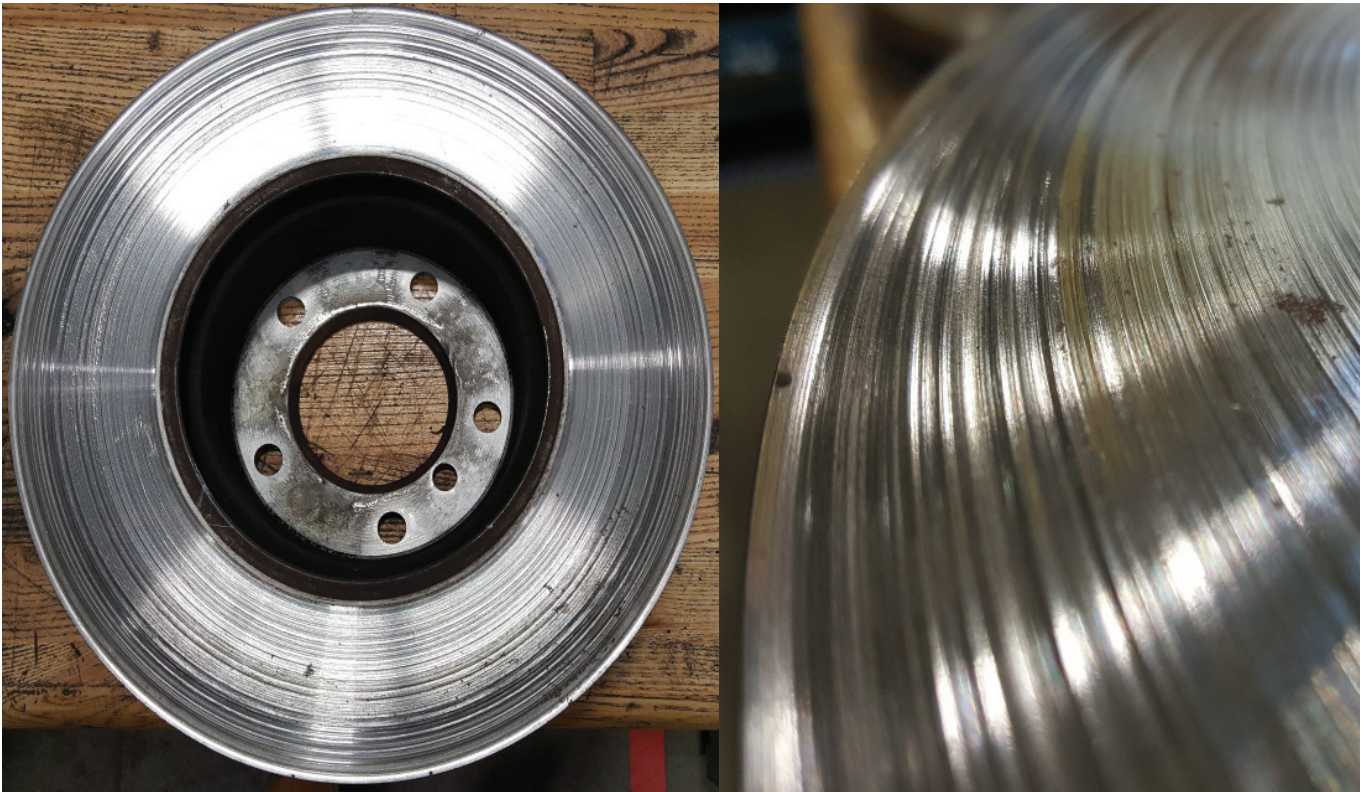
CATEGORIZATION OF BRAKE DISC-GROOVES

CATEGORY 3 – DEEP GROOVES* : RESURFACING NOT POSSIBLE, ROTORS MUST BE REPLACED

* - IF MEASURED ROTOR THICKNESS IN THE DEEPEST GROVE IS BELOW MINIMUM THICKNESS PLUS 0.5 MM
