## DELIVERY STOP: REWORK TAIL LIGHTS

This Service Information bulletin replaces SI B63 01 19 **dated February 2019**.

F22 (2 Series Coupe)	F23 (2 Series Convertible)	F30 (3 series)	F31 (3 Series Sports Wagon)
F34 (3 Series GT)	F80 (M3)	F87 (M2)	G01 (x3)
G12 (7 Series)

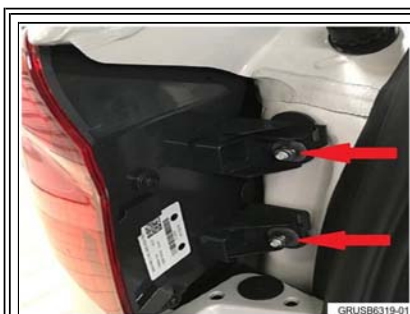
2. Visually inspect the mounting area of the tail light as shown to the left.

Different models may appear slightly different, but all models will be inspected in the same general location of the mounting tabs.

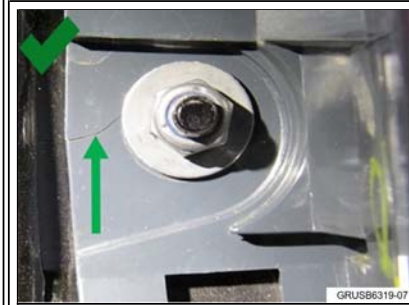
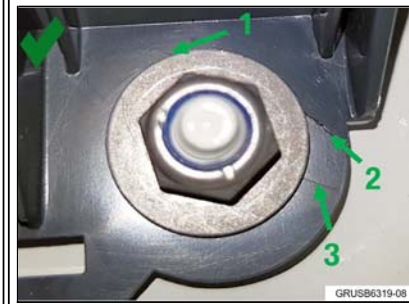
4. Reference the photos shown to the left, which demonstrate **acceptable** cracking and which require no further correction.

Description of picture:

1 – small crack, not circulating, no net of cracks, **OK**

2 – small crack, not circulating, no net of cracks, **OK**

3 – weld line, **OK Attention:** the position of the weld line can vary from model to model

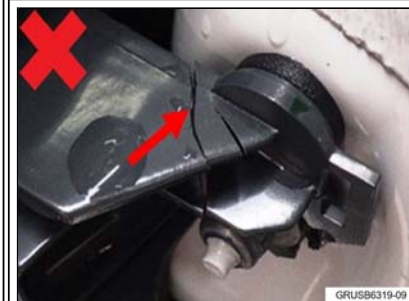
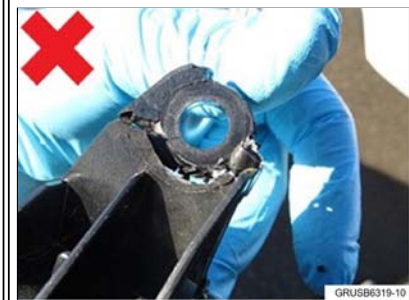
The tail light mounting brackets may be cracked or broken.

During assembly, oil may have contaminated the plastic housing of the rear tail lamps, causing damage to the mounting points of the tail light assembly.

5. Reference the photos to the left showing examples of cracks that are **NOT** acceptable and which require tail light replacement.

Holder broken  
Eye broken off

7. Remove one or both rear lights, depending on whether one or both lights are found to be damaged following the ISTA repair instructions for the applicable model.

10. Once the vehicle body has completely dried, install a new tail light on the affected side(s). **Replace all of the tail light mounting nuts with new nuts.** The tail light mounting nuts **MUST BE REPLACED** if they were removed to replace a tail light.
