## LED LIGHT CARPET IS DIM OR DISTORTED

This Service Information bulletin supersedes SI B63 03 18 **dated July 2018**

G01 (X3)	G02 (X4)	G05 (X5)	G07 (X7)
G12 (7 Series)	G20 (3 series)	G32 (640i xDrive Gran Turismo)

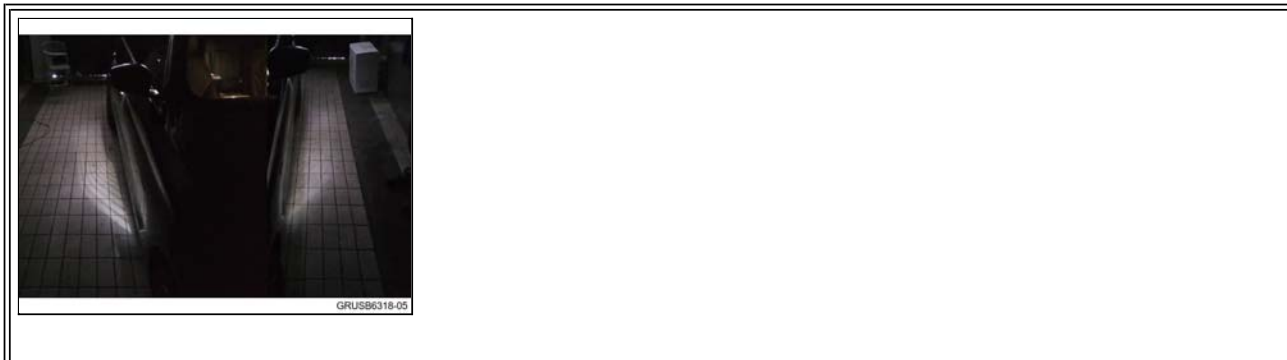
The light carpet may appear dim or distorted on one or both sides. See the photo below demonstrating the difference side to side.

The light carpet LED lens may be blocked by debris.

Clean the lens of the light carpet module. Replace the light carpet module only if the lens cannot be sufficiently cleaned.

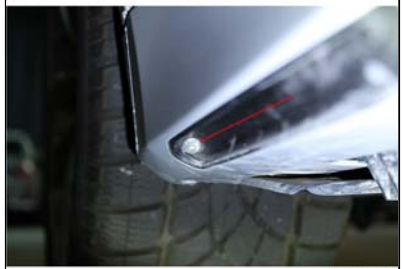
<p style="text-align: right; font-size: small;">GRUSB6318-02</p>	<p>1. Using a flashlight, inspect the lens of the light carpet module from underneath the vehicle.</p> <p>Is the lens covered by debris?</p> <p>Yes: Proceed to step 2.</p> <p>No: Continue troubleshooting, this SI B does not apply.</p>
