Service Solution Title - SS 1034023 FCCC MTG Park Brake Routing & Clipping

Applicable Vehicles - Certain FCCC M Line (Walk In Van) Chassis built between February 2, 2018 and March 7, 2018 with MT88 Engine controller.

## MTG Park Brake Cable Routing Repair Instructions

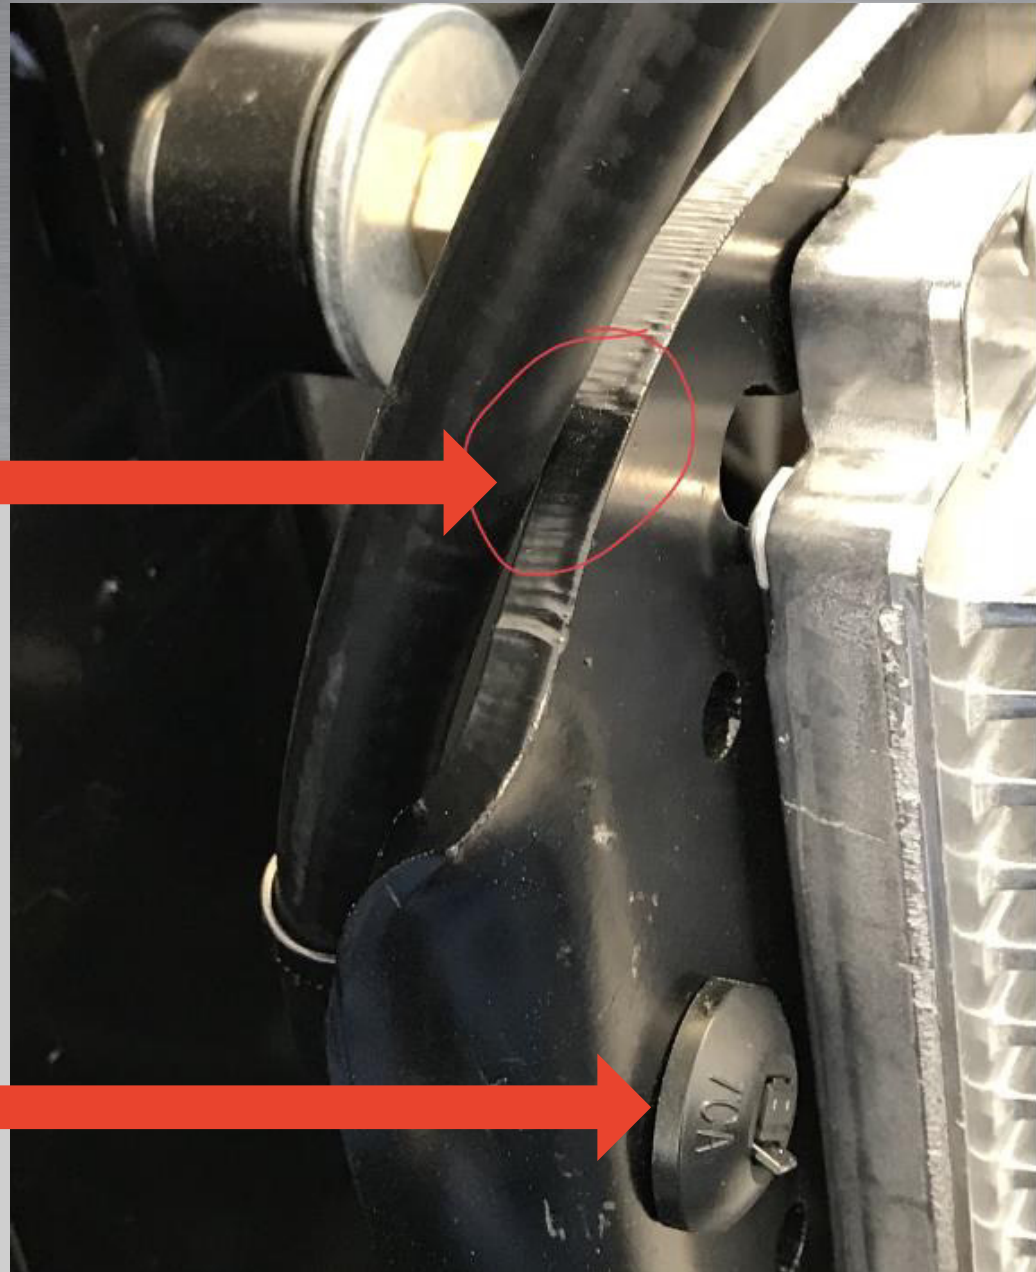
Possible park brake cable interference

Step 1: cut and discard spacer and button band
