12/17/2018
CAL 54-001

Subject: Battery Power Cable Routing

Models Affected: Specific Western Star 4900FA & 4900SA Model vehicles manufactured at the Portland or Cleveland manufacturing plant from February 28, 2014 to October 19, 2018

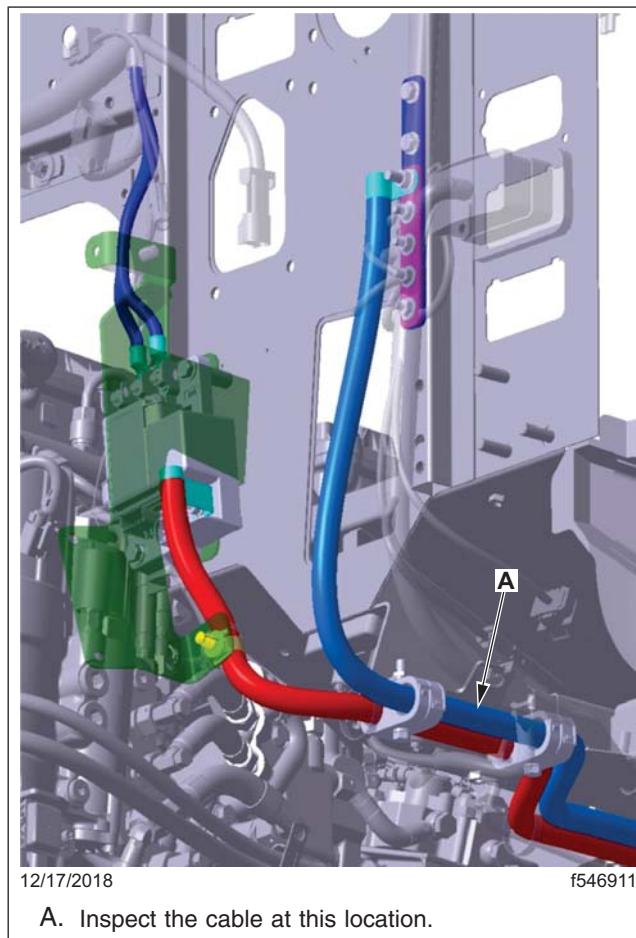
Fig. 1, Battery Cable Routing Under the Cab

Trucks equipped with battery power cable routing from the battery to the PNDB on the front wall may not have adequate clearance between the cab and the cab support bracket. Certain 4900FA & 4900SA trucks were shipped from the Portland or Cleveland truck manufacturing plant possibly without proper cable routing.

1. Park the vehicle, apply the parking brakes, and shut down the engine. Chock the tires.
2. Open the hood.
3. Inspect the battery cable routed between the battery box and the PNDB (located on the firewall) for signs of rubbing on the cab support bracket. See **Fig. 1** for location.

4. If signs of chafing or rubbing are present, disconnect the batteries and replace parts as needed, using BOM 29A-D40005.
